# Service Bulletin No. 407B

<i>MODEL</i>	<b>D Series</b>	<i>TYPE</i>	<b>Field Change Program</b>	<i>SECTION/GROUP</i>	<b>12-Suspension</b>	<i>DATE</i>	<b>June 26, 2014</b>
<i>SUBJECT</i>	<b>GABRIEL SHOCK ABSORBER POLYURETHANE BUSHING</b>						
<i>CONDITIONS</i>

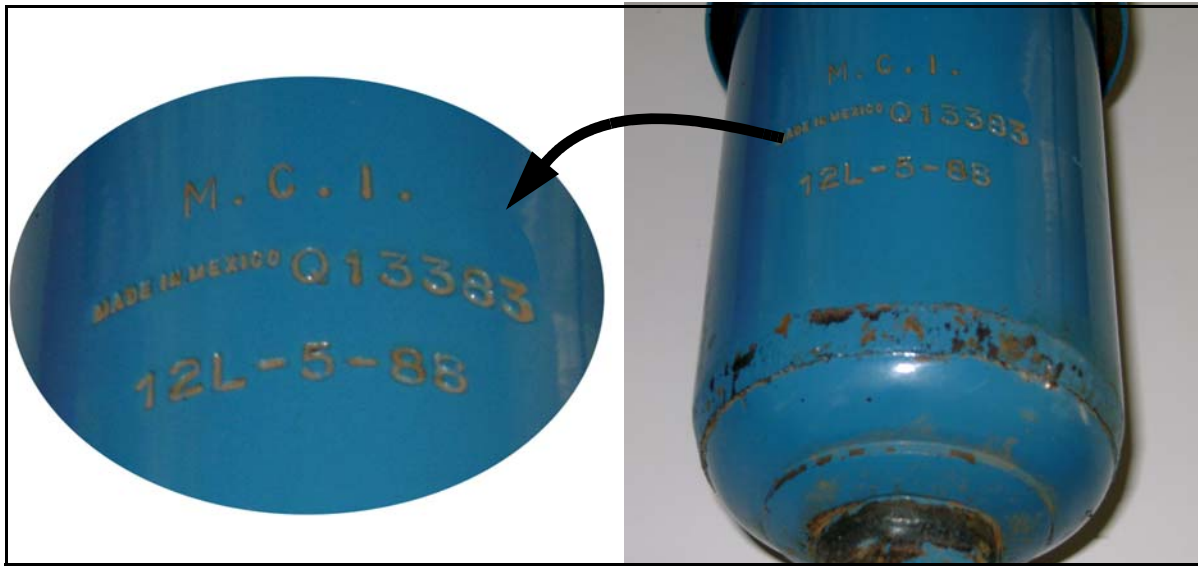
Figure 1.

1. Turn the main battery disconnect switch to the OFF position.
2. Using wheel lifts, lift the coach to the desired work height.
3. Position jack stand supports under the coach frame support points.
4. Carefully lower the axle a little to clear the lower shock absorber stud.
5. Visually inspect and record the date code on the front, drive and tag axle shock absorbers ( refer to Figure 1 ).

*If the date code on the shock absorber is stamped Q13 and the bushing is red, proceed to the procedure steps below to replace the bushing.*

*If the date code on the shock absorber is stamped Q13 and the bushing is not red, no further action is required. Proceed to the next shock absorber.*

*If the date code on the shock absorber is not stamped Q13, no further action is required regardless of the bushing color. Proceed to the next shock absorber.*

*Upon inspection, if the shock absorber stud is damaged take a digital photo of the fractured stud as well as the shock absorber part number and the date code ( refer to Figure 1 ). Contact the MCI Fleet Support Technical Center at 1-800-241-2947 for further information regarding replacement.*

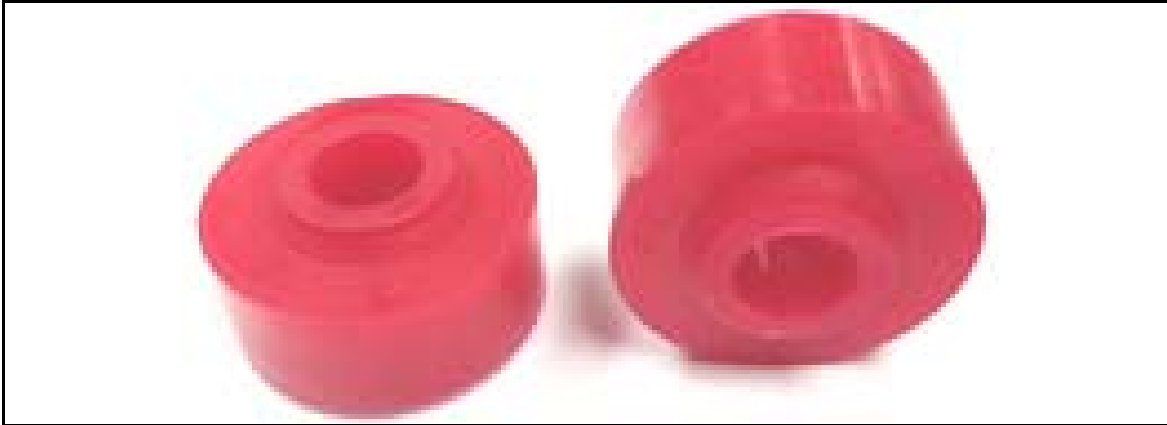
**Figure 2.**

6. Remove and retain the nut from the lower location ( stud end ) of the drive axle shock absorber.
7. Compress the shock absorber upwards.
8. Remove and discard the existing lock nut, washers and red polyurethane bushing from the lower location ( stud end ) of the drive axle shock absorber ( refer to Figure 2 ).

12. Unfasten and remove the hex nut, retaining washers and the existing red polyurethane bushing from both ends ( upper and lower stud end locations ) of the shock absorber. Discard the existing lock nut, washers and red polyurethane bushing ( refer to Figure 2 ).
13. Orient and install the new bushings, p/n 12-05-1320.
14. Re-install the shock absorber with new washers, p/n 12J-3-104 and new lock nut, p/n 19-3-153.
15. Drive the lock nut down until the outer diameter of the bushing extrudes to the same diameter of the washer.

9. Orient and install the new black bushings, p/n 12-05-1320.
10. Install the new washers, p/n 12J-3-104, and lock nut, p/n 19-3-153.
11. Drive the lock nut down until the outer diameter of the bushing extrudes to the same diameter of the washer.
