Freightliner
Service Bulletin

32-50

Incorrect ECAS Ride Height Sensor and Linkage Installation

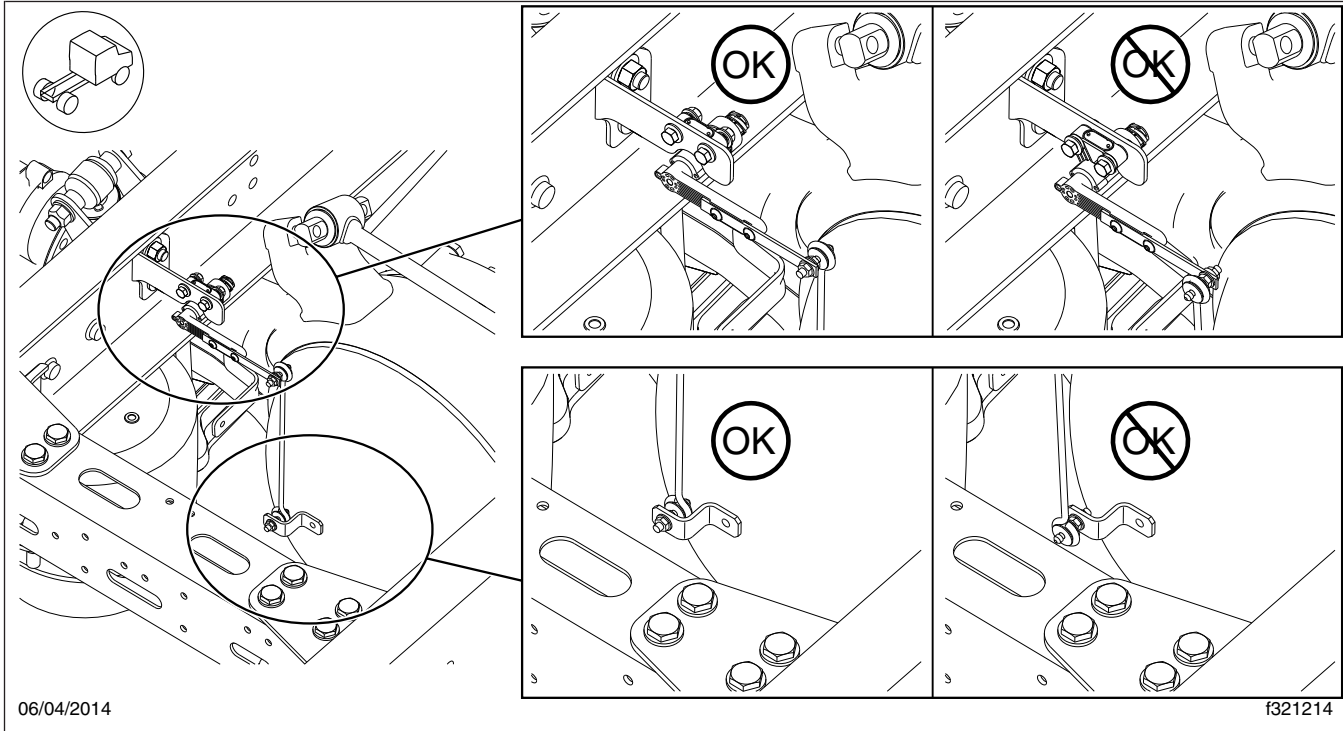
Fig. 1, Inspection of the Ride Height Sensor Installation

6. Compare the ride height sensor position of the vehicle to [Fig. 1](#). The sensor should be installed on the forward side of the sensor bracket, and the linkage rod should be on the forward side of the Z-bracket on the axle. The linkage rod should be upright, with no fore-aft tilt, as shown in [Fig. 2](#).

If the sensor or linkage rod are out of position, reposition them to match [Fig. 1](#). While the sensor is off the vehicle, inspect it for damage. If any cracking is found on the arm or body, replace the sensor.

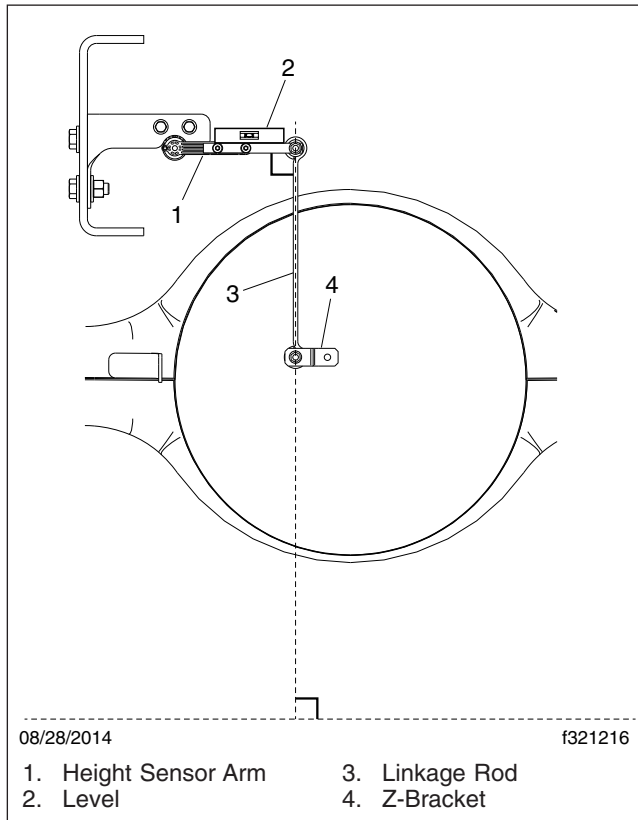
Fig. 3, Correct Position of the Arm, Linkage, and Z-Bracket

7. Check the position of the height sensor arm and linkage rod. See [Fig. 3](#). Check that the arm is level using a level, then use a plumb bob or carpenter's square to check that the linkage rod is at a 90° (right) angle to the level sensor arm.

If the arm is level, and the linkage rod is 90° to the arm and perpendicular to the ground, no further work is necessary.

If the arm is not level, and/or the linkage rod is not 90° to the arm, check the position of the Z-bracket as follows.

- 7.1 Remove the mounting stud from the Z-bracket.
- 7.2 Pin the arm to the sensor body using a 5/32-inch drill bit. If the arm isn't level when pinned, loosen the mounting fasteners and adjust the position of the sensor body on the frame bracket until the arm is level.

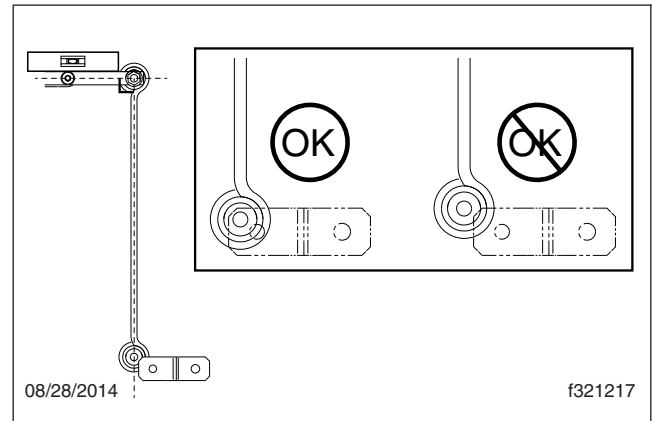
Fig. 4, Permissible Variation in Z-Bracket Position

- 7.3 With the height sensor arm level and the linkage rod at 90°, check if the linkage end hole is within the perimeter of the Z-bracket mounting face. See [Fig. 4](#).

If the end hole is within the perimeter of the Z-bracket mounting face, as shown in **Fig. 4**, the component positions are sufficient. No further work is necessary.

If the end hole is not within the perimeter of the Z-bracket mounting face, as shown in **Fig. 4**, install a new Z-bracket in the correct position. See **Positioning the Z-Bracket**.
