## **Subject: Meritor WABCO OnGuard System**

**Models Affected: Specific Freightliner Cascadia vehicles manufactured November 13, 2012, through March 13, 2014, with a Meritor WABCO OnGuard system.**

# Field Service Campaign

September 2014  
SF499A-H  
REVISED NOTICE

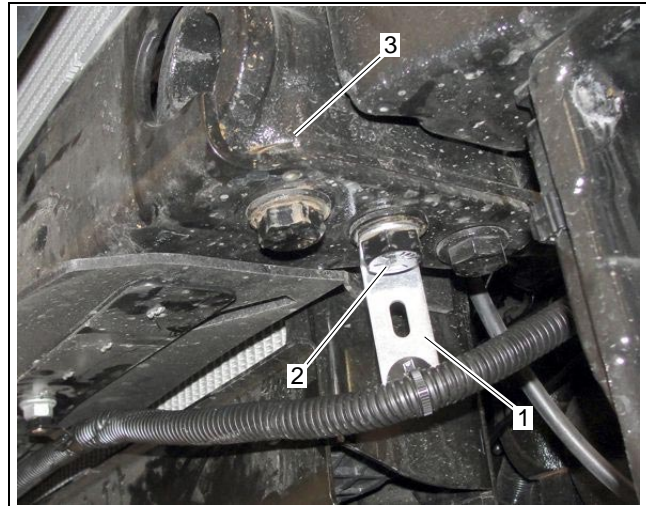
**IMPORTANT:** Make sure that the harness is oriented away from the OnGuard mounting bracket. The harness will be chafed and damaged if it contacts the bracket.
