**No.: 14 TS-26**  
September 18, 2014

SUBJECT: **Replacement of the High Pressure Fuel Pump Camshaft Oil Seal**

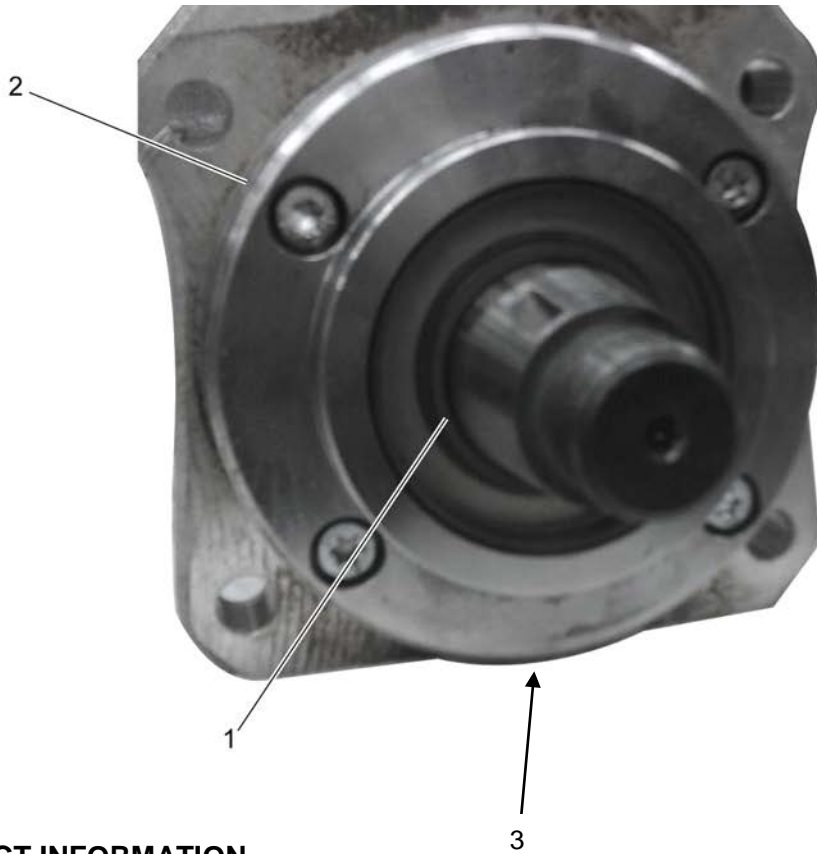
d470302b

High Pressure Fuel Pump (HPFP) camshaft oil seal (1) can fail causing an oil leak at the weep hole location (3) on the HPFP. Replacement of the HPFP is no longer necessary; replace the oil seal instead. High Pressure Fuel Pumps affected are EPA07/10 and GHG14 DD13/15/16 engines, built before engine serial number 201835 with Racor three-filter and KM59 (GEN1) two-filter systems and ESN 205055 with KM63 (GEN2) two-filter system .

Do not mistake an oil leak at the HPFP for the O-ring (2) at the groove on the HPFP that seals the HP pump into the timing case. The O-ring (2) on the HPFP is serviceable on all pumps. The camshaft seal will leak at the weep hole location (3).

18SP706 and service tool W470589055900 will provide the necessary tools, parts, and instructions required to replace the HPFP camshaft seal (1).
