Technical Bulletin

87 14 03 June 18, 2014 2037095

Air Conditioning Blows Warm, Compressor-Condenser Refrigerant Line

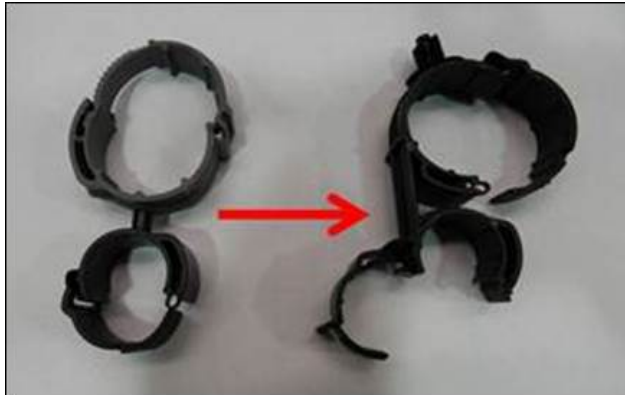
New double retainer refrigerant line holder 5N0 121 093L.

If vehicle has double retainer N 106 668 02, replace it with 5N0 121 093L

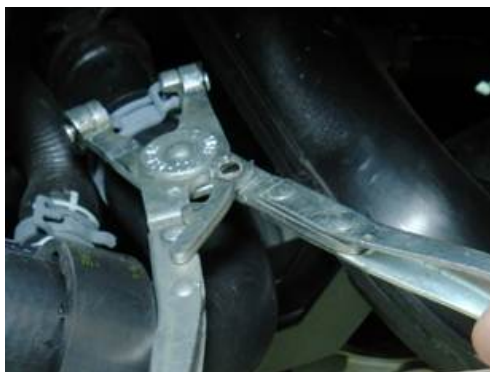
Figure 1

Disconnect only the clamp off the existing coolant temperature sensor housing. The housing pipe attached to the engine can stay connected.

- Remove the radiator hose from the thermostat housing to drain the coolant (Figure 1).

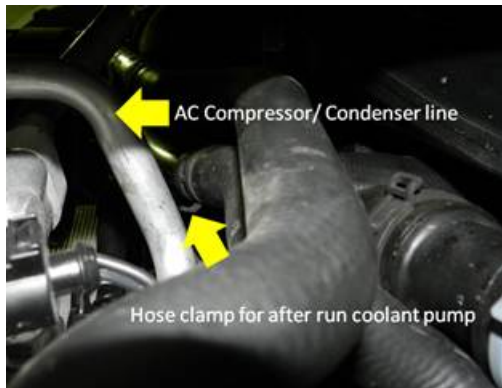
The picture shown in Figure 2 shows the AC line installed to capture the potential contact area.

- Locate the after run coolant pump and turn the clamp $\frac{1}{2}$ a turn from its original location away from the compressor/condenser line.
