VW Elsa Newsletter

Edition 96: July 28, 2014

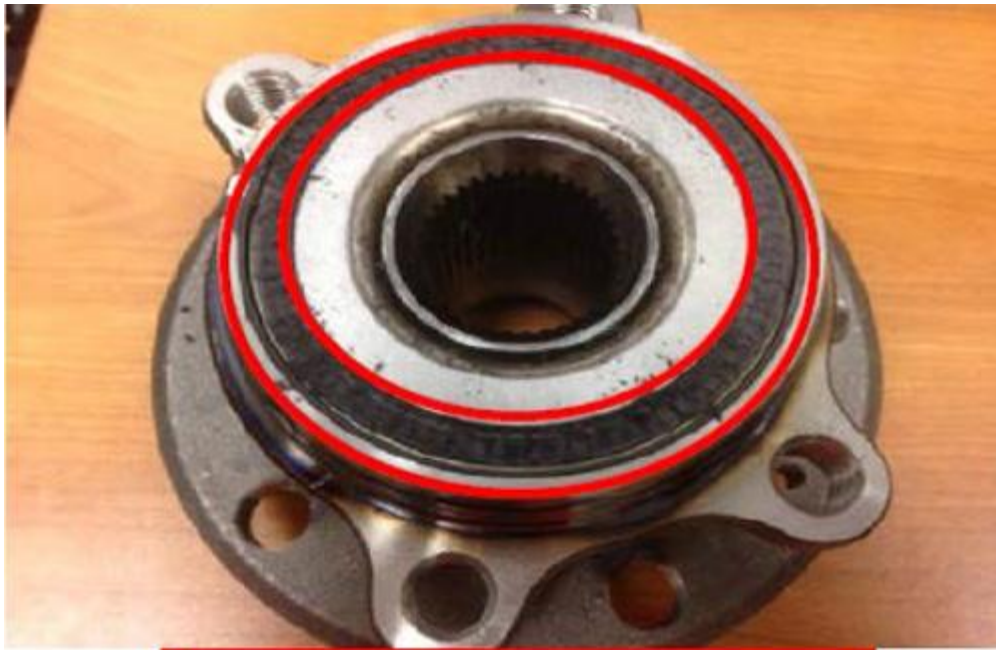
This can be the due to the Encoder Ring being ground down on the wheel bearing hub unit, resulting in a damaged part.

Cause: Damage from swapping the speed sensors left to right (or vice versa) during diagnosis. (Complete width of encoder damaged)

Encoder Ring Destroyed

Tip: Discontinue the practice of swapping sensors from side to side during workshop diagnosis.

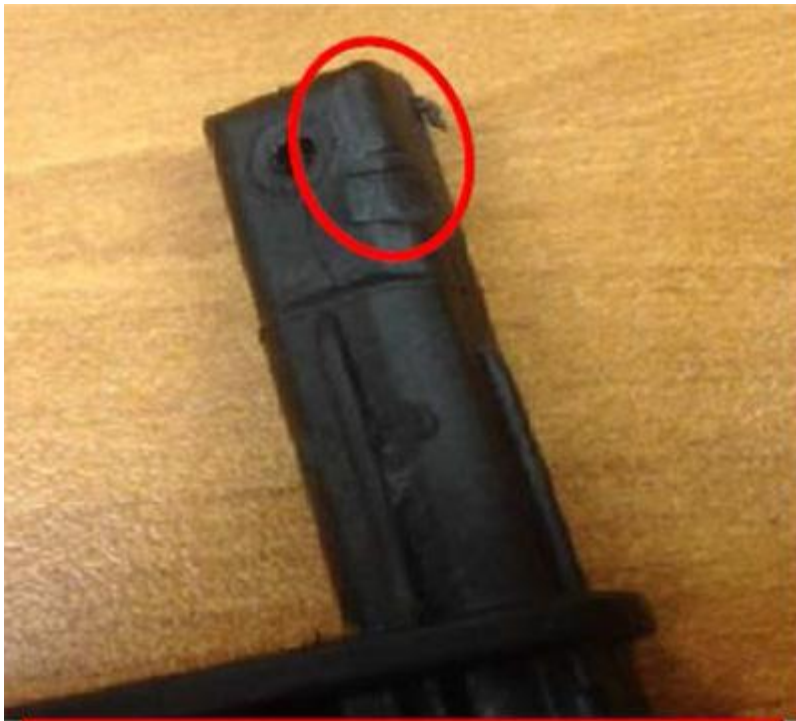
Speed Sensor Interference

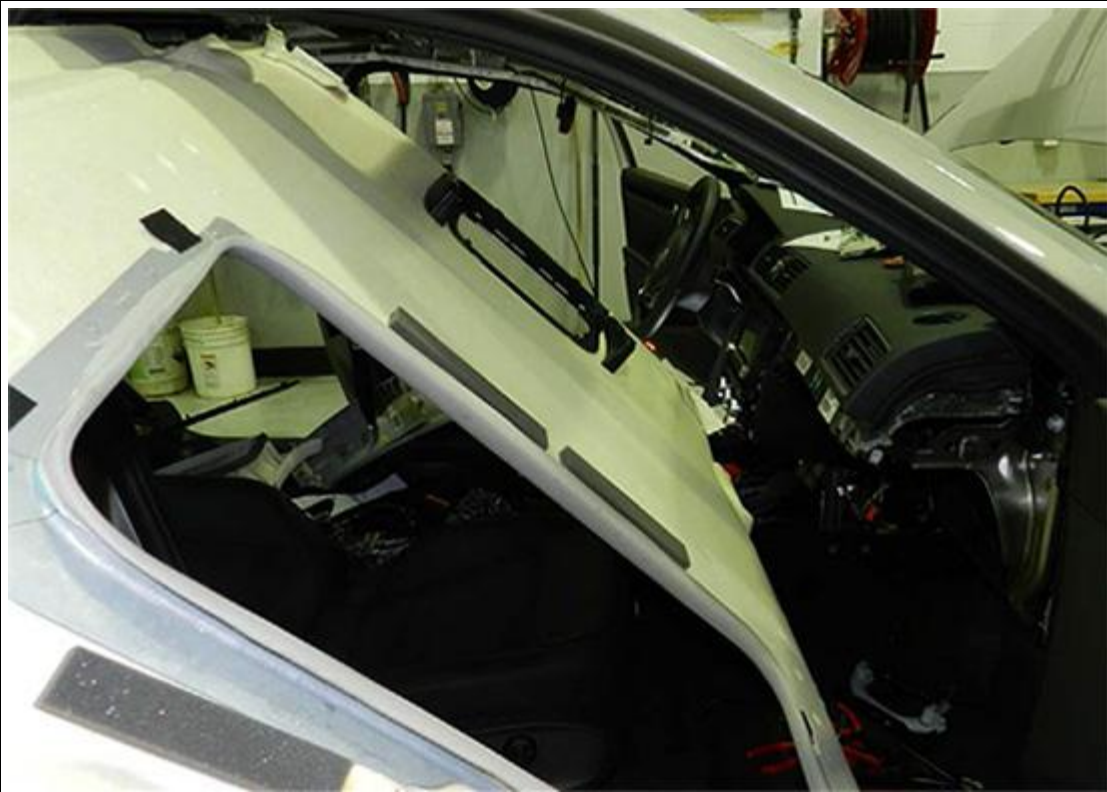
Below are steps of the headliner removed/reinstalled without being bent through the front passenger door with glove box removed and both front seats reclined flat.

All steps should be followed from ELSA. Every piece of trim the repair manual has you remove is very important to create the clearance needed to remove the headliner from the vehicle and get the new headliner into the vehicle.
