VW Elsa Newsletter

Edition 105: September 29, 2014

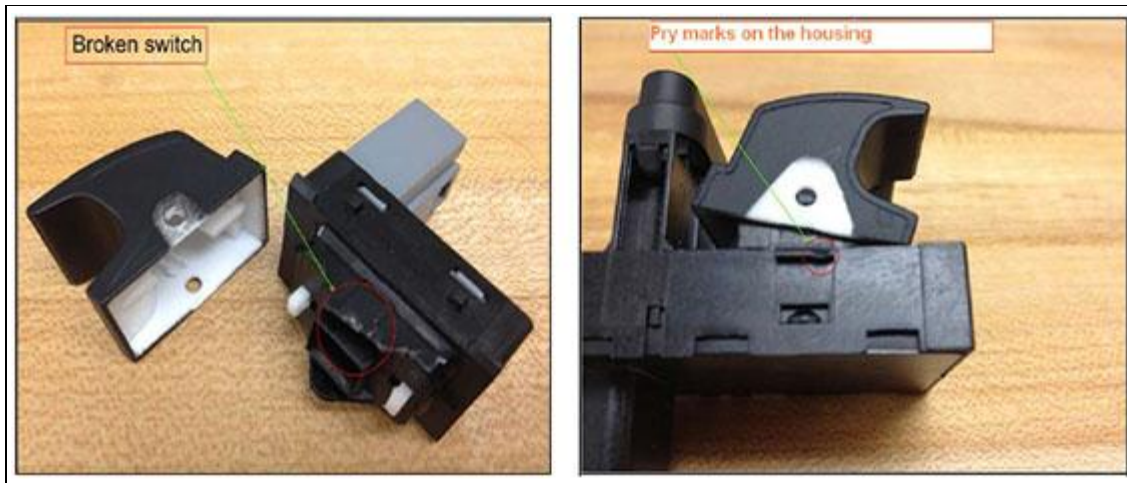
64-12-02 Window Switch Replacement September 19, 2014: Update to information.

Be advised that when replacing a window switch on the listed models, that the switch is not damaged during the removal process. It is preferred to use a bone tool to remove the switch from the housing as opposed to a screwdriver, to prevent the risk of the repair being debited (see examples below). It is also recommended to remove the window switch prior to removal of a door trim panel. This is in order to avoid the weight of the trim damaging the switch or the wire harness. Always check the connections and wiring prior to replacement of the switch.
