OIL PRESSURE SENSOR REPLACEMENT Prevost vehicles

Special Bulletin

SP14-300B

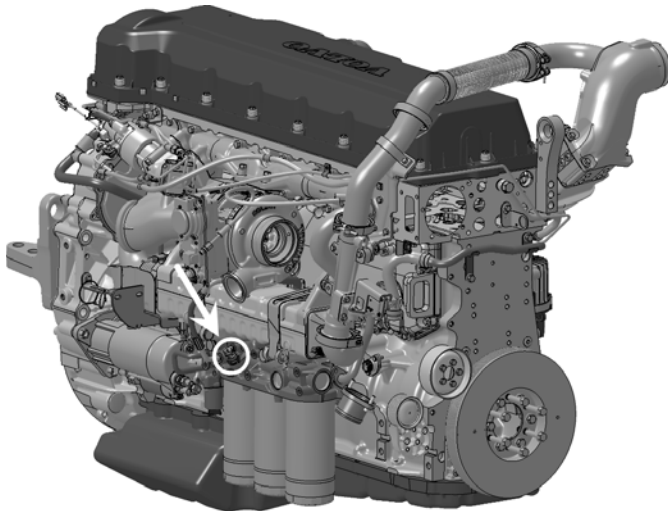
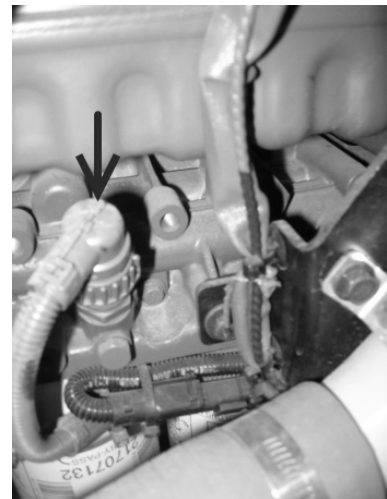
- 1) Disconnect the **PCJ oil pressure sensor** connector rotating the knurled collar counterclockwise. See the images below to locate the sensor.

- 2) Unscrew the sensor from the oil filter housing.
- 3) Inspect the engine harness for oil contamination. If a sensor is being replaced for electrical faults and oil has NOT wicked into the harness, **REPLACE THE SENSOR ONLY.** (p/n 21634021)
 - a. Install the new pressure sensor (p/n 21634021). Torque: 18.5 ± 2 ft-lb.
 - b. Reinstall the connector and rotate clockwise to lock.
- 4) If a sensor has failed **AND** is wicking oil into the engine harness, **REPLACE THE SENSOR AND INSTALL THE JUMPER HARNESS** p/n 22205127.

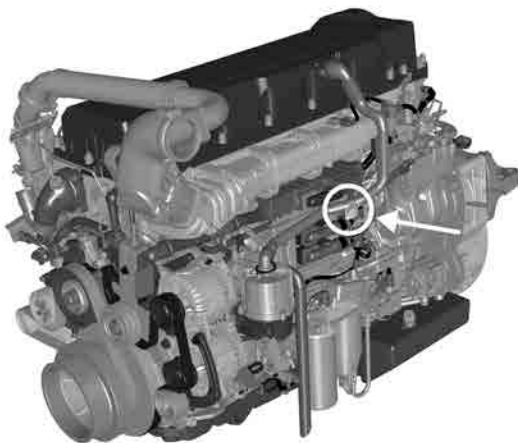
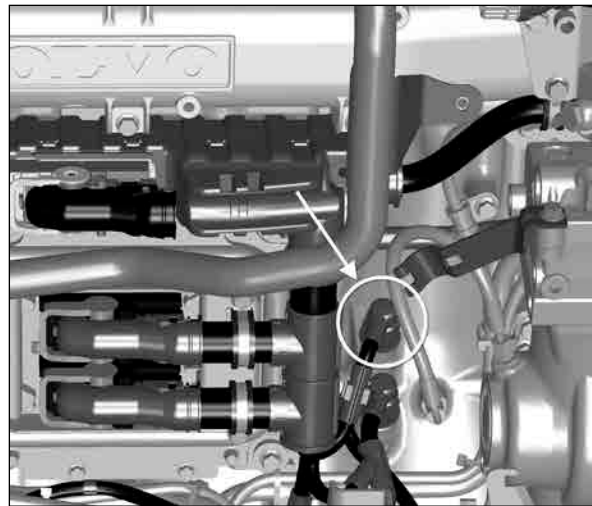
- f. If oil has wicked to the engine control module connectors, clean the connectors thoroughly with electronic cleaner and dry with compressed air.
- 5) On the other side of the engine (curb side), locate the **Engine oil pressure sensor** (Main gallery)

- 6) Disconnect the oil pressure sensor connector rotating the knurled collar counterclockwise. Refer to images below to locate the sensor.

- 7) Unscrew the sensor from the engine block.
- 8) Inspect the engine harness for oil contamination. If a sensor is being replaced for electrical faults and oil has NOT wicked into the harness, **REPLACE THE SENSOR ONLY.** (p/n 21634021)
- a. Install the new pressure sensor (p/n 21634021). Torque: 18.5 ± 2 ft-lb.
 - b. Reinstall the connector and rotate clockwise to lock.
- 9) If a sensor has failed AND is wicking oil into the engine harness, **REPLACE THE SENSOR AND INSTALL THE JUMPER HARNESS** p/n 22205127.
- a. Clip applicable cable ties and remove P-clamps securing the oil pressure sensor harness.
