## STEERING COLUMN COVER HARDWARE REPLACEMENT

Prevost vehicles

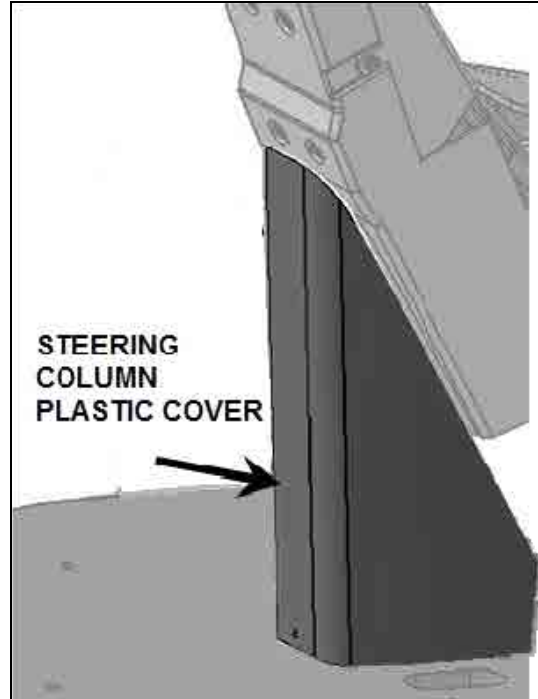
FIGURE 1

- 1) In the driver's section, locate the steering column plastic cover at the bottom of the steering column (figure 1).

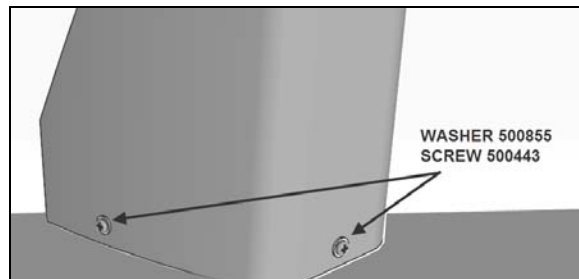
FIGURE 6 – 3<sup>rd</sup> FASTENING POINT NOT VISIBLE ON THE IMAGE

- 6) Reinstall the lower plastic cover, replacing each former trim panel fastener with:  
1x screw #500443,  
1x washer #500855

(see figure 6)
