# Service Bulletin

## SAFETY and EMISSIONS RECALL

### 2014 Grom125 FUEL PUMP REPLACEMENT

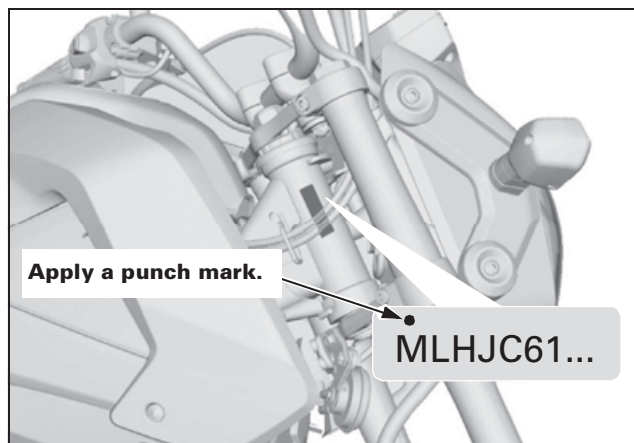
After you have completed the REPAIR PROCEDURE, apply a punch mark above the first character of the VIN located on the frame as shown.

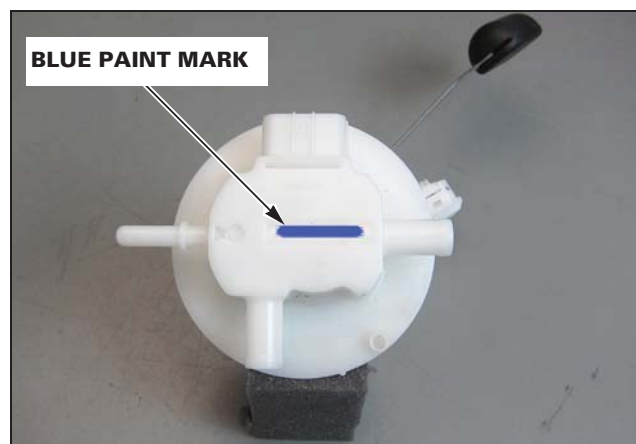
Be careful not to mix up the defective and replacement parts. The countermeasure part is identified by a blue paint mark as shown. Use care during unpacking and installation as the paint mark is easily wiped off.
