Technical Bulletin

21 15 02 January 20, 2014 2025464 Supersedes T. B. V211404 dated May 1, 2014 for labor operation update.

Frozen Charge Air Cooler – Engine Will Not Start

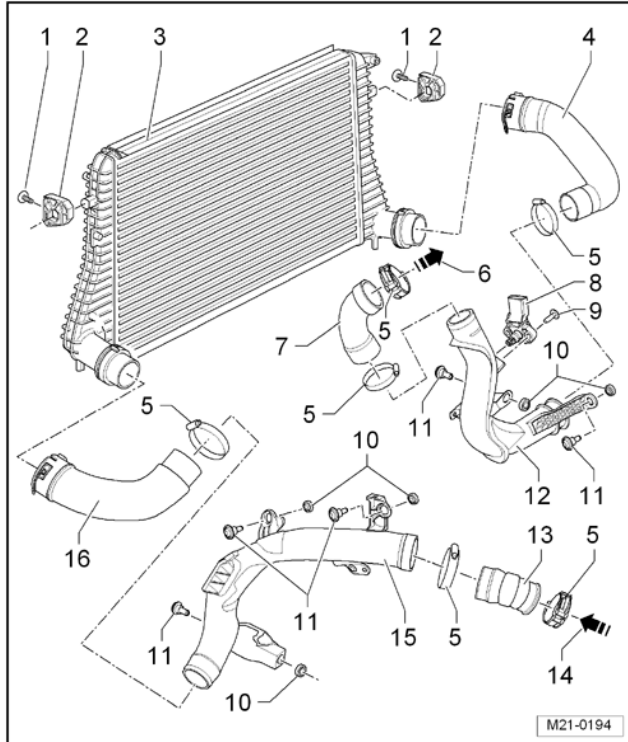
Figure 1

Engine will not start after standing in cold weather below 0°C (32°F), MIL may be illuminated with various induction and/or boost system faults stored in ECM.

Moisture from the intake air condenses and collects in the charge air cooler. At cold temperatures this moisture can freeze causing blockage of the intake air system.

Install revised charge air cooler kit P/N 1K0 198 803B to avoid the formation of this moisture in the boost system.

- Lock carrier in service position. See Repair Manual Group 50 in Elsa.
- Separate A/C condenser from charge air cooler.
- Remove radiator and radiator fan assembly.
- Remove the original charge air cooler (item 3 in figure 1) from the vehicle.

- Remove the lower charge pressure hoses (items 4 and 16 in figure 1) and clean of any moisture, ice crystal formation or sludge. See Repair Manual Group 21, Turbocharger/G-Charger, Description and Operation, Component Overview, in Elsa.

- Install the revised charge air cooler (item 3 in figure 1) with regulating flap and connect the regulating flap vacuum hose.
- Re-assemble all charge air pipe connections.
- Connect A/C condenser to charge air cooler using fasteners from kit, and install radiator with fan assembly.
- Reassemble front carrier.
- Re-aim headlights.
