VW Elsa Newsletter

Edition 107: October 13, 2014

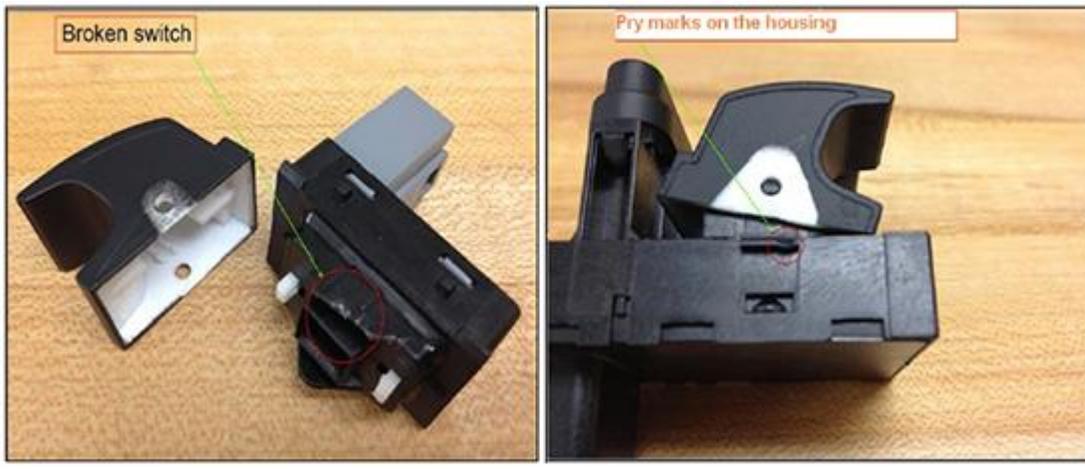
**64-12-02 Window Switch Replacement
October 3, 2014: Update to information.**

Be advised that when replacing a window switch on the listed models, make certain that the switch is not damaged during the removal process. It is preferred to use a bone tool to remove the switch from the housing as opposed to a screwdriver, to prevent the risk damage (see examples below). It is also recommended to remove the window switch prior to removal of a door trim panel. This is in order to avoid the weight of the trim damaging the switch or the wire harness. Always check the connections and wiring prior to replacement of the switch.

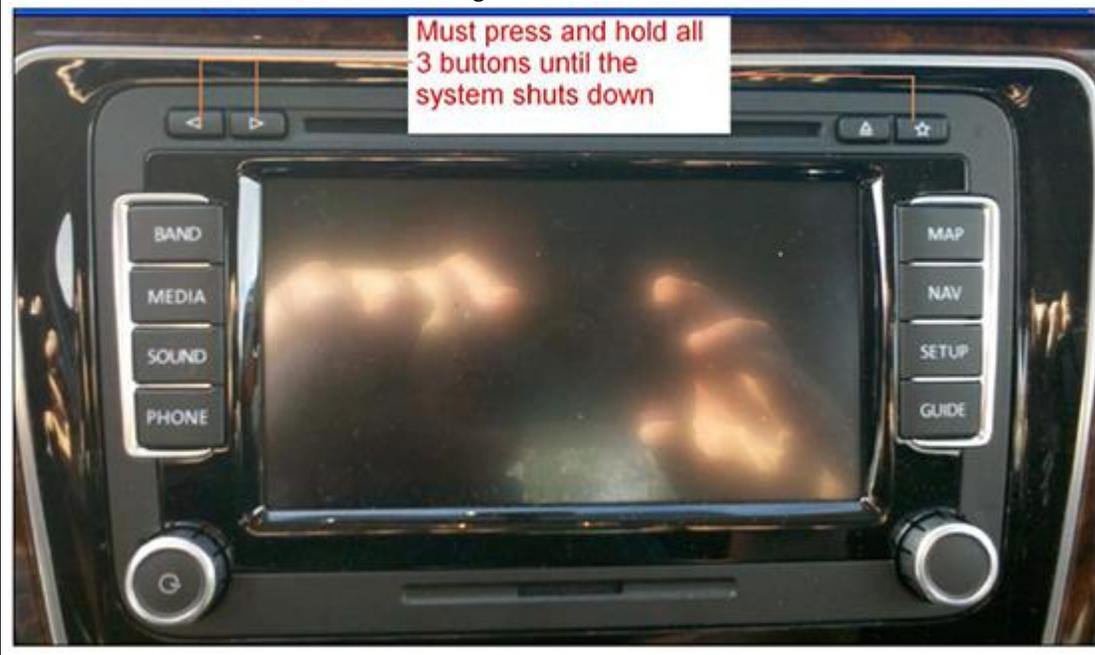
**91-11-17 Replacement Radio/Navigation Unit has no Sound
October 3, 2014: Update to model year information.**

Replacement RNS 510 radio/navigation units may be shipped in transportation safeguard mode and therefore will have no sound output. In order to switch the unit out of this mode, hold down the forward seek button, the back seek button, and the music button at the same time until the unit shuts down. Once the unit is powered back 'ON' the safeguard mode will be deactivated.
