# UPDATE Technical Bulletin

October 1, 2014

## 45D7 UPDATE - TPMS/ESC Software (NVLW)

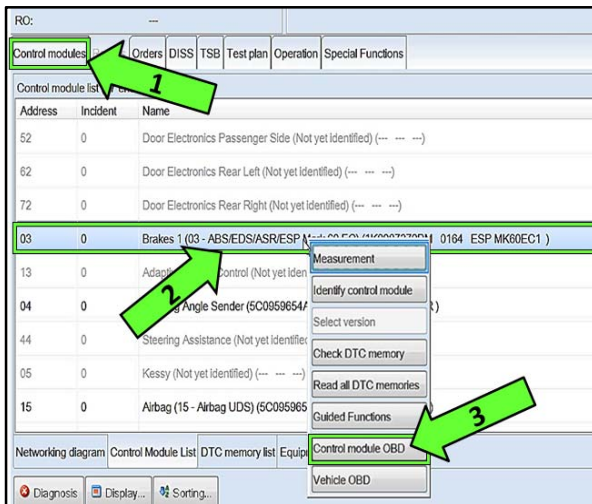
- ← From the Control modules tab <arrow 1>, right click on 03 for ABS <arrow 2>.
- ← Select Control module OBD <arrow 3>.

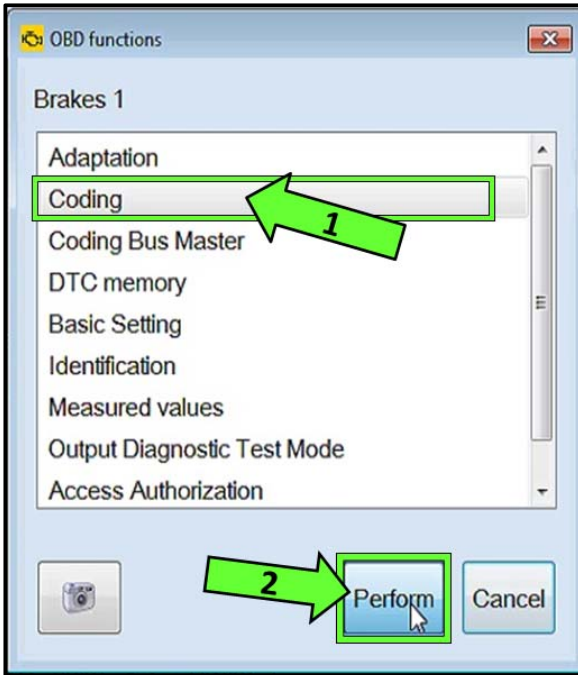
← Select Coding <arrow 1>, then select Perform <arrow 2>.

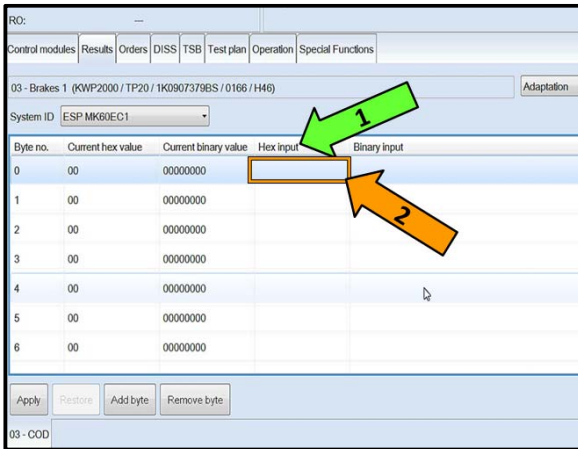
← Under Hex Input <arrow 1>, select the blank box <arrow 2> that lines up with the byte to be changed (e.g. "0" shown).

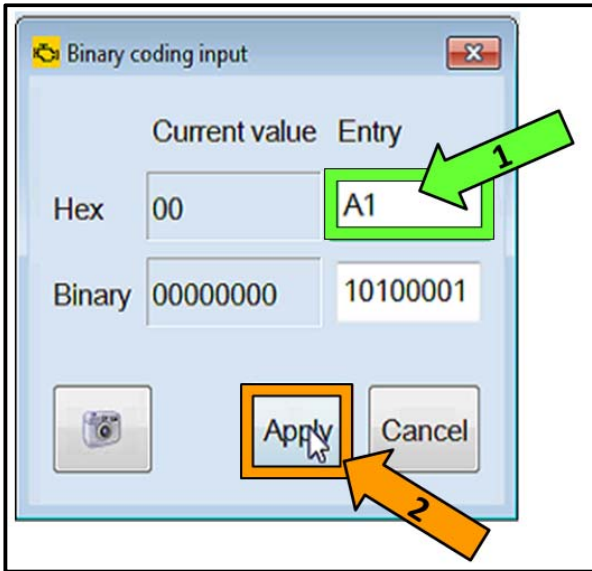
⇐ In the Hex Entry box <arrow 1>, input the Hex value for the byte to be changed, and then click Apply <arrow 2>.

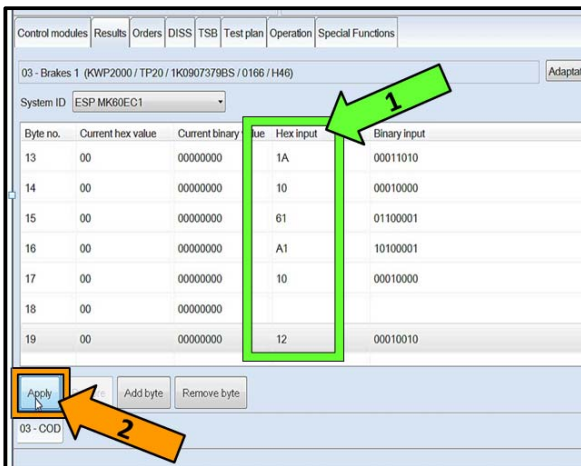
⇐ Validate that all Hex Input data <arrow 1> matches original coding.

⇐ Select Apply <arrow 2>.
