Technical Bulletin

91 14 09 October 6, 2014 2031136 Supersedes T. B. V911305 dated February 8, 2013 to include a special claiming HST revision number in the warranty table.

Update Programming RCD-510 Radio (Premium 8)

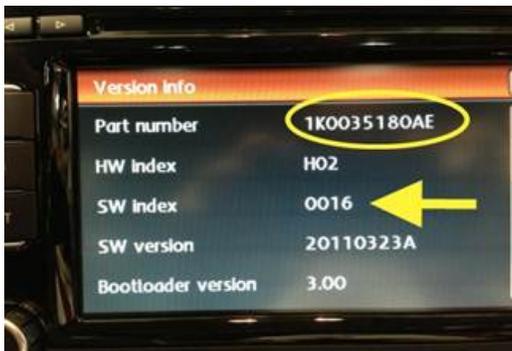
2012 vehicles, software 383F

- Verify current part number is **1K0.035.180.AE, 1K0.035.180.T, 1K0.035.188.D, 1K0.035.188.E** <circle>.
- Verify current SW index is one of the following software levels: 0007, 0008, 0009, 0010, 0011, 0012, 0013, 0014, 0015, 0016 <arrow>.

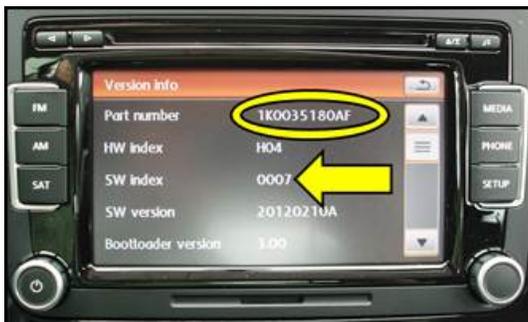
2013 vehicles, software 37DC

- Verify current part number is **1K0.035.180.AF, 1K0.035.180.AG, 1K0.035.188.F, 1K0.035.188.G, 5C6.035.180, 5C6.035.180.A** <circle>.
- Verify current SW index is "0006, 0007, 0008" <arrow>.

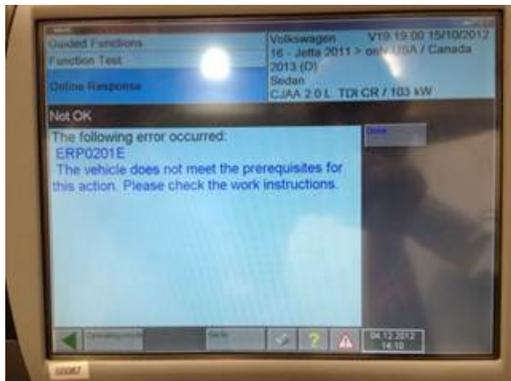
- Wrong radio used will display the following error code.
