## Service Bulletin 509

January 2014

**Affected Models** .....Tiger 800 and Tiger 800XC

**Subject** .....Clutch Cable Routing

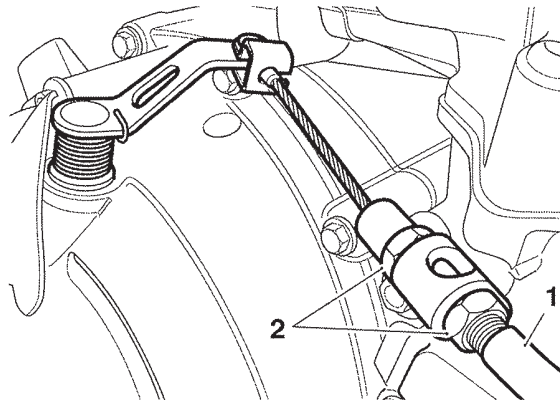
1. Clutch cable
2. Adjuster

- Some affected motorcycles listed in the VIN range will have been modified and repaired by Triumph prior to their release from the factory.
  - The modified motorcycles can be identified by checking the 'VIN Enquiry' on [Triumphonline.net](http://Triumphonline.net).
1. Slacken the cable lock nut and release the adjuster at the clutch cover end to give maximum play in the cable.

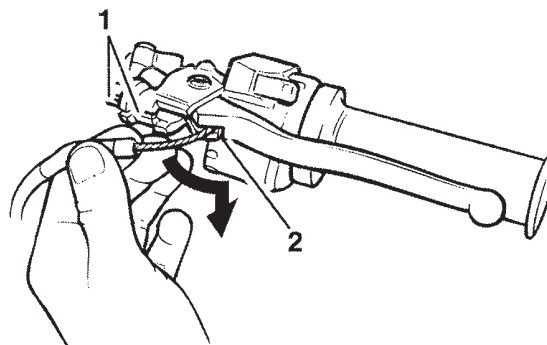
gaau\_1

1. Cable adjuster/lever bracket slots
2. Cable release point

2. Align the clutch cable adjuster and lever bracket slots.
3. Pull in the clutch lever and turn the inner cable anti-clockwise through the slots in the adjuster, until the cable can be detached from the lever by pushing downwards.

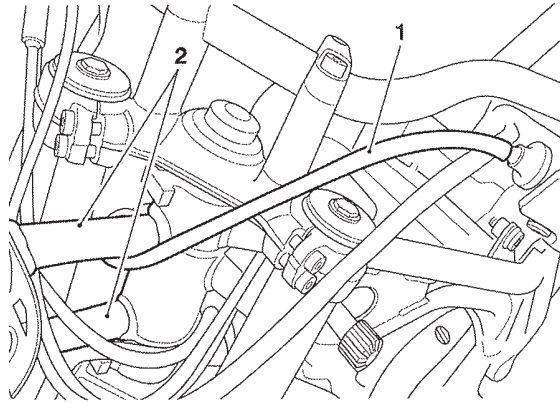
We have identified a need to re-route the clutch cable as it has been incorrectly routed above the headlight/instrument mounting bracket in the headstock area.

**1. Clutch cable**

**2. Headlight/instrument bracket**

4. Re-route the cable such that it is between the two bars of the headlight/instrument bracket, as shown below.
