## Service Bulletin 507

February 2014

**Affected Models** .....Thunderbird Commander and Thunderbird LT

**Subject** .....Additional PDI Checks

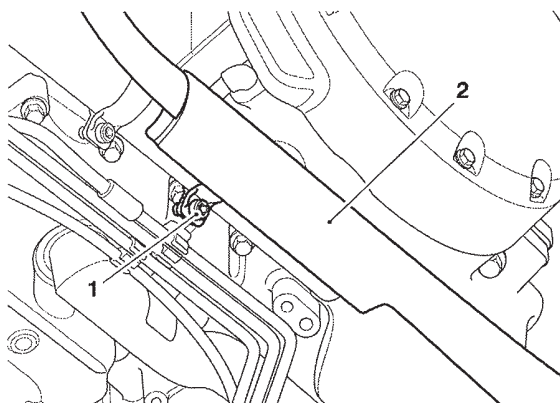
1. Fixing

2. Front heat shield, right hand side

1. Check and, if necessary, tighten the fixing for the left and right hand front exhaust heat shields to **9 Nm**.

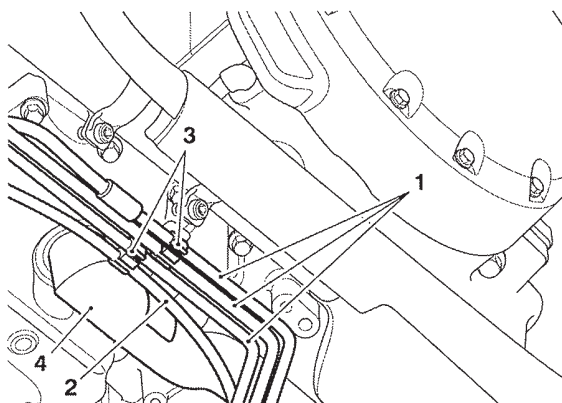
1. Brake hard lines
2. Clutch cable
3. Clips
4. Coolant pipe

1. Detach the three brake hard lines and the clutch cable from their clips located on the bracket near the coolant pipe under the engine.

2. Using suitable pliers, remove the two plastic clips from the bracket.

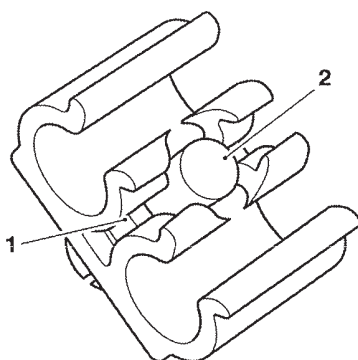
1. Clip
2. Rivet

3. Position the new clips onto the bracket as noted for removal.
4. Using a suitable pin punch, carefully push in the plastic rivet until it clicks into position and is flush with the base of the clip.

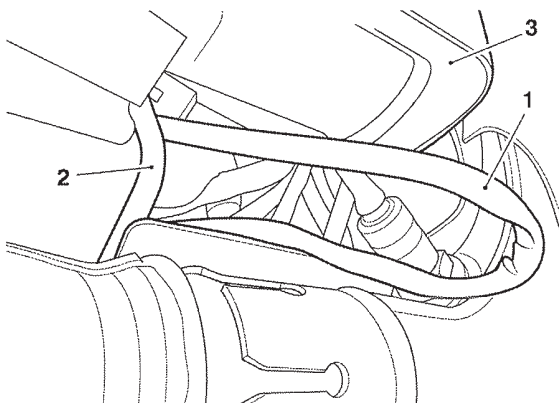
1. Right hand oxygen sensor harness

2. Brake hard line

3. Radiator

2. Locate the harness for the right hand oxygen sensor and gather all the slack. Move the slack in the oxygen sensor harness to the left hand side of the radiator, ensure the harness is positioned behind the brake hard line.

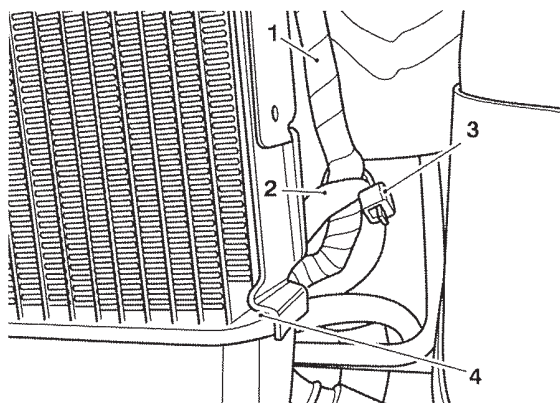
1. Main harness
2. Right hand oxygen sensor harness
3. Cable tie
4. Radiator

3. Secure the harness for the right hand oxygen sensor to the main harness with a cable tie, as shown below. Cut off any excess cable tie.

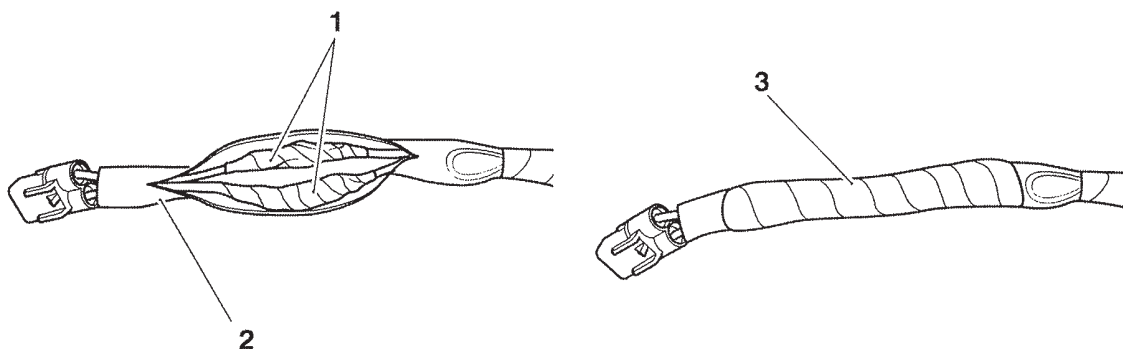
- An additional 0.25 hours may be claimed via warranty for the repair of harness as described below.
5. Carefully, and without damaging the wires, slice along the damaged area of the covering for the cooling fan part of the main harness and check the condition of the two wires. Do not slice the covering from end to end.
  6. Depending on the condition of the wires carry out one of the following:
    - If the two wires are stuck together, separate the two wires and insulate each wire with insulating tape.
    - If the insulation around the wires is damaged, insulate each wire with insulating tape.

1. Insulating tape, wire repair
2. Harness cover
3. Insulating tape, covering the cut in the harness cover

7. When the wires have been repaired or are serviceable, cover the wires with the harness covering and use black insulating tape to completely cover the slit, as shown in the illustration below.

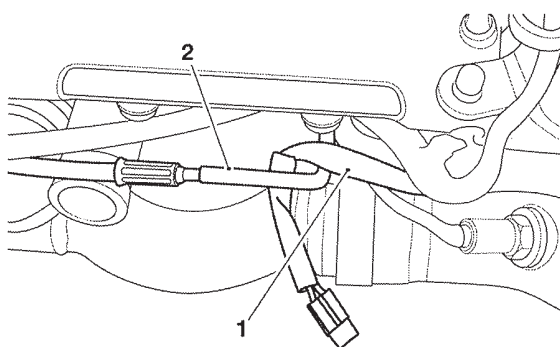
1. Main harness, cooling fan
  2. Brake line
9. Re-connect the cooling fan to the main harness and attach the multiplug onto its clip near the bottom of the radiator.

8. Route the cooling fan part of the main harness over the top of the brake line, as shown below (radiator shown removed for clarity).

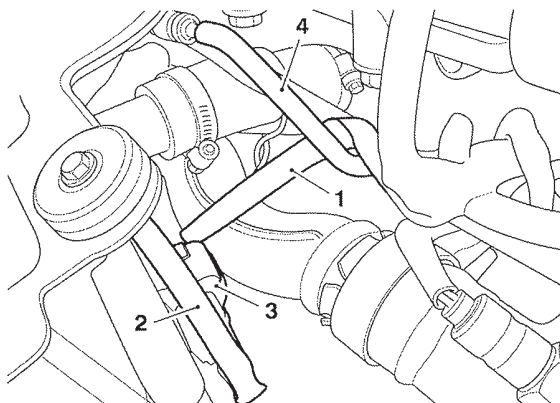
- 1. Main harness, for cooling fan
- 2. Cooling fan harness
- 3. Multiplug
- 4. Brake hard line

10. Ensure the cooling fan harness is routed as shown below, noting that the harness must pass over the brake hard line.
