Technical News 157
May 2014
Strictly Confidential

Item	Subject	Model Affected
Item 1.	Fork Oil Level	Thunderbird Commander and Thunderbird LT
Item 2.	Service Manual Amendment - Exploded View ABS System	Tiger Sport
Item 3.	Torque Change, Seat Infill Panel Locating Lug Fixings	Tiger Explorer and Tiger Explorer XC
Item 4.	Harness, Gear Position Sensor and Harness/ Gear Position Sensor Parts Kit	Rocket III Roadster
Item 5.	Torque Change, M10 ABS Hard Line Unions	Speed Triple ABS, Speed Triple R ABS and Sprint GT
Item 6.	Front Fork Disassembly and Assembly	Daytona 675 Models from VIN 564948 and Street Triple Models from VIN 560477
Item 7.	New Packing Crate and Footboard Reassembly	America
Item 8.	Main Frame Parts Kit	Daytona 675 Models from VIN 564948 and Street Triple Models from VIN 560477
Item 9.	Torque Change, Clutch Cover Fixings	Daytona 675 and Daytona 675R from VIN 564948
Item 10.	ABS Front Brake Line	Tiger Sport, Tiger 1050 ABS

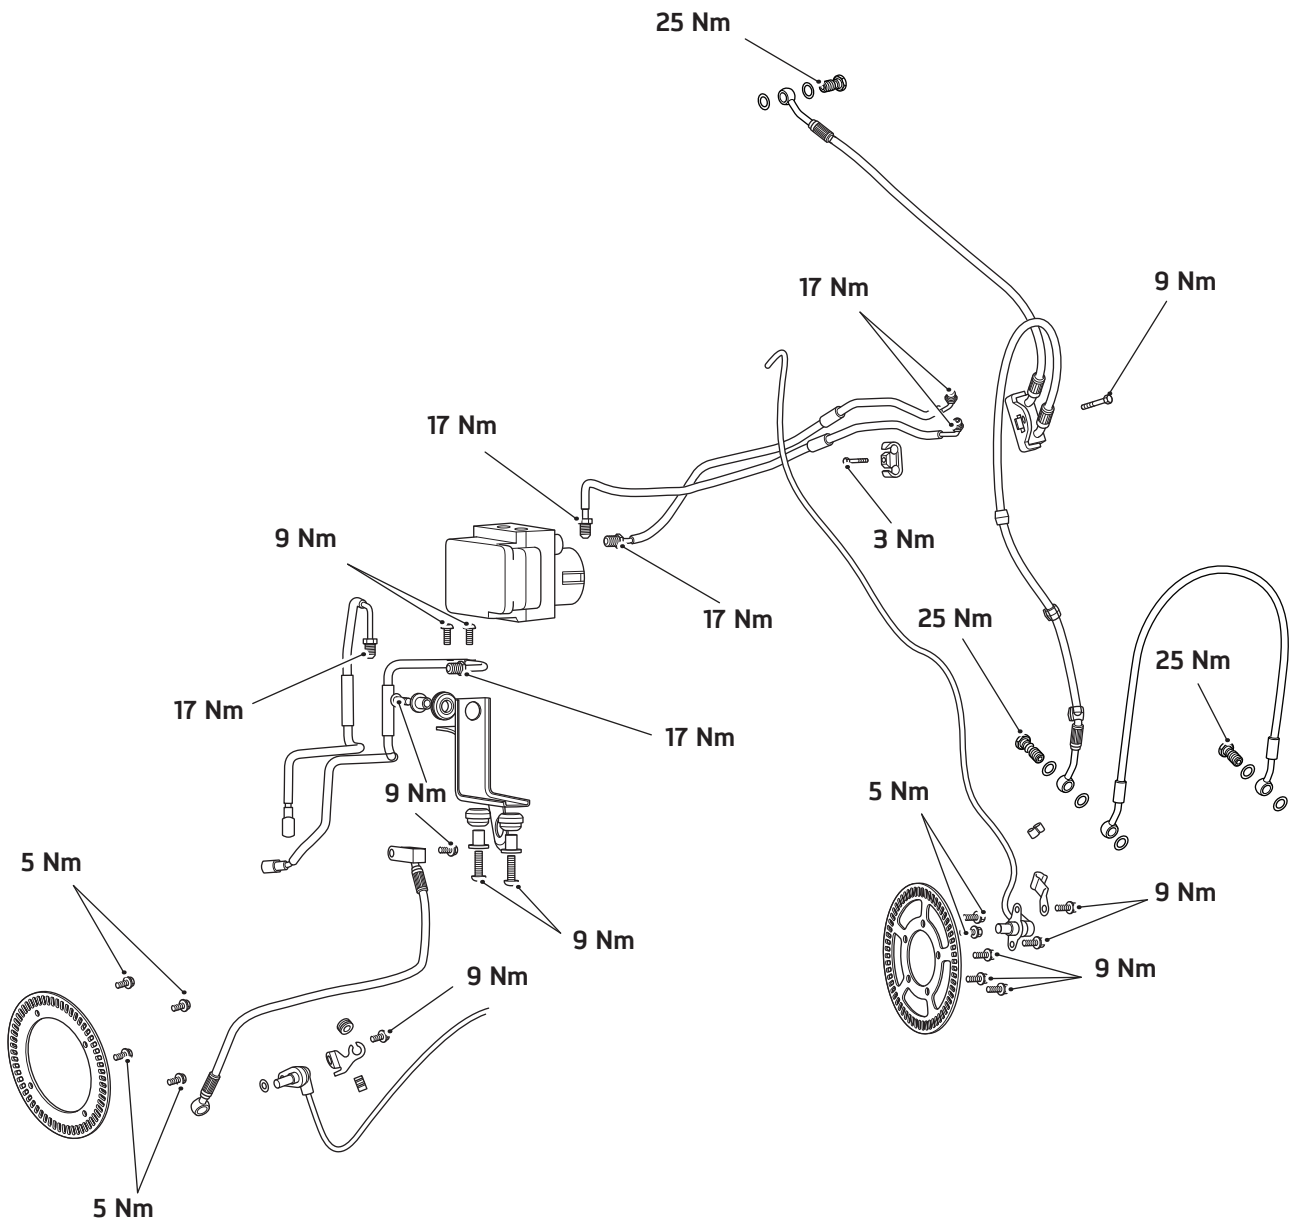
The exploded view of the Tiger Sport ABS system in the above Service Manual shows the incorrect routing of the ABS hard lines between the ABS modulator and the front brake lines. The following illustration must replace the current one as an amendment to the Service Manual.

If for any reason the brake lines are removed they must be connected as shown below.

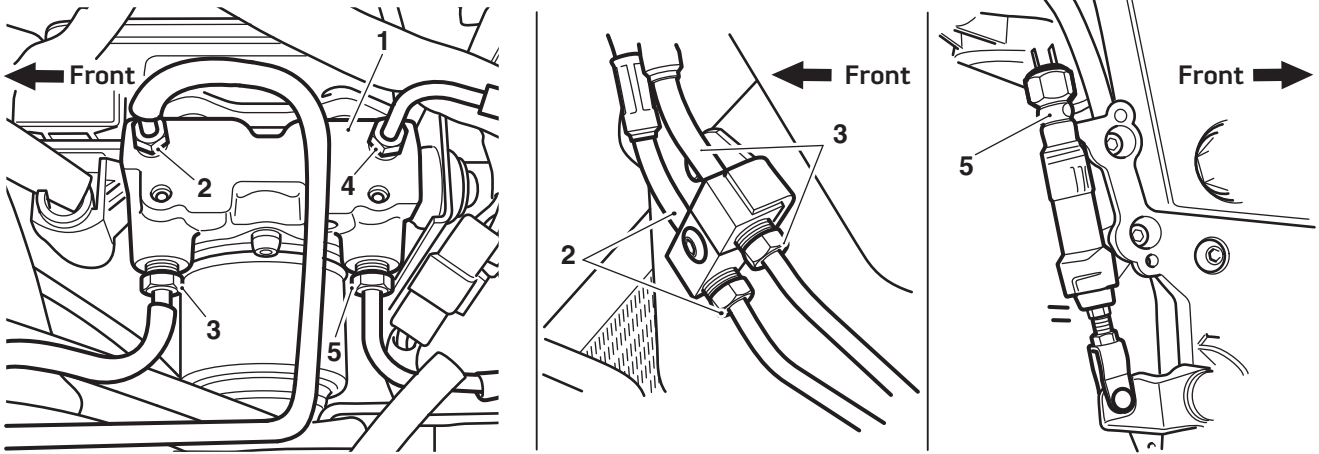
1. ABS modulator
2. ABS modulator to front brake caliper
3. ABS modulator to front brake master cylinder
4. ABS modulator to rear brake caliper
5. ABS modulator to rear brake master cylinder

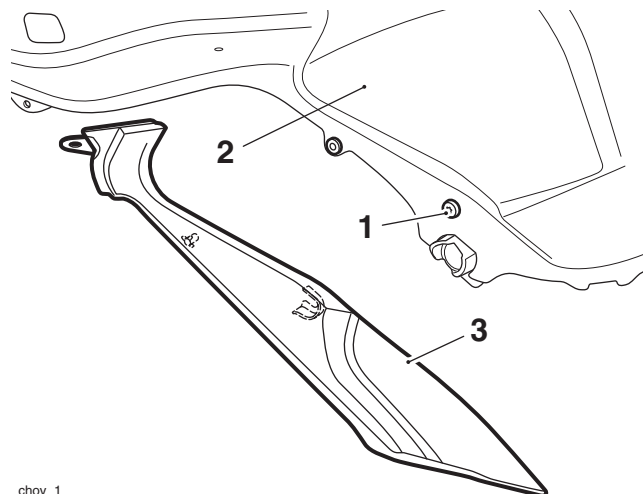
The torque figure for the seat infill panel locating lug fixings has changed to **9 Nm** on the above models. The locating lug fixings are positioned on either side of the fuel tank as shown below.

- choy_1
1. Seat infill panel locating lug fixing (left hand shown, right hand similar)
 2. Fuel tank
 3. Seat infill panel

- The torque figures for all other fixings securing the seat infill panels remain unchanged.
- Models already in service need not be retightened unless the fixings have been loosened or removed.

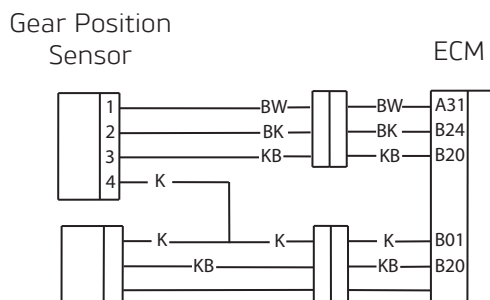
Old Gear Position Sensor with Fly Lead

The gear position sensor pinpoint test procedure has also changed. The pinpoint test procedure for the new gear position sensor and old gear position sensors with a fly lead is as follows:

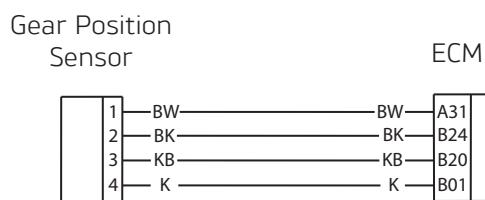
New Gear Position Sensor

A new harness and gear position sensor have been released for Rocket III Roadster models from engine number 651833. The new gear position sensor is fitted with a long electrical lead which is now connected directly to the main harness without the use of a fly lead.

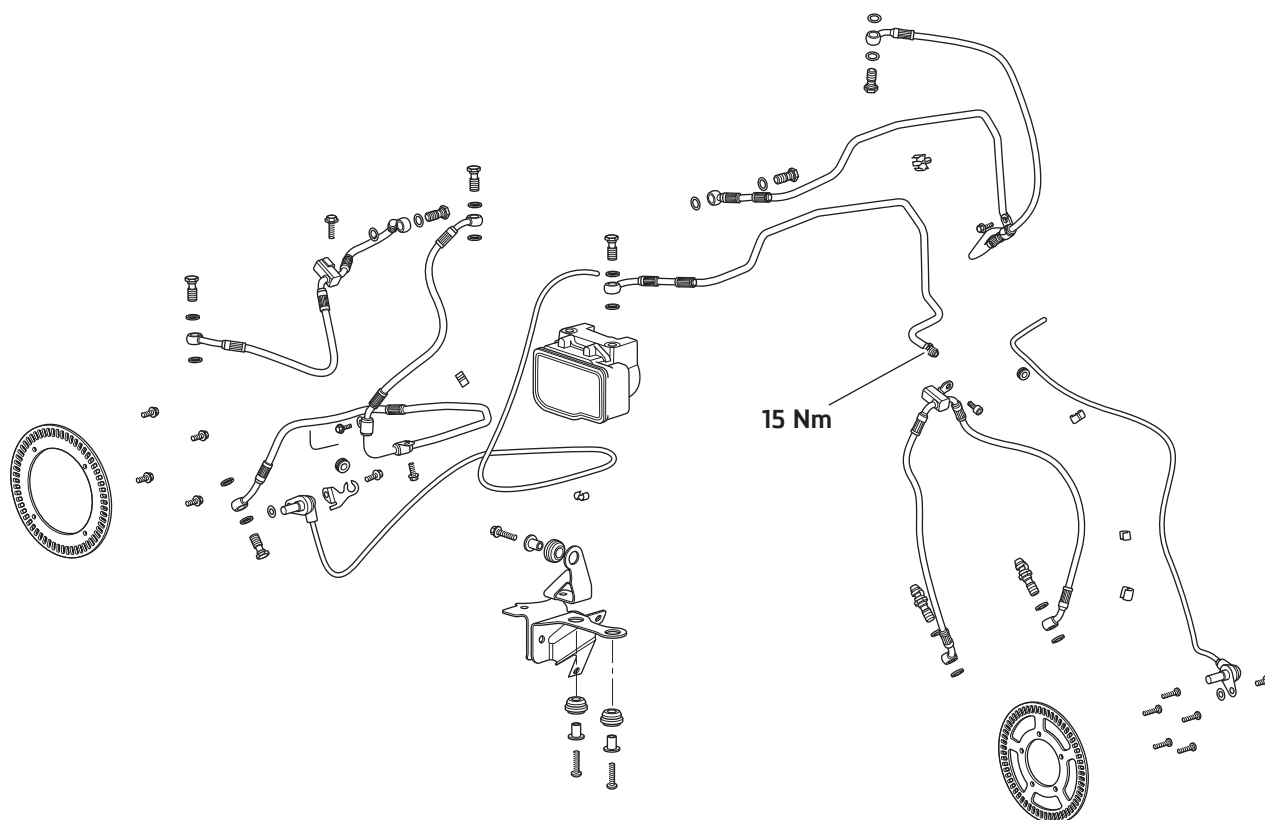
ABS System - Speed Triple ABS and Speed Triple R ABS

The torque figure for the M10 ABS hard line unions has changed to **15 Nm** on the above models.

- Models already in service need not be retightened unless the fixings have been loosened or removed.
- Only the torque figures for the M10 ABS hard line unions have changed. The torque values for all other fixings pictured in the following illustrations remain the same.

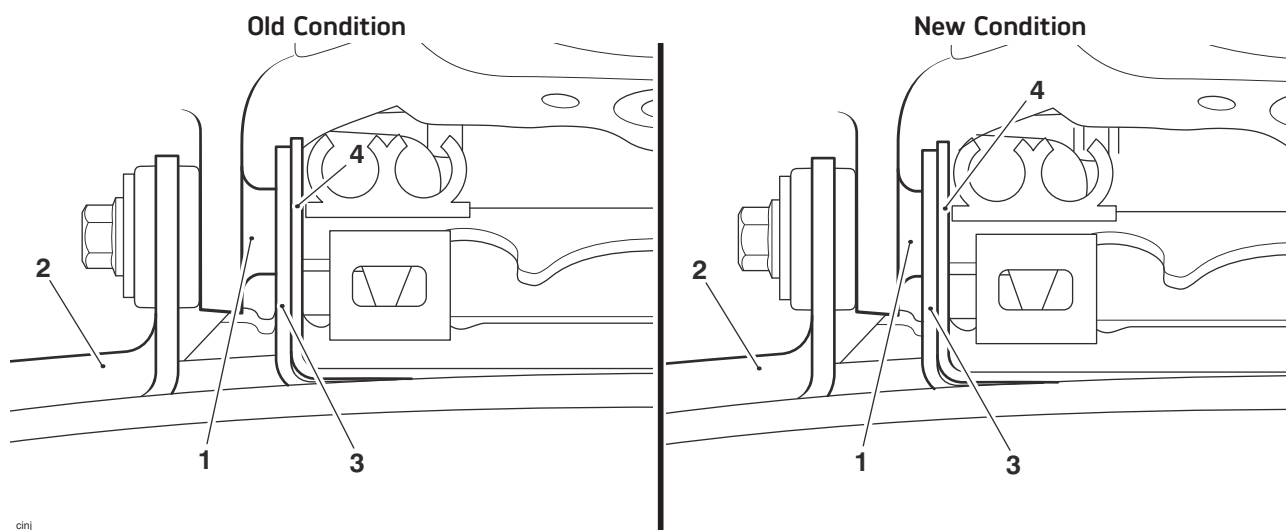
The radiator mounting bosses on the main frame have been modified on the above models from VIN 626498. The two mounting bosses are now thicker, which reduces the distance between the two bosses.

1. Radiator mounting boss, right hand side shown

This change does not affect the mounting of the radiator but the rubber air deflector and its retaining plate have also been modified because of the distance between the two bosses.

Should a frame assembly need to be replaced the following parts kits are available.

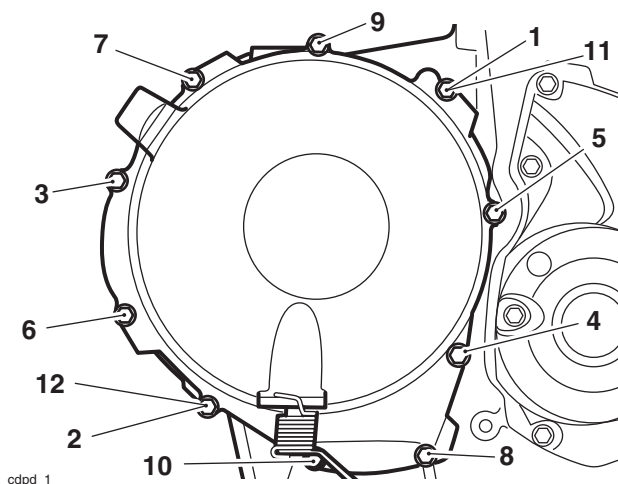
Clutch Cover Tightening Sequence

The torque figure for the clutch cover fixings has changed to **11 Nm** on the above models. If for any reason the clutch cover fixings are loosened or removed:

- Discard the copper washer located on fixing number four.
- Fit a new copper washer.
- Retighten the fixings to **11 Nm** in the sequence shown below.

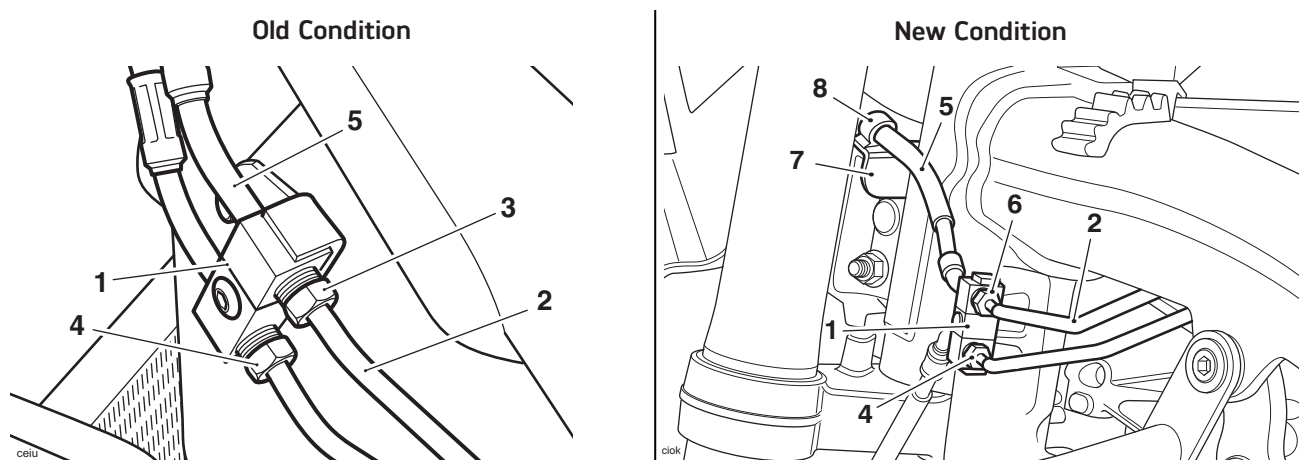
The following new ABS items have been introduced to the above models from VIN 650174:

1. Front brake line connector housing
2. Hard line to ABS modulator
3. M10 union
4. M10 union
5. Brake hose from the master cylinder
6. M12 union
7. Bracket
8. Cable clip

Triumph Genuine Parts will no longer support the old condition front line connector housing and the hard line to the ABS modulator. If either of these parts require replacement then both must be replaced at the same time with the addition of the bracket and cable clip. To facilitate this a parts kit (T2027221) is available. The parts kit consists of the following:
