Service Bulletin 517
Issue 1 - August 2014

| Subject: Indicator Stem Incorrectly Installed | | | | |
| 517 | Tiger Explorer ABS | From | 627380 | Brazil Market only |

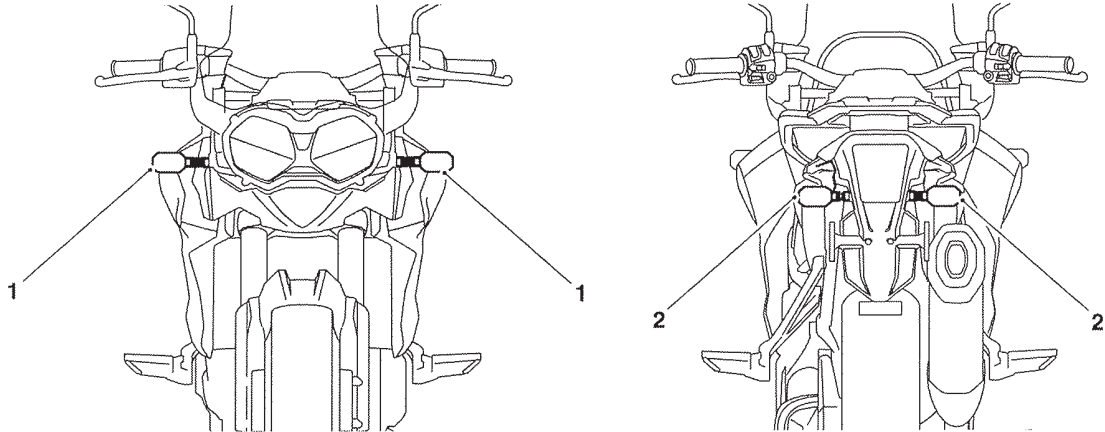
1. Check the direction indicators for correct fitment, as shown below.

1. Front direction indicator (long stem)
2. Rear direction indicator (short stem)

1. If the direction indicators are not installed correctly, reposition to the correct location.

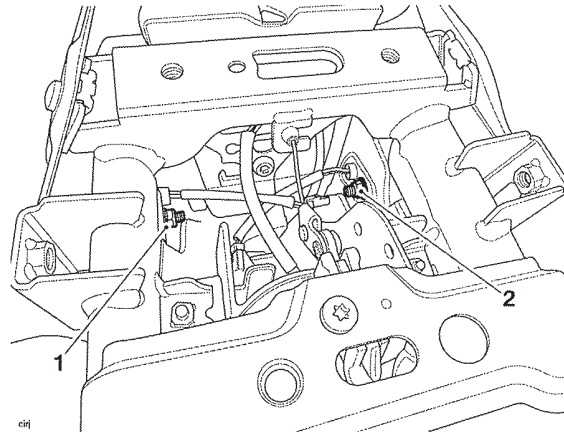
1. Fixing, right hand rear
2. Fixing, left hand rear

1. Remove the seat, as described in the Service Manual.
2. Disconnect the battery, negative (black) lead first.
3. Remove the rear panel, as described in the Service Manual.
4. Undo and remove the long stem (front) direction indicator(s) if fitted.

- Lock nuts can be reused, providing resistance can be felt when the locking portion passes over the thread of the bolt or stud.
 - Always use the correct replacement lock nut as recommended in the Triumph Genuine Parts catalogue.
5. Fit the short stem (rear) direction indicator(s) and tighten the fixings to **5 Nm**, as described in the Service Manual.
 6. Reconnect the battery, positive (red) lead first and tighten the battery terminals to **4.5 Nm**.
 7. Refit the seat, as described in the Service Manual.
