## Technical News 158

August 2014

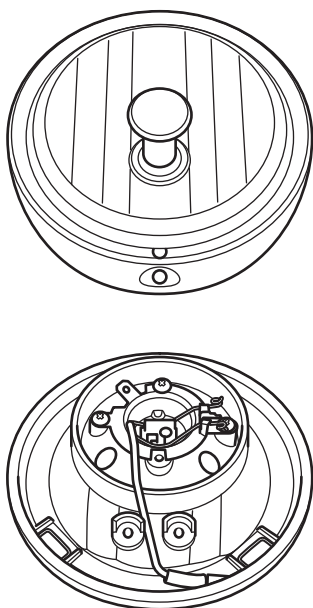
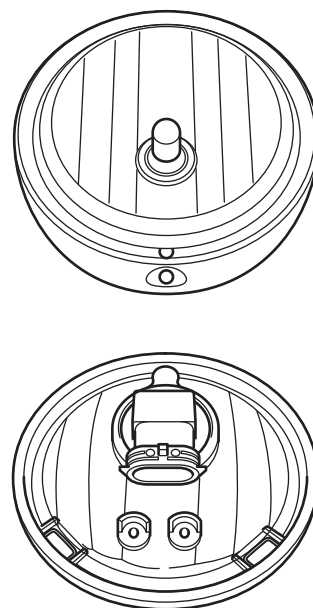
The bulb wattage for the new condition fog lights has changed from 55 W to 35 W and the electrical connector is different.

The illustration below shows the visual differences between the original and new condition fog lights.

- The replacement bulb is H8 12 V 35 W.

- If fitted with the original condition fog lights, the replacement bulb is H3 12 V 55 W.
- If fitted with the original condition fog lights and a fog light unit is to be replaced, both fog light units must be replaced. To facilitate this a spares kit (part number T2702727) is available.
- If fitted with the new condition fog lights, the replacement bulb is like for like H8 12 V 35 W.
- If fitted with the new condition fog lights, the fog lights can be replaced like for like. Refer to the EPC.

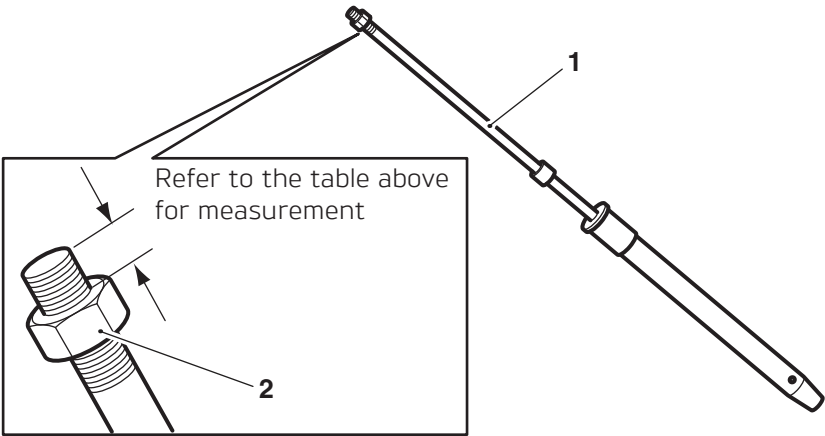
The measurement for the exposed thread above the damper rod lock nut described in the Service Manual for the above models is not correct.  
When assembling the front forks of the above models, refer to the table below for the correct measurement of the damper lock nut position.

| Model | VIN Range | Measurement |
| Daytona 675 | Up to VIN 381274 | 12 mm |
| Daytona 675 | From VIN 381275 to VIN 564947 | 11 mm |
| Street Triple R | Up to VIN 560476 | 11 mm |

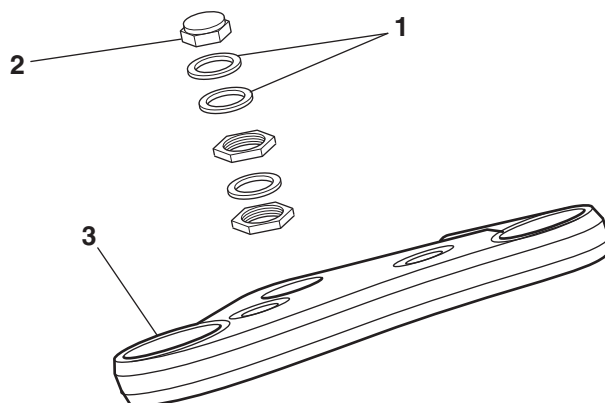
A second washer has been introduced to the above models from VIN 655530 and is located with the original washer between the upper yoke and its top nut. The torque figure for the top nut remains at **65 Nm**.

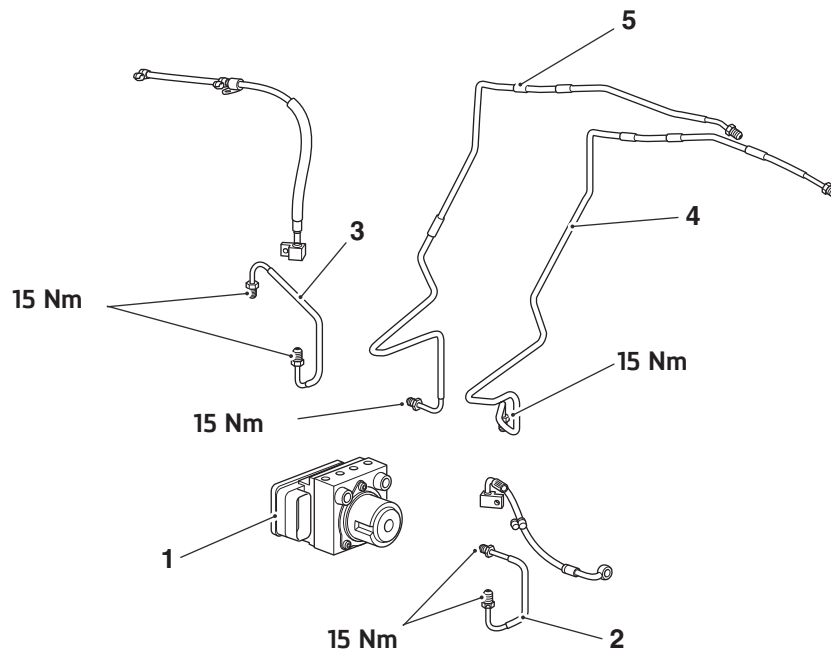
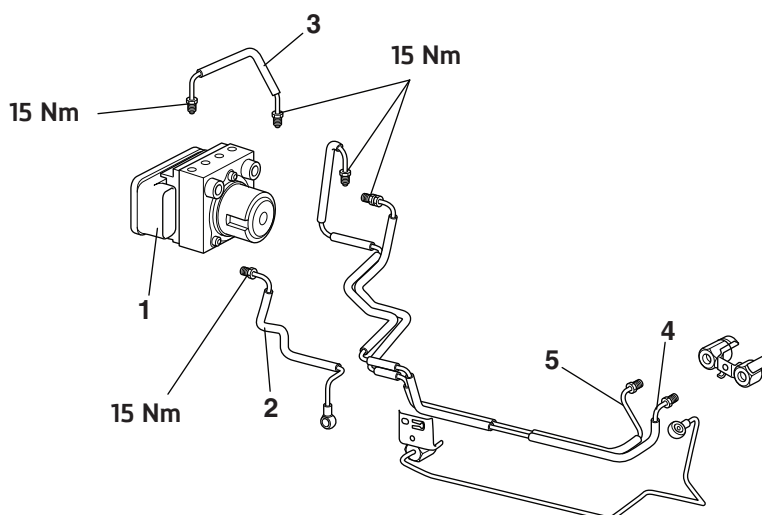
**Rocket III Touring ABS and Rocket III Roadster**

The torque figure for the 10 mm unions on ABS brake lines have changed to **15 Nm** on the above models.

- Models already in service need not be retightened unless the fixings have been loosened or removed.

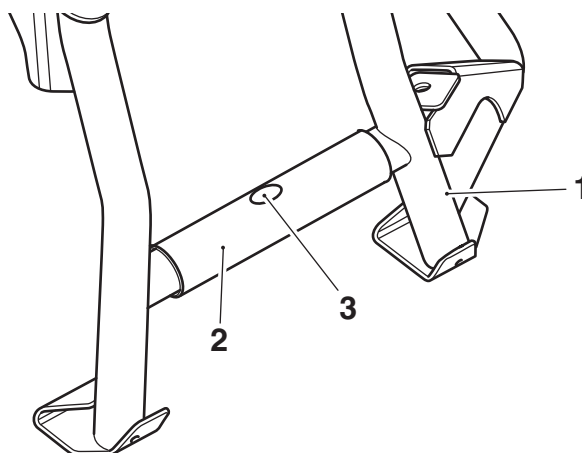
A plastic cover has been fitted to the centre stand on the above models from VIN 666617. The plastic cover is to prevent stone chip damage to the cross member of the centre stand.

If a new centre stand is required for models built prior to VIN 666617, a spares kit (part number 2081375) is available.

1. Remove the original centre stand from the motorcycle and discard the two fixings.
2. Fit the centre stand from the kit and tighten the new fixings to **50 Nm**.

3. Fit the plastic cover to the centre stand, as shown below, aligning the hole in the cover to the hole in the centre stand and fit the fir tree clip.

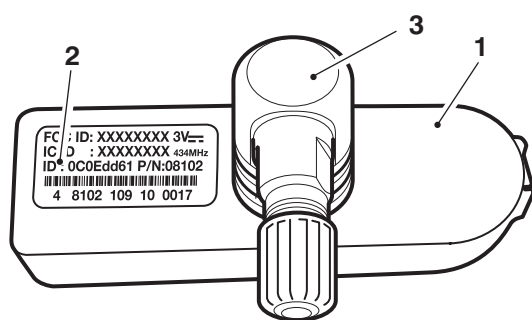
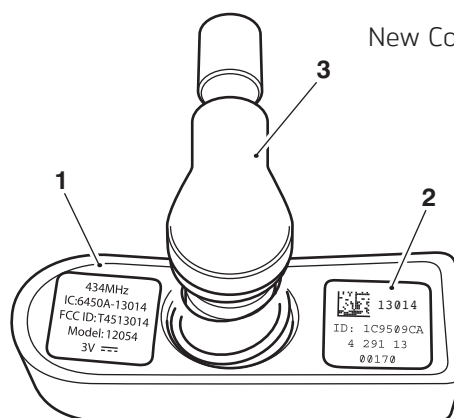
A new tyre pressure sensor has been introduced and is retrofittable. Parts will no longer support the original condition tyre pressure sensor.

The only visible difference between the original and new condition tyre pressure sensor is the tyre valve and the label with the sensor's ID number, as shown in the illustration below:

It is not necessary to replace both wheel tyre pressure sensors if replacing one of the original sensors with the new condition sensor.

Always refer to the Chassis Diagnostic section in the Triumph Diagnostic Tool User Guide when replacing the tyre pressure sensor(s).

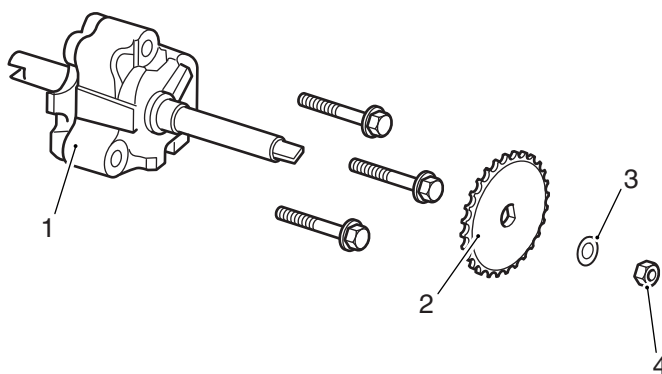
A washer has been introduced to the oil pump on the above models from engine number 655147. It is positioned between the oil pump sprocket and the lock nut. The addition of the washer enables the lock nut to have a greater thread engagement.

If the oil pump has been removed from engines built up to engine number 655146, Triumph recommend that a M10 washer (part number T3550239) is fitted between the oil pump sprocket and the lock nut on installation.

The torque figure for the lock nut remains at **30 Nm**.

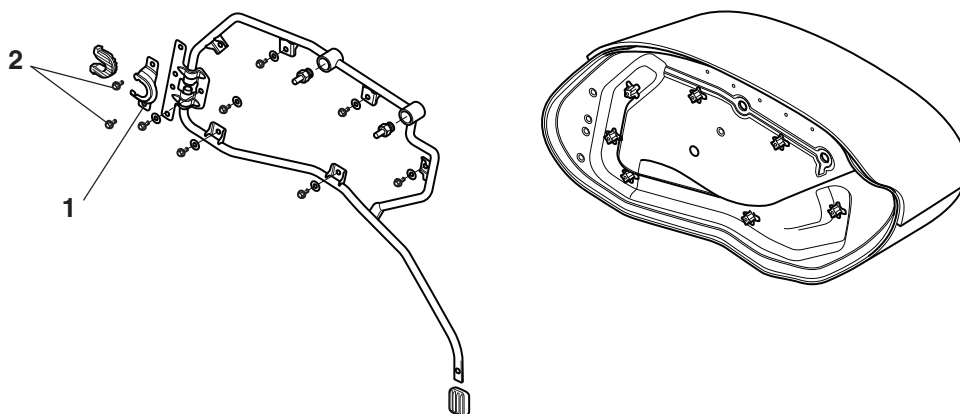
The torque figure for the rear mounting bracket fixings on the panniers has changed to **9 Nm** on the above models.

- Models already in service need not be retightened unless the fixings have been loosened or removed.

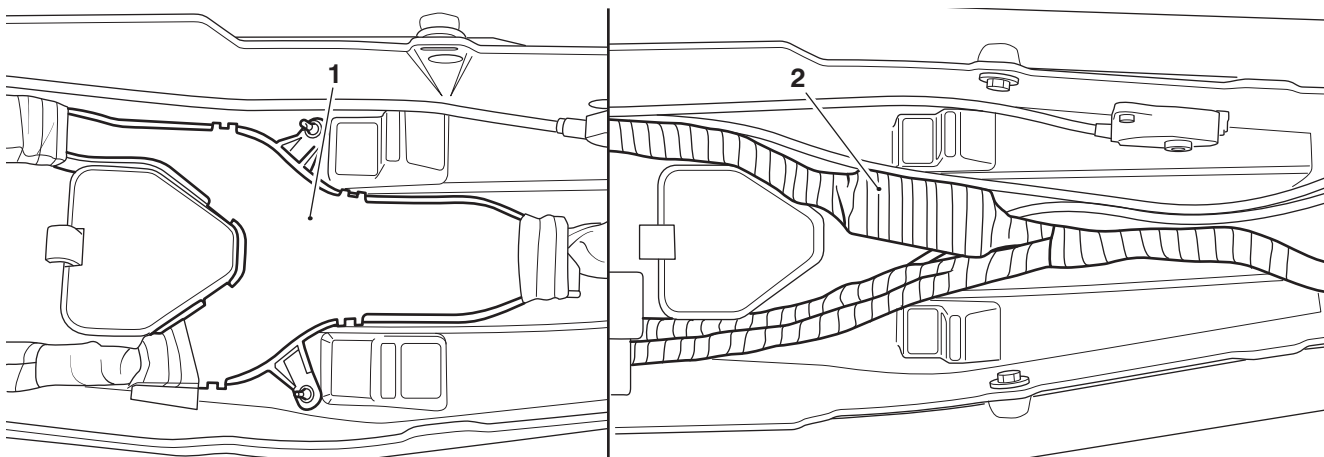
A new conduit has been introduced to the main harness on the above models from VIN 670284 and is retrofittable.

Parts no longer support the harness with the original condition conduit.

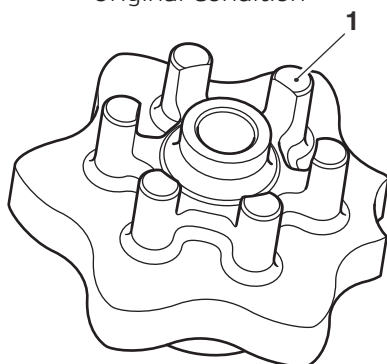
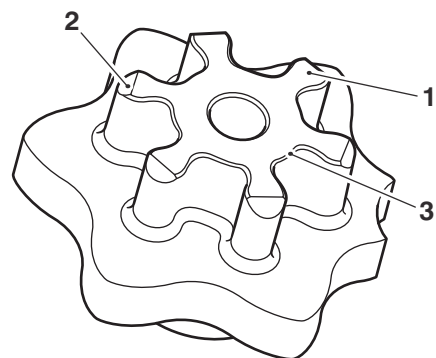
The following areas of the detent wheel have changed compared to the original condition:

- Profiled cut-outs to the pins
- Strengthening webs between the pins and the main body.

- If replacing the pivot plate with a new condition part, the detent wheel must also be replaced with the new condition detent wheel. To facilitate this, a spares kit (part number T1194905) is available.
- If replacing the original condition detent wheel, the new condition detent wheel can be fitted without renewing the pivot plate.

For engines built from engine number 662498, the items can be replaced like for like, refer to the EPC.

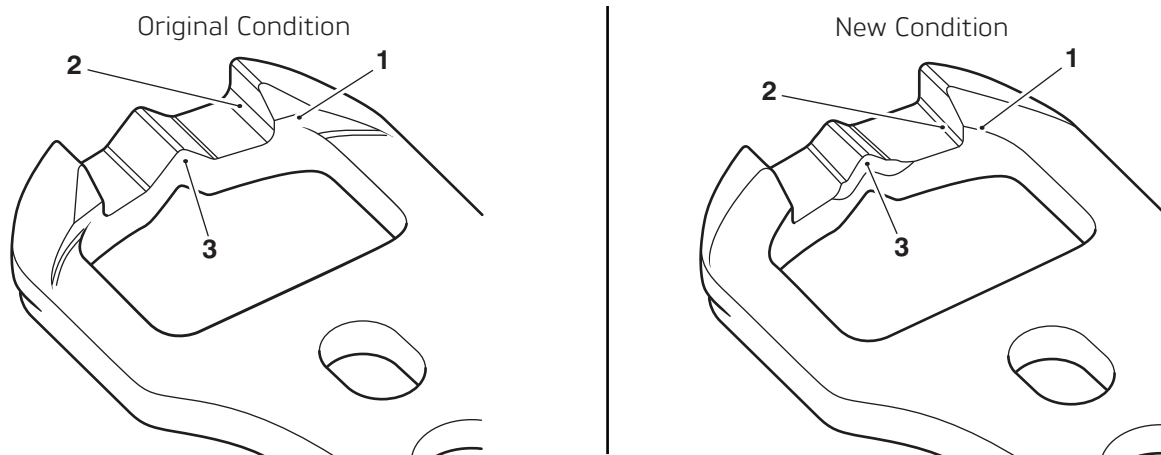
The following areas of the pivot plate have changed compared to the original condition:

- The ramp of the driving claw
- The central claw is smaller
- The root radius of the driving claw is smaller.

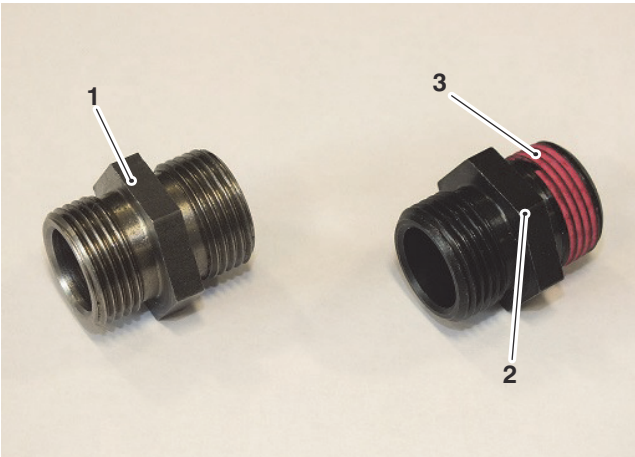
A new oil filter adaptor has been introduced to the above engines. The original adaptor, part number T1210523, requires ThreeBond 1305 to be added to the threads for the crankcase side and is torqued to **10 Nm**. The new adaptor, part number T1210438, is darker in colour and has the pink encapsulating compound on the threads for the crankcase side and is torqued to **16 Nm**.

For engines with the original oil filter adaptor, if removed from the crankcase side the threads must be cleaned and fresh ThreeBond 1305 applied to the threads for the crankcase side only and torqued to **10 Nm**. If a new oil filter adaptor is to be fitted, fit the new condition adaptor with the encapsulated compound. Fit the threads with the encapsulated compound to the crankcase side and tighten to **16 Nm**.

For engines with the new condition oil filter adaptor, if removed from the crankcase side it must be discarded and a new one fitted with the encapsulated threads to the crankcase side and torqued to **16 Nm**.
