Technical Service Bulletin

48 Creaking or squeaking noises from steering column (sealing boot)

48 14 57 2034351/3 January 29, 2014. Supersedes Technical Service Bulletin Group 48 number 13-47 dated August 2, 2013 for reasons listed below.

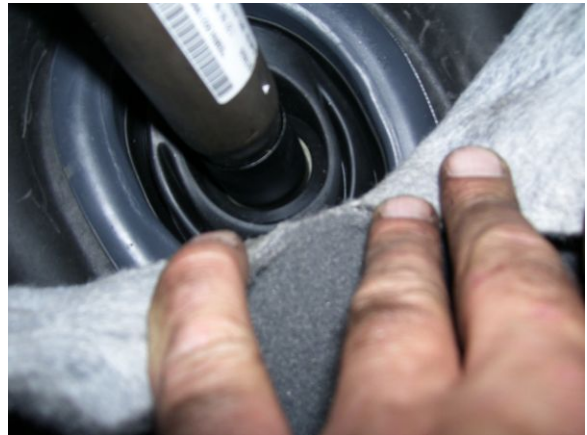
The noise comes from the sealing sleeve/steering column opening on the bulkhead. Listen to the attached audio file for example of the noise.

Insufficient lubrication of the intermediate steering shaft in the area of the sealing sleeve.

Figure 1. Sealing sleeve on the bulkhead.

1. Check the correct fit of the sealing sleeve (Figure 1).

2. Spray the intermediate steering shaft in the area of the bearing ring with special lubricant spray (**G 052172A2**). While spraying, turn the steering wheel side-to-side and adjust the steering column axially and vertically until the noise disappears.

**Note:** Do not lubricate the u-joints of the steering shaft.
