# Technical Service Bulletin

## 91 Front TopView camera cannot be calibrated; picture appears upside down

91 14 22 2035912/2 January 10, 2014. Supersedes Technical Service Bulletin Group 91 number 13-16 dated November 27, 2013 for reasons listed below.

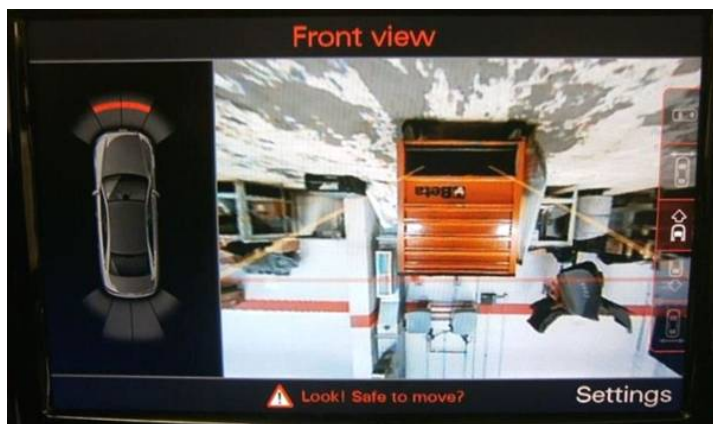
After the camera control module, J928, has been replaced, the front image is upside down and cannot be changed (Figure 1). The calibration cannot be completed.

Figure 1. Upside down image.

The coding of the camera control module is not completed correctly.

1. Using ODIS, enter binary coding of the J928 control module:

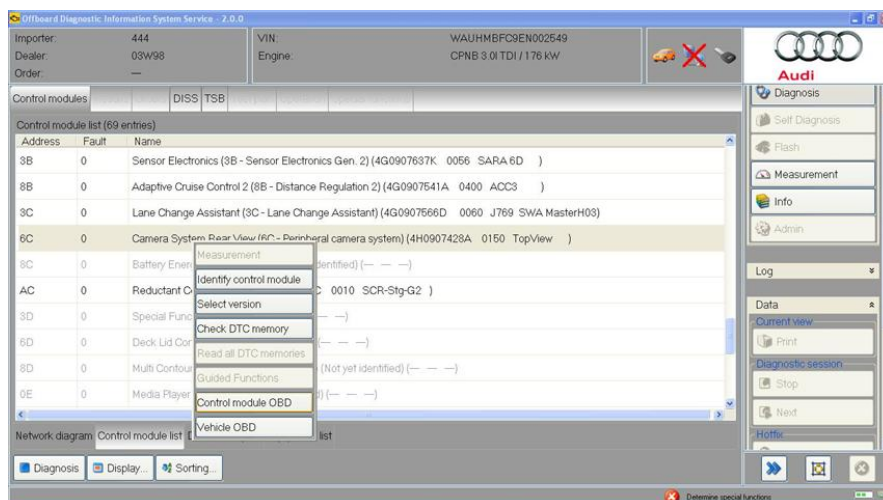
Figure 2. Selecting Control module OBD.

- Right-click on the 6C module, then select *Control module OBD* (Figure 2).

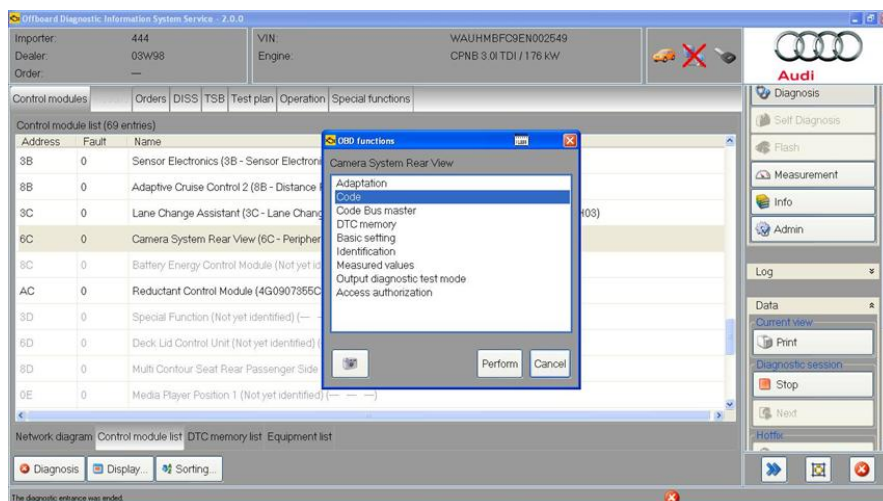
Figure 3. Selecting Code.

- Choose *Code* from the menu (Figure 3). The tester will state that the operation failed. Click past this warning message and proceed.

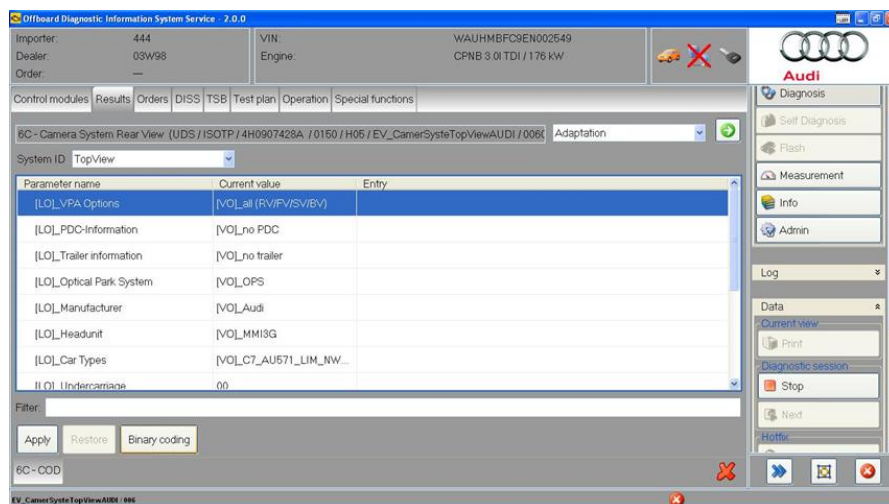
Figure 4. Binary Coding button at bottom of screen.

- c. Click the *Binary Coding* button at the bottom of the screen (Figure 4).

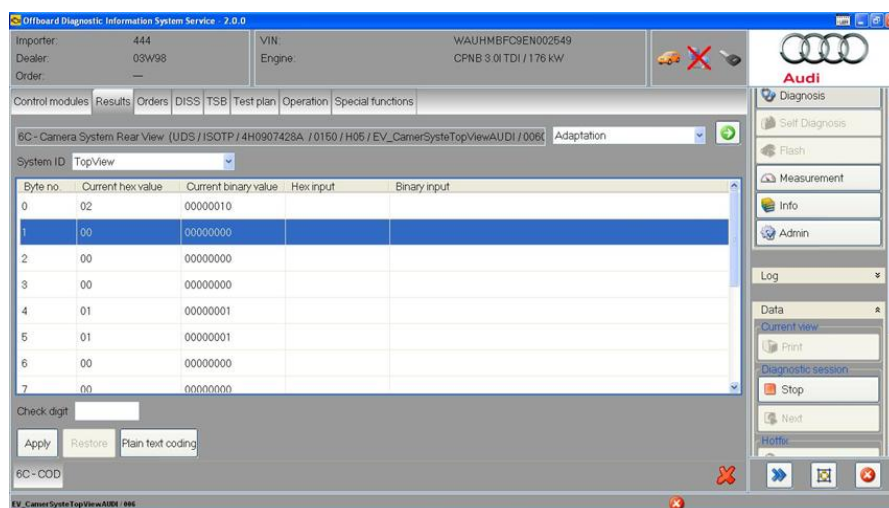
Figure 5. Current value of Byte 1.

2. Read the value of Byte 1 in the *Current hex value* column (Figure 5). Record this number for future use.

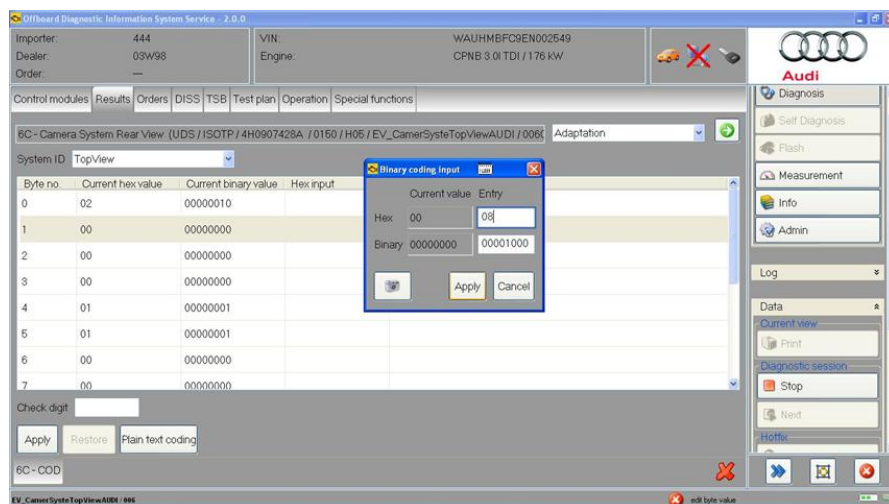
**Figure 6.** New HEX value entered. Click Apply button.

3. Click on the *Hex input* column next to Byte 1 and change the value based on the following list:
- A6/A7: Change value to HEX 08
  - A8 MY2011-2013: Change value to HEX 02
  - A8 MY 2014+: Change value to HEX 13

4. Apply the value (Figure 6).

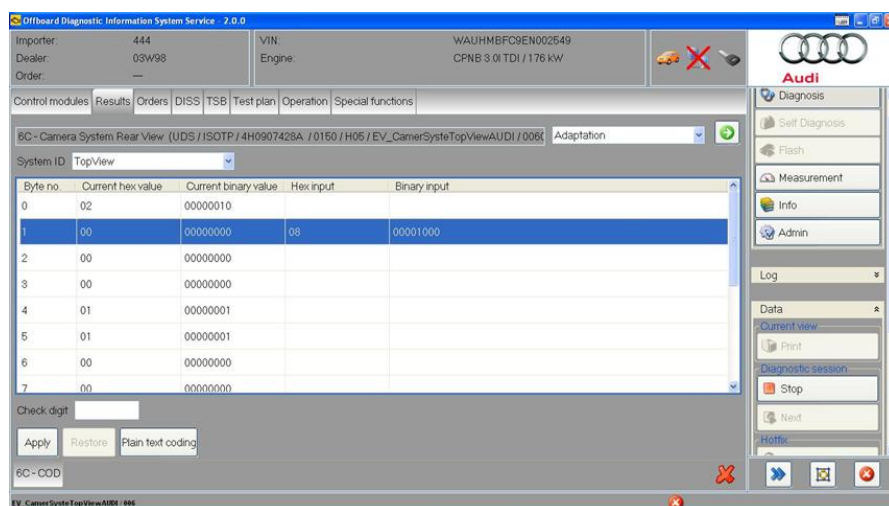
**Figure 7.** New HEX value entered. Click Apply button.

5. Choose Apply again (Figure 7).

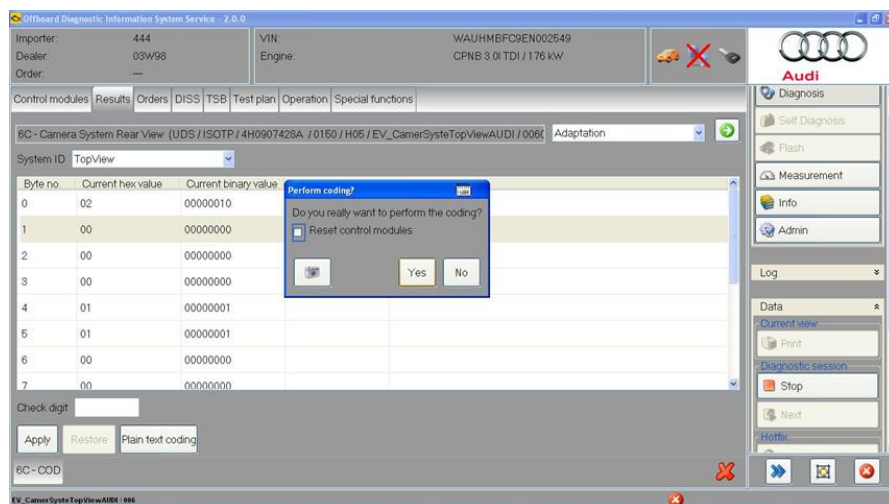
**Figure 8.** Uncheck ‘Reset control modules’. Perform the coding.

6. On the confirmation page, uncheck the option to *Reset control modules*. Select “Yes” (Figure 8). Two more errors will appear, stating that the values cannot be checked, and that the read operation failed. Click past these errors and the new coding value will now be in byte 1.

7. Repeat steps 3 – 6, but instead change Byte 1 back to the original value written down in Step 2. In Step 6, again uncheck *Reset control modules* when applying the coding.
