# Audi

## Technical Service Bulletin

#### 94 Xenon headlight flickers or is inoperative on one side (DTC 00978 or 00979)

94 14 31 2021751/4 January 16, 2014. Supersedes Technical Service Bulletin Group 94 number 10-19 dated June 7, 2010 for reasons listed below.

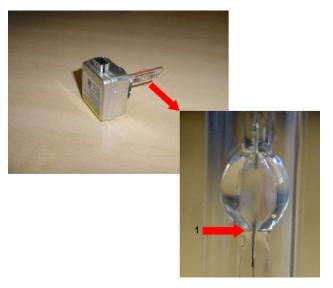
The xenon bulb may have an internal leak at the crimp of the electrodes, and xenon gas can be released (Figure 1).

Without an adequate amount of xenon gas, the bulb cannot establish a stable light arc. The xenon igniter control unit (ballast) repeatedly tries to establish an arc, which may cause a flickering of the headlight.

Figure 1. The location of the xenon bulb leak.

- 1. Swap the bulbs between the left and right headlights.
  - If the condition does not follow the bulb:
     Check the power supply and control unit of the headlight assembly according to Guided Fault Finding.
  - If the condition does follow the bulb:
     Proceed to step 1 under If the condition occurs intermittently, below.
