Technical Service Bulletin

46 Squealing from front brakes (PR-1LA or 1LB)

46 14 75 2033674/7 March 12, 2014. Supersedes Technical Service Bulletin Group 46 number 14-70 dated February 25, 2014 for reasons listed below.

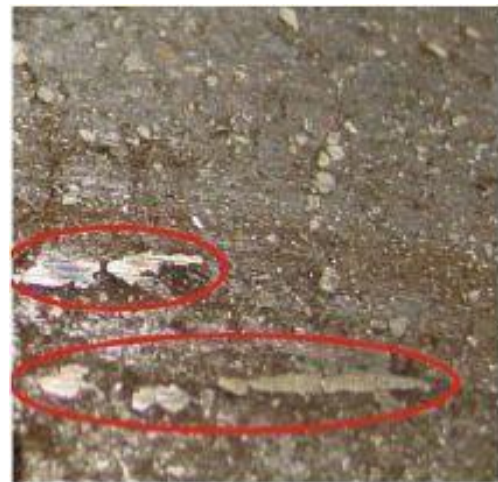
- Foreign bodies between brake disc and brake pad, such as small stones, grit, or sand.
- Un-ground or corroded friction materials.
- Brake discs or brake pads are close to their wear limit. (Front brake disc wear limit: 28mm. Front brake pads wear limit with backing plate and dampening sheet: 10mm.)
- Metallic deposits from disc material in brake pad (Figure1).

Figure 1. Metallic deposits.

- Deposits in brake pad.

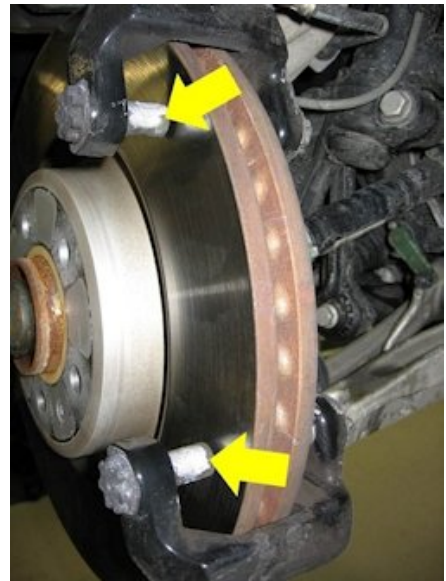
Figure 2. Caliper carrier guide pins with anti-seize (**G 052560A2**) lubricant applied where the pads make contact.

2. Remove the front brake caliper with the brake pads still attached and apply a thin coat of anti-seize (**G 052560A2**) lubricant to the guide pins of the caliper carrier (Figure 2). Only apply this lubricant to the section of the guide pins that will be contacted by the brake pads.
