Technical Service Bulletin

80 Coolant loss from coolant valve, engine warning light on, "Limp Home" mode active, cabin heating is insufficient

80 14 06 2033806/5 March 11, 2014. Supersedes Technical Service Bulletin Group 80 number 13-05 dated September 11, 2013 for reasons listed below.

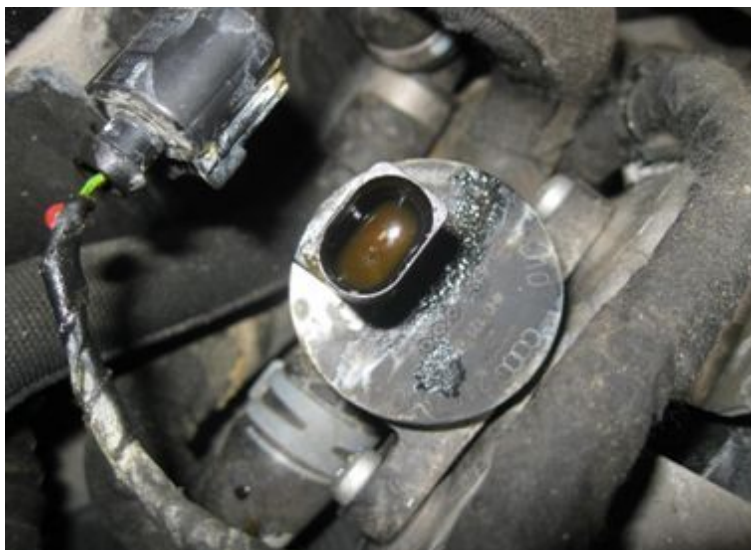
Inspection of the coolant control valves N82, N509, or N488 reveals the presence of coolant inside the electrical connector as shown in the illustration (Figure 1).

Figure 1. Coolant residue in the connector housing of the coolant regulating valve.

1. Diagnose the defective coolant valve (N82, N509, or N488) using Guided Fault Finding where stored DTCs are found.
2. Replace the defective coolant valve.

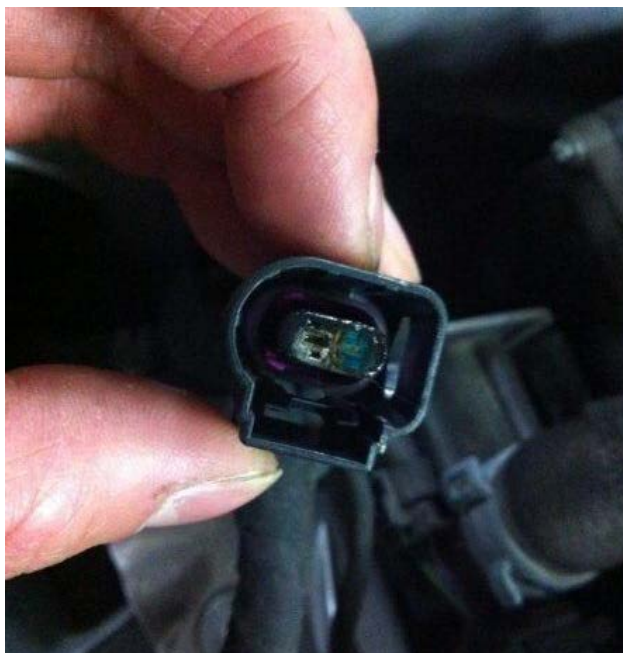
The connectors, wiring harness, and/or connected control units may have been damaged from exposure to coolant (Figure 2).

Figure 2. Corrosion formation on the connector pins.

Tip: Check the connectors, wiring harness, and connected control units for coolant damage. Perform repairs as necessary.
