Technical Service Bulletin

97 No start (DTC P068A00)

97 14 41 2036764/1 March 18, 2014.

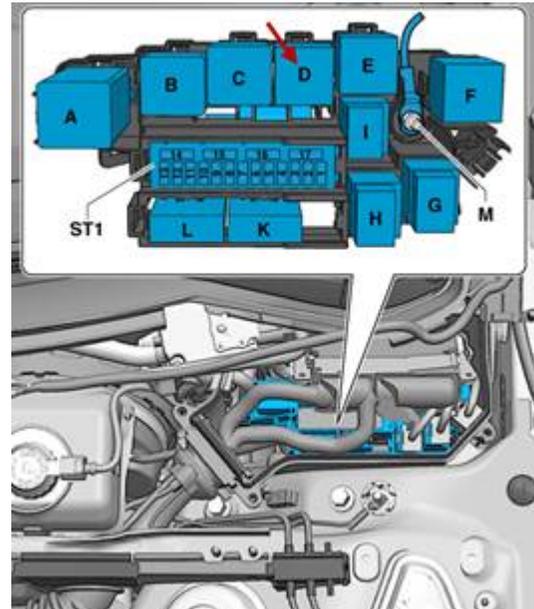
Figure 1. Location of J271 relay (D), as shown in Elsa.

2. Check Elsa for the location of the J271 relay (*Wiring diagrams >> Component locations >> Component Locations: Relays*) (Figure 1).

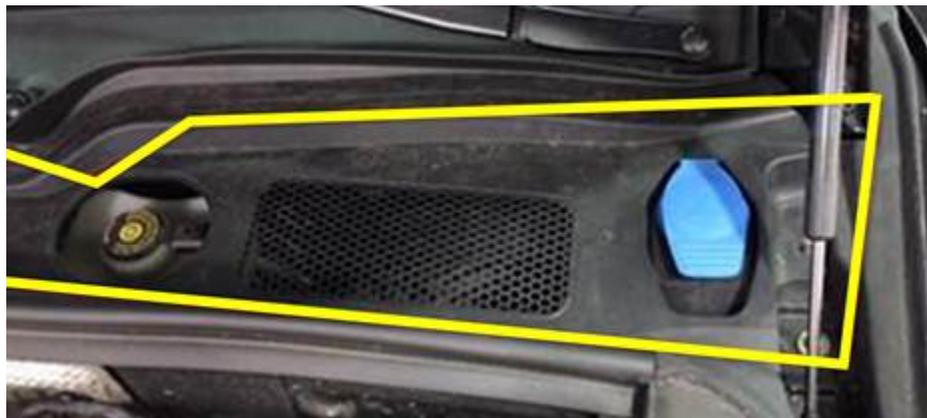
Figure 2. Plenum cover.

3. Remove the plenum cover (Figure 2).

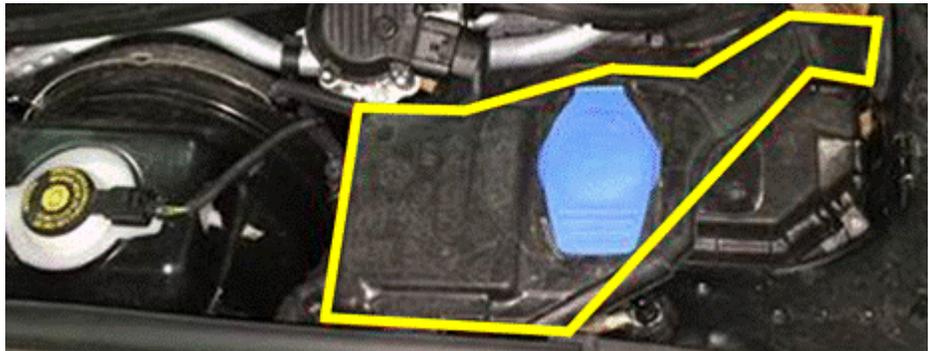
Figure 3. Washer reservoir fuel neck.

4. Remove the washer reservoir fuel neck (Figure 3).

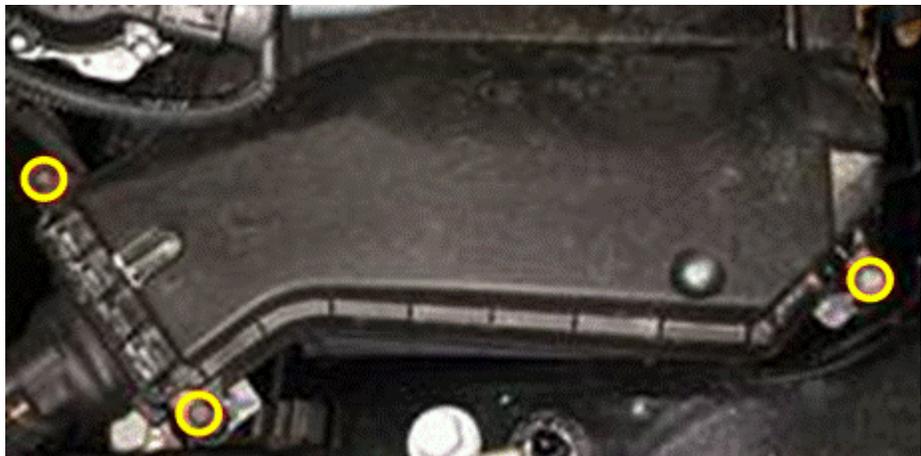
Figure 4. Screws to be removed (outlined).

5. Remove screws to gain access to the relay/fuse panel (Figure 4).

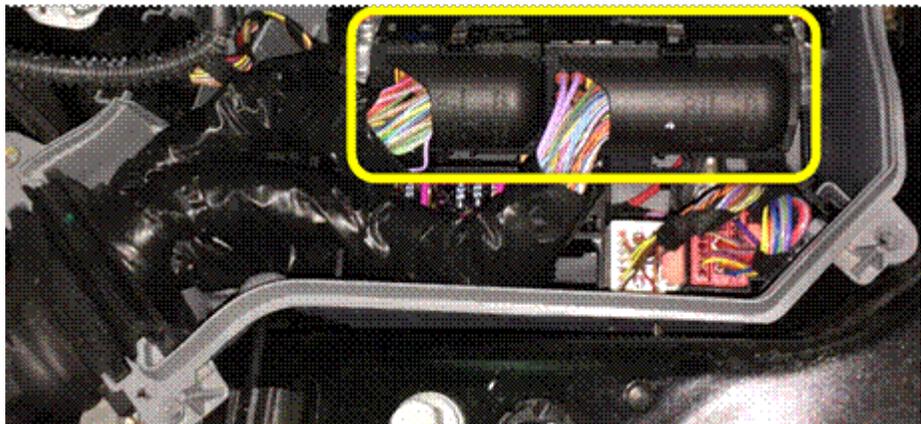
Figure 5. Engine control module (ECM).

6. Remove the ECM (Figure 5).

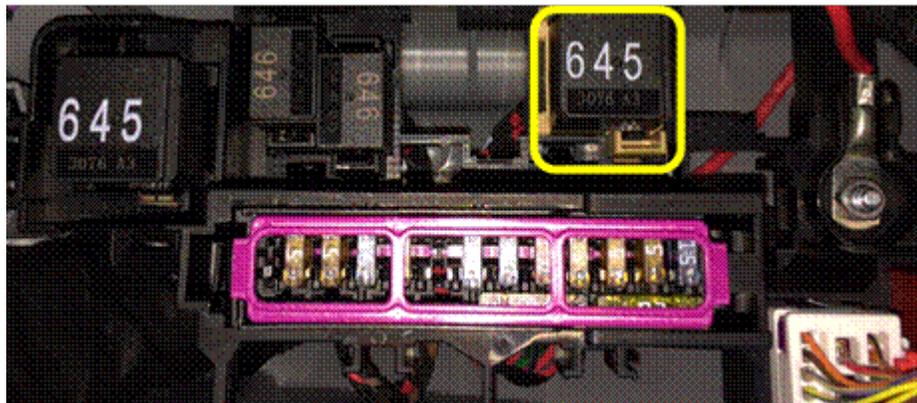
The motronic engine control module power supply relay, J271, is not functioning properly. Because the J271 relay controls battery voltage (Terminal 30) via a ground signal sent from the ECM, numerous faults can occur in multiple control modules when it is not functioning properly.

Figure 6. J271 relay (outlined).

7. The J271 relay is now accessible (Figure 6).

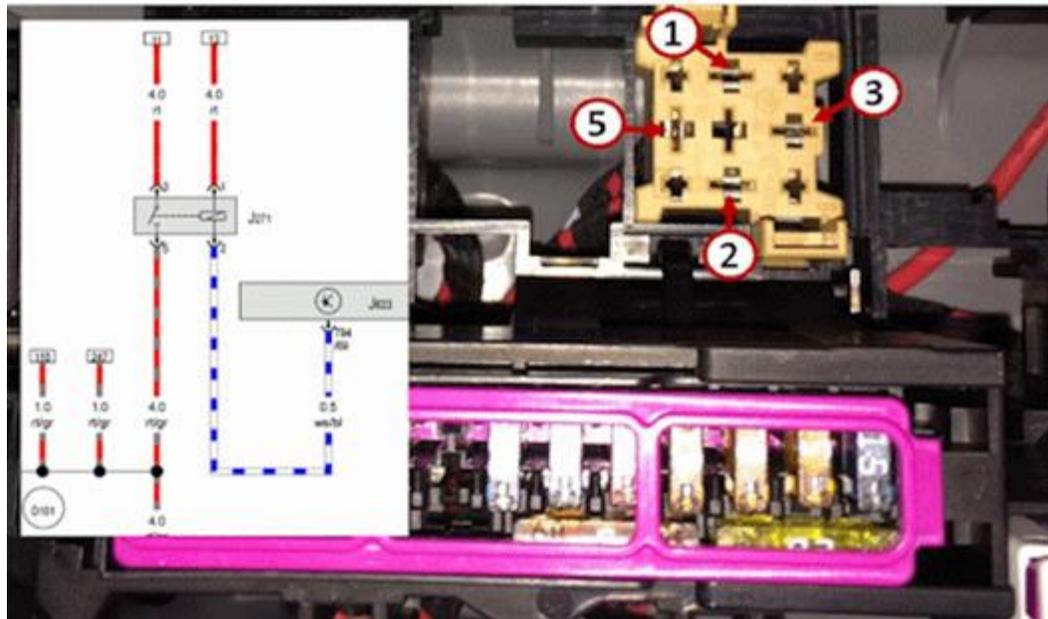
Figure 7. J271 relay terminals. Terminal 1: power from SA2, Terminal 2: switched ground from J623, Terminal 3: 30 power from SA2, and Terminal 5: switched power from J271.

9. Check for battery voltage on J271 relay terminals 1 and 3 (Figure 7).
If no voltage is found, do not proceed with this bulletin. Continue with diagnosis.

10. With the ECM disconnected, check the wiring from J271 relay terminal 2 to the ECM:
- If voltage and wiring are good, replace the J271 relay.
 - If voltage and wiring are not good, do not proceed with this bulletin. Continue with diagnosis.
