97 No start (DTC P068A00)

97 14 42 2036764/2 March 31, 2014. Supersedes Technical Service Bulletin Group 97 number 14-41 dated March 18, 2014 for reasons listed below.

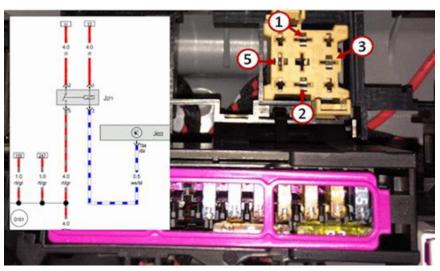
Figure 8. J271 relay terminals. Terminal 1: power from SA2, Terminal 2: switched ground from J623, Terminal 3: 30 power from SA2, and Terminal 5: switched power from J271.

- 9. Check the J271 relay according to the instructions in Elsa at: Engine >> Generic Scan Tool >> ST Generic Scan Tool >> Diagnosis and Testing >> Diagnostic Procedures >> Engine Component Power Supply Relay, Checking.
- 10. Check for battery voltage on J271 relay terminals 1 and 3 (Figure 8).

If no voltage is found, do not proceed with this bulletin. Continue with diagnosis.

- 11. With the ECM disconnected, check the wiring from J271 relay terminal 2 to the ECM:
 - If voltage and wiring are good, replace the J271 relay.
 - If voltage and wiring are not good, do not proceed with this bulletin. Continue with diagnosis.
