Technical Service Bulletin

87 Air conditioning inoperative

87 14 49 2020124/12 April 25, 2014. Supersedes Technical Service Bulletin Group 87 number 13-44 dated August 26, 2013 for reasons listed below.

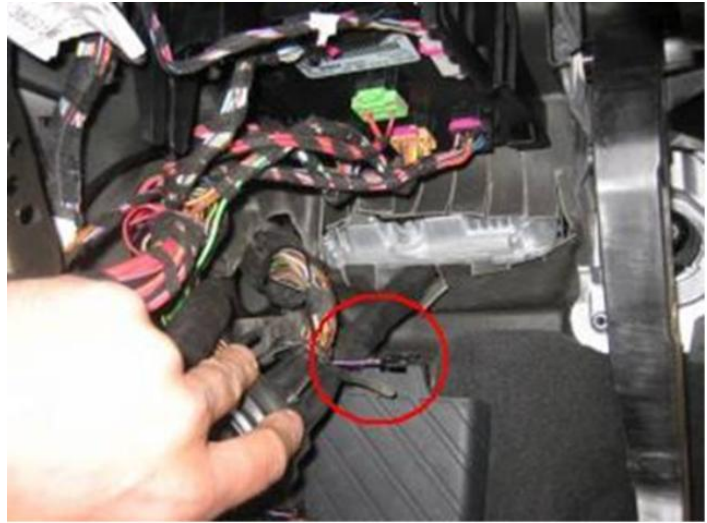
There are two known sections in the wiring harness that can be affected, but the potentially affected areas are not limited to these two known sections. One of the known sections is in the driver's footwell area where the wire harness enters the interior of the car from the engine bay (Figure 1).

Figure 1. Wire harness in driver footwell area.

6. If a cut wire is found, install an overlay wire for the LIN bus signal. Do *not* attempt to repair the existing wire harness.

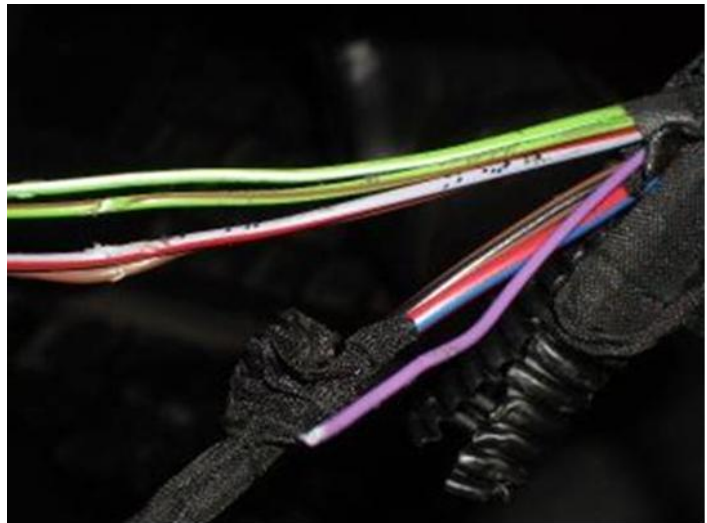
The second known section is in the wire harness located under the driver's side headlight (Figure 2).

Figure 2. Wire harness under driver's side headlight.

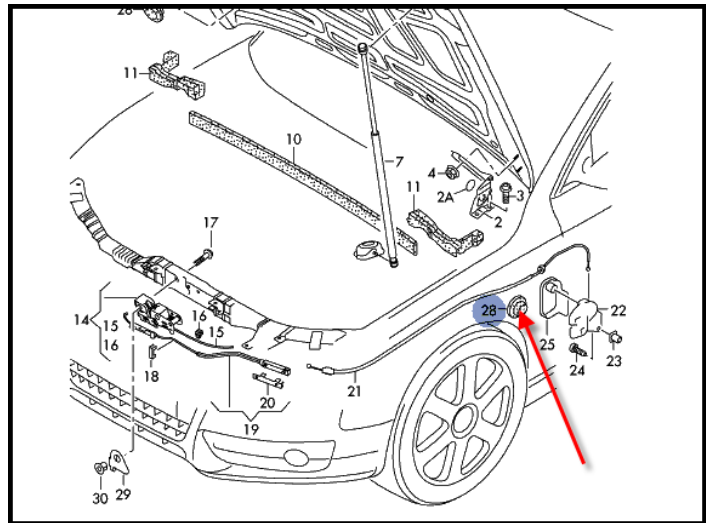
Figure 3. Grommet in driver's side fender/lower A-pillar area used for pass-through for new overlay wire.

- a. Route the new LIN bus wire from the vehicle electrical system control module, J519, to the sender for sensor G395 so that it enters the interior of the vehicle through the driver's side fender/lower A-pillar area through the grommet indicated in the images at right (Figures 3 and 4).

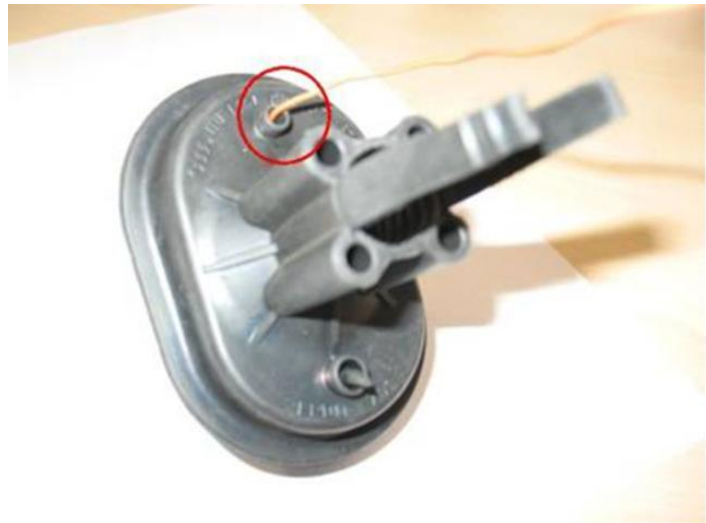
Figure 4. Access hole in grommet.

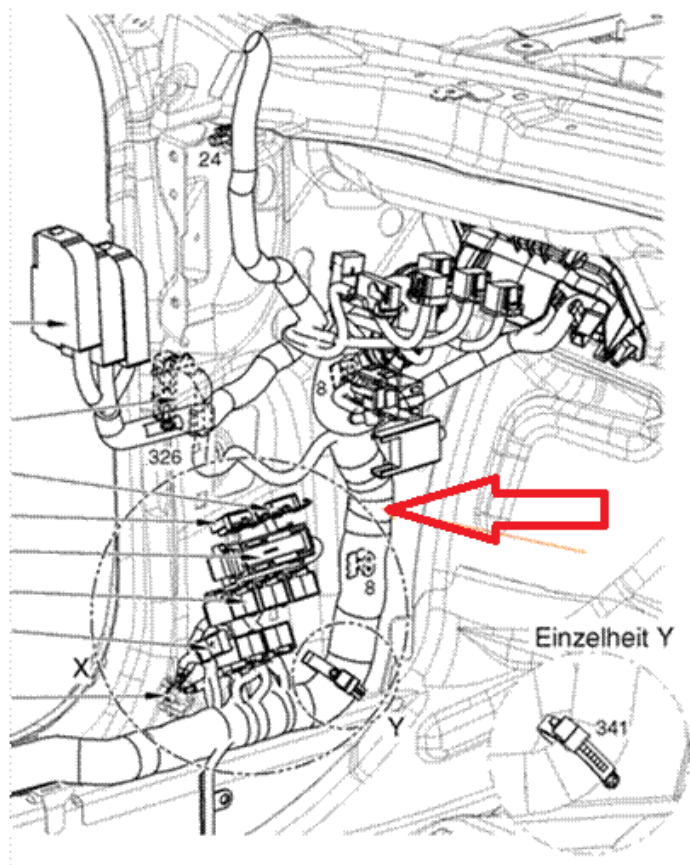
Figure 5. Cable routing with charisma switch option.

On vehicles with a charisma switch (ride selection switch located on the instrument panel) route the new cable of the sender for sensor G395 to junction B549 (Figure 5, red arrow).

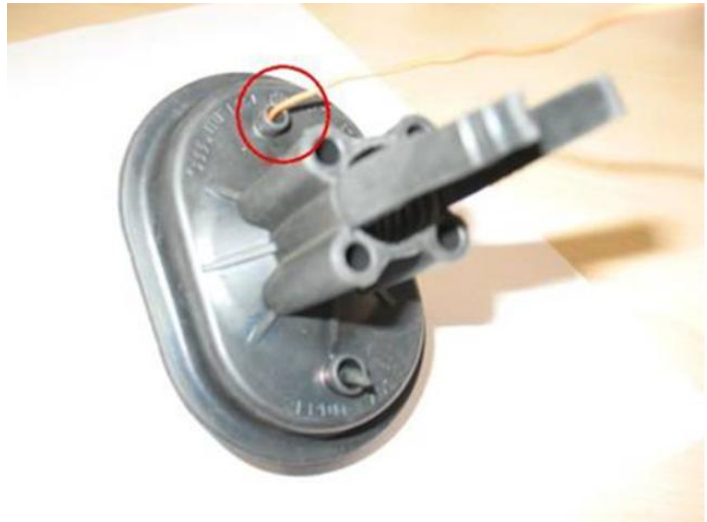
Figure 6. Access hole in grommet to be sealed with Butyl sealant.

- b. Seal off the opening around the wire with Butyl sealant to prevent water intrusion (Figure 6).
