Technical Service Bulletin

90 Instrument cluster, driver information system (DIS) display is blank with white

90 14 49 2029781/3 April 28, 2014. Supersedes Technical Service Bulletin Group 90 number 13-40 dated September 9, 2013 for reasons listed below.

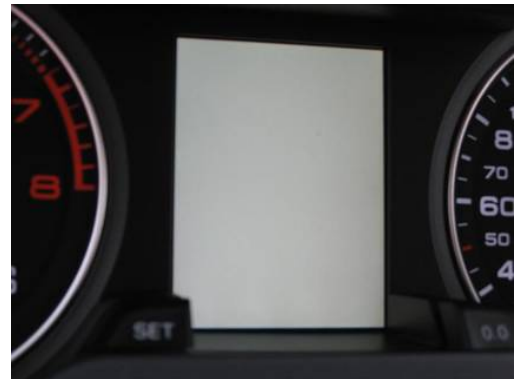
- The driver information system (DIS) display screen is completely blank or appears to be all white (Figure 1).
- The condition is intermittent and the DIS can function normally when the key is cycled off and back on.
- This condition only affects vehicles with the highline instrument cluster (PR No. 9Q7 or 9Q8).

Figure 1. Blank white DIS Screen in the instrument cluster.

The issue is attributed to incorrect software for clusters with the Hitachi display screen.

1. Replace the cluster.
2. If the issue is repeatable, attach a photo of the condition to the damaged part or repair order.
