# Technical Service Bulletin

## 91 Bluetooth call quality issues for caller on other end of call (A6, A7, A8)

91 14 34 2027718/7 April 8, 2014. Supersedes Technical Service Bulletin Group 91 number 14-20 dated January 3, 2014 for reasons listed below.

Model(s)	Year	VIN Range	Vehicle-Specific Equipment
A6, A7, A8	2011 - 2013	All	Bluetooth®

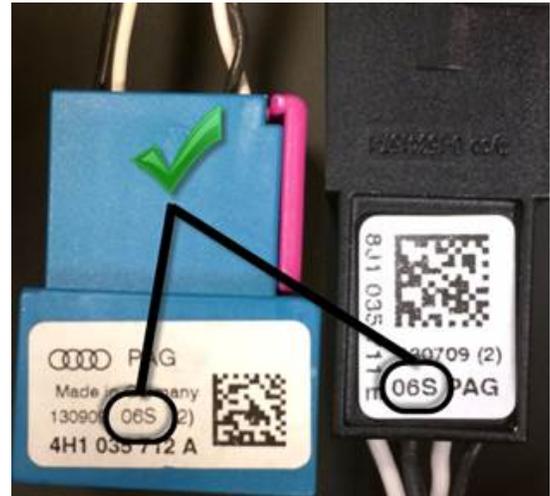
Improved microphone installation procedure and optimized the microphone seal, beginning with January 2012 vehicle production. Microphones with improved seals are at the 03S level or greater (Figure 1).

Figure 1. Microphones with improved seals.

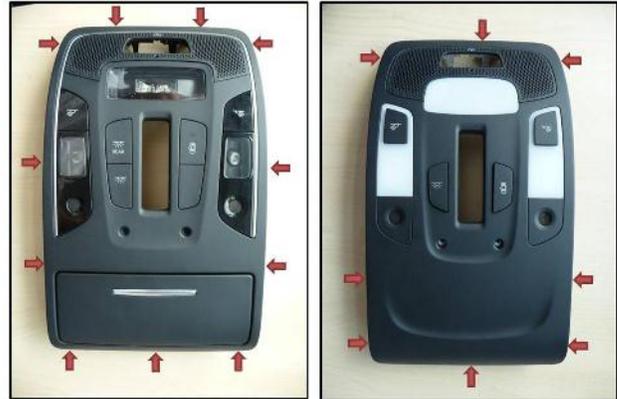
**Figure 2.** Clip location for A6/A7 high-line roof module (left) and for mid-line roof module (right)

- Use your fingers to remove the decorative trim from the base plate. If necessary, gently pry the trim with a trim stick or bone tool, then finish removing it with your fingers.
- There are a number of different clips holding the trim plate to the base plate depending on the trim level of the vehicle (Figure 2).

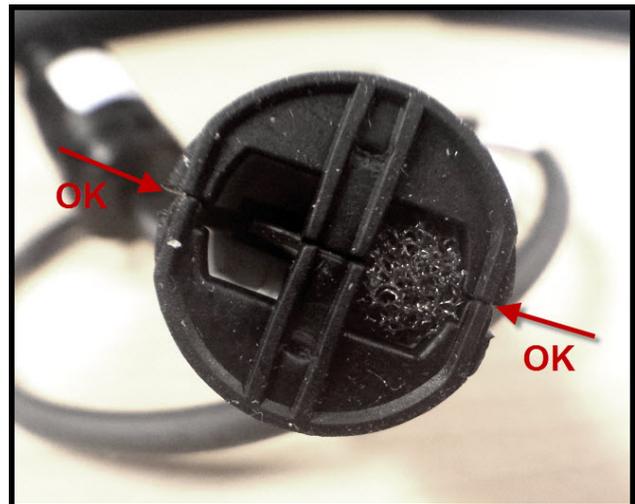
- There are two splits in the rubber seal. This is normal as long as the two halves of the seal are touching each other (Figure 3).

**Figure 3.** Undamaged seal

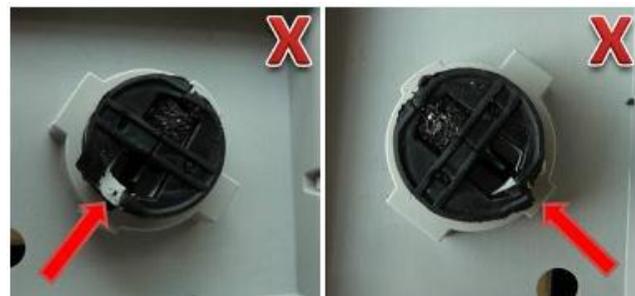
The microphone seal was damaged during installation into the roof module.

- If the two halves of the seal are loose and move freely, the seal is damaged (Figure 4).

**Figure 4.** Examples of damaged seals

If any of the seals are damaged, install a replacement microphone:

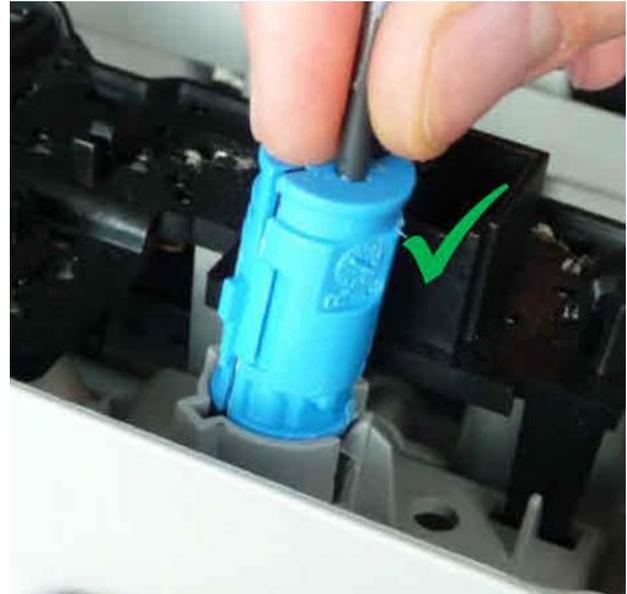
**Figure 5.** Proper installation.

- In order to prevent damage to the microphone seal, install the microphone while the decorative trim is removed from the base plate. Slowly install the microphone perpendicular to the base plate (Figure 5). Do not install the microphone at an angle, as this may pinch the seal (Figures 6 and 7).
- Carefully inspect the new microphone seal after it has been snapped into place.

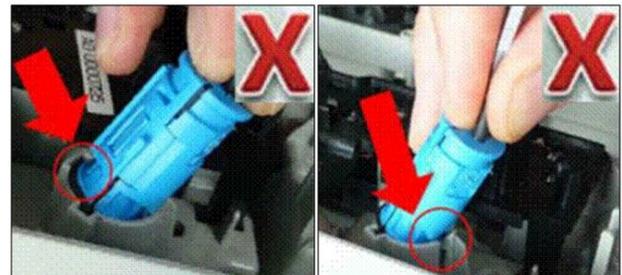
**Figure 6.** Incorrect installation at an angle, showing a pinched seal on the left.

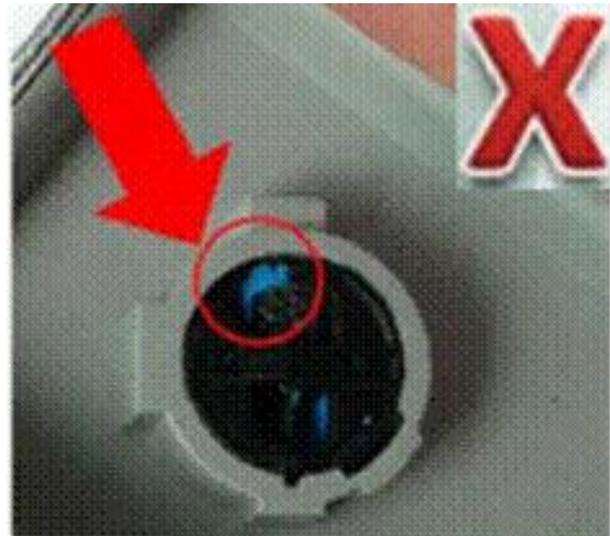
*Figure 7. Damage caused by a pinched seal.*
