91 Bluetooth® - Cannot initiate call - Android phone

91 14 37 2030947/3 April 10, 2014. Supersedes Technical Service Bulletin Group 91 number 13-92 dated July 16, 2013 for reasons listed below.

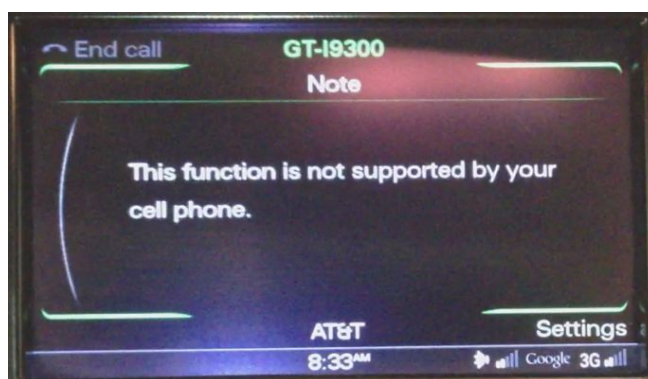
The customer complains that when he or she is trying to place a phone call from the vehicle while using a Bluetooth®-connected phone, the phone call disconnects before it begins and an error shows on the MMI display. The message may be "Function not supported" (Figure 1) or "Network error".

Figure 1. Error message on MMI display.

When a call is placed using this phone, the prompt must be answered every time or the customer must adjust the phone settings to disable the prompt.

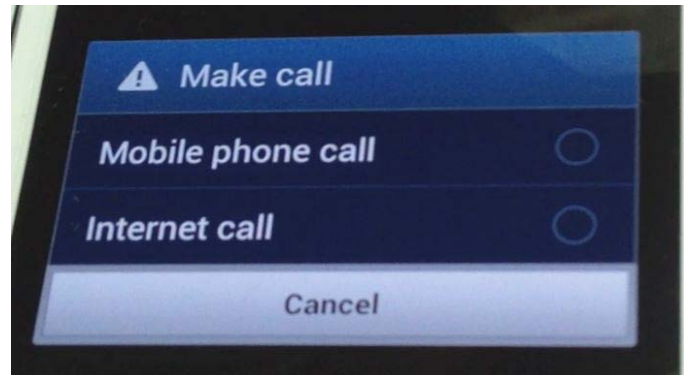
When the phone receives the request to place a call from the vehicle, a prompt appears on the phone asking the user to choose how the call should be placed (Figure 2). If the prompt is ignored, the MMI system disconnects the call because it assumes that the phone is not responding.

Figure 2. Prompt that appear on the phone.
