# Technical Service Bulletin

## PSS 91 MMI 3G+ GPS location is inaccurate (MY14 & MY13)

91 14 41 2035919/2 April 30, 2014. Supersedes Technical Service Bulletin Group 91 number 13-17 dated December 3, 2013 for reasons listed below.

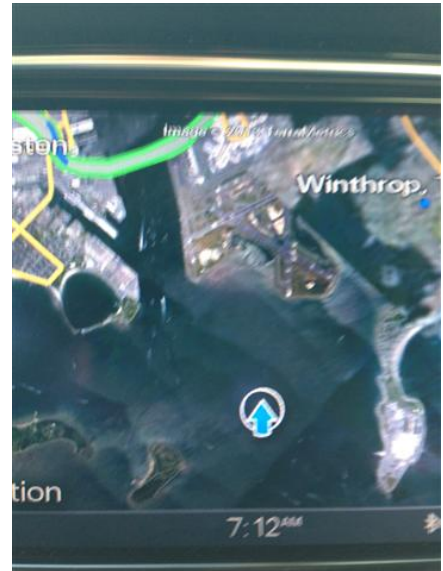
The vehicle is a model year 2013 vehicle and TSB 2036607: *91 MMI3G+ Navigation GPS Location is inaccurate*, has been completed. The GPS location or vehicle direction indicated on the navigation map does not match the vehicle's actual location or direction of travel (Figure 1).

**Figure 1.** GPS location incorrect.

- If TSB 2036607, *91 MMI3G+ Navigation GPS Location is inaccurate*, has not been completed, stop now and complete it for all model year 2013 vehicles.
- If TSB 2036607, *91 MMI3G+ Navigation GPS Location is inaccurate*, has been completed and the 0 satellite condition only occurs with the HVAC blower on while in panel vent mode, proceed to the *Service* section of this bulletin.

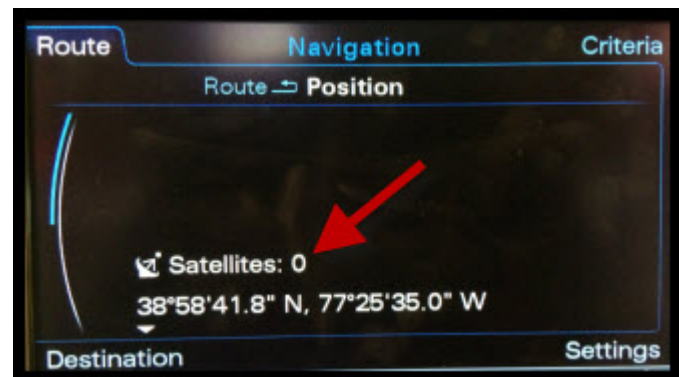
Figure 2. Number of satellites received.

To view the number of satellites being received, go to *Nav >> Route >> Current Position (first item in list) >> Scroll up* (Figure 2). If the system does *not* receive any satellites during this timeframe, submit a Technical Assistance Center ticket.

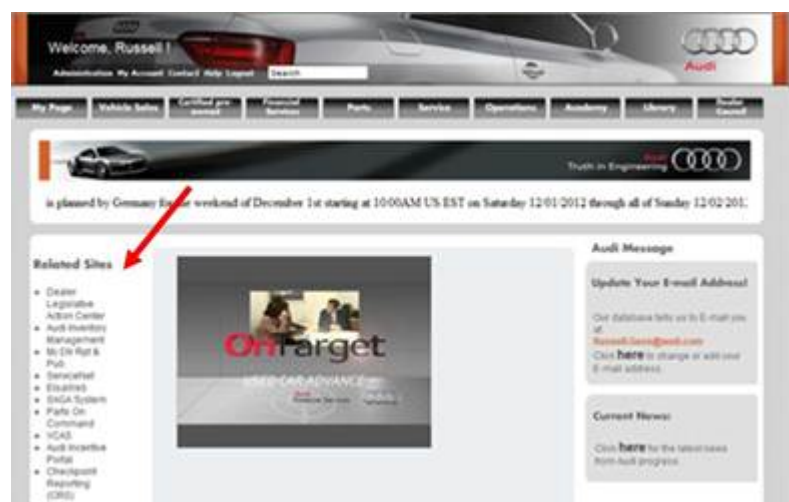
Figure 3. Related Sites section on Accessaudi.com landing page

- Do not replace any components because doing so will not resolve the customer's concern.
- Create a PSS record in the PSS application via the hyperlink in Accessaudi.com (Figure 3) or Technical Assistance page in Elsa (Figure 4).

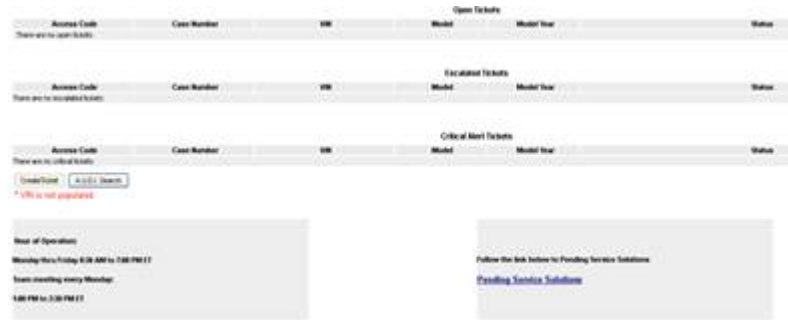
Figure 4. Technical Assistance page
