Technical Service Bulletin

91 MMI3G+ Navigation GPS Location is inaccurate (MY13 only)

91 14 42 2036607/1 April 30, 2014.

Model(s)	Year	VIN Range	Vehicle-Specific Equipment
A4, A5, A5 Cabriolet, Q5, Q7, A6, A7, A8	2013	All	MMI3G+ with Navigation

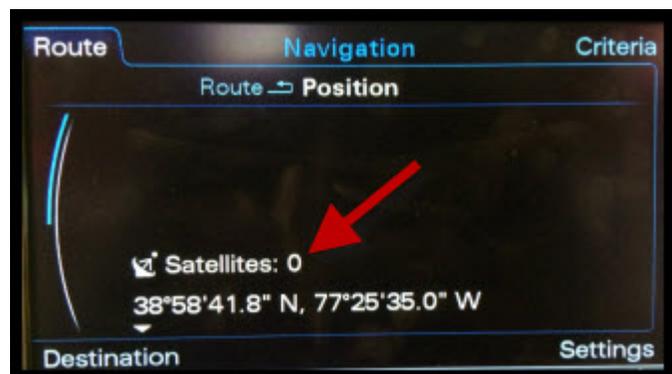
1. Turn the HVAC system blower off.
2. Verify that the MMI navigation system consistently shows 0 satellites (Figure 1) with the car outside in clear view of the sky.

Figure 1. Zero satellite reception in MMI.

- **If the system shows 0 satellites:** Reset the GPS hardware in the MMI main unit before proceeding to step 4. To reset the hardware, turn the ignition off and disconnect the quad lock connector from the back of the main unit for one minute.
- **If the system shows one or more satellites and the Navigation map shows the correct location:** proceed to step 4.

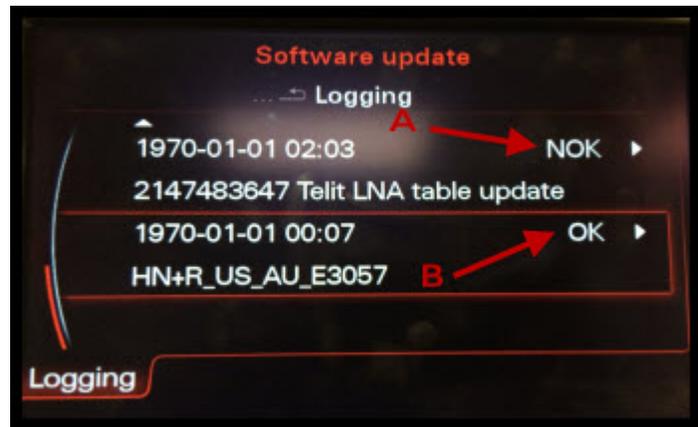
4. Perform the ZUG K0715 software update as outlined in TSB 2030465: *91 MMI 3G+ Sound system "popping" and various other technical Issues (K0715 Update)*.
5. After the update is complete, verify that all systems show "OK". If "NOK" is displayed, the update was not completed successfully and it should be performed again (starting with step 3) until it is successful.

Figure 2. Update not completed successfully (A); Update completed successfully (B).
