# Technical Service Bulletin

## 94 Daytime running light (DRL) inoperative (DTC 02895 or 02897)

94 14 38 2032184/3 April 7, 2014. Supersedes Technical Service Bulletin Group 94 number 13-21 dated July 9, 2013 for reasons listed below.

Model(s)	Year	VIN Range	Vehicle-Specific Equipment
Q5	2013 - 2015	All	Audi xenon plus daytime running lights with LED

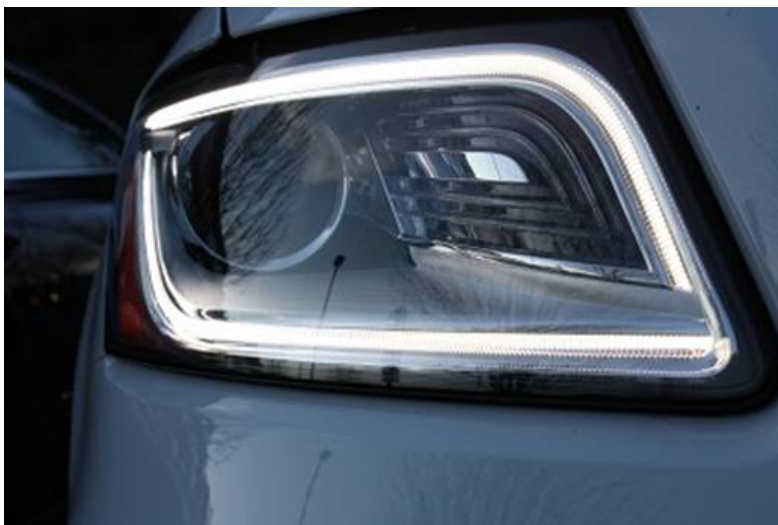
The MY2013+ Audi Q5 LED DRLs use light-emitting “pipes” or “guides” instead of multiple, individual LEDs. There are two light pipes per headlight. Each light pipe uses a single LED for illumination (Figure 1).

**Figure 1.** Upper and Lower light pipes illuminated.

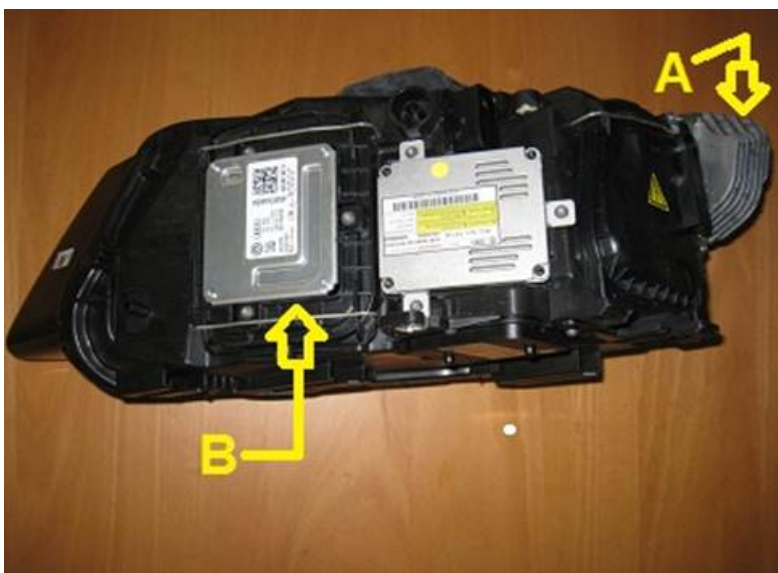
The LEDs with heatsinks are contained in a single module (Figure 2, A) mounted to the outer backside of each headlight.

The LED unit with heat sink utilizes a gasket and is keyed into the headlight housing to maintain proper alignment of each LED and light pipe. The LED units (L176 and L177, left and right, respectively) are controlled via a control module (J860 and J861, left and right, respectively) located separately on the backside of the headlight (Figure 2). These LED units and LED control modules are electrically interchangeable from side to side, but the LED units are mechanically specific to each headlight side.

**Figure 2.** Backside of headlight with LED heat sink (A) and LED control module (B).

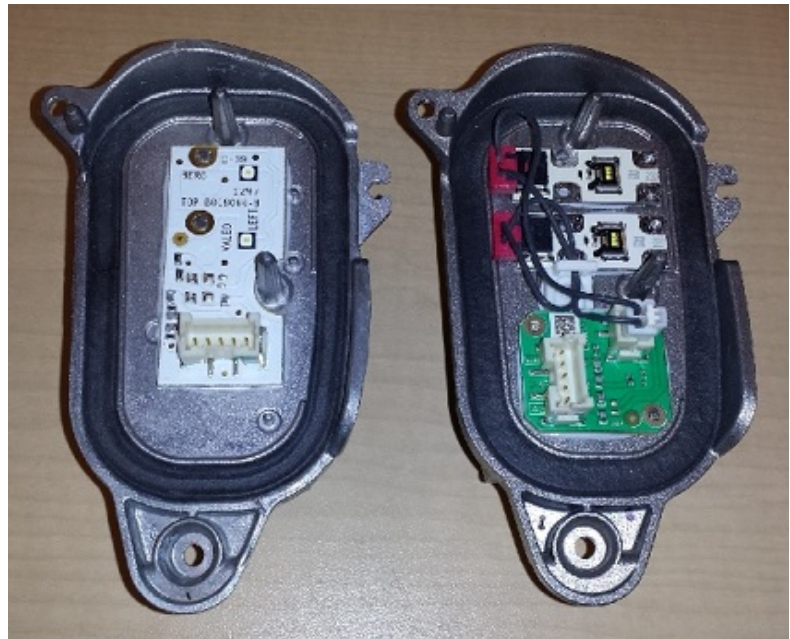
As of March 12<sup>th</sup>, 2013 production, the LED unit with heat sink has been updated (Figure 3). If a failure occurs, these parts do *not* need to be replaced in pairs.

**Figure 3.** Current (left) and early (right) style LED DRL units.

The appearance of the replacement part for the LED DRL has changed, but functionality is the same. If an LED DRL needs to be replaced, they do not need to be replaced as a pair.

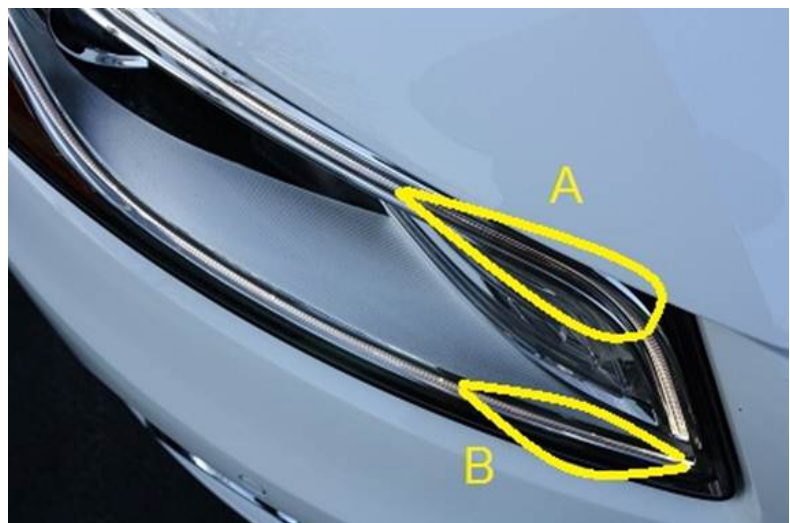
If the customer complaint is that the LED DRLs appear to be partially inoperative, please confirm this complaint while the customer is present. The LED DRL can be perceived as inoperative due to the viewing angle taken by the customer.

- A defect may be perceived for top-down viewing angle (Figure 4).

**Figure 4.** Upper light pipe perceived defect (A). Lower light pipe perceived defect (B).

Explain to the customer that the LED illumination appears differently to someone standing in front of the vehicle than it appears to oncoming traffic. The viewing angle of someone standing in front of the vehicle will give a visual effect of an LED DRL inoperative or partially-inoperative condition.

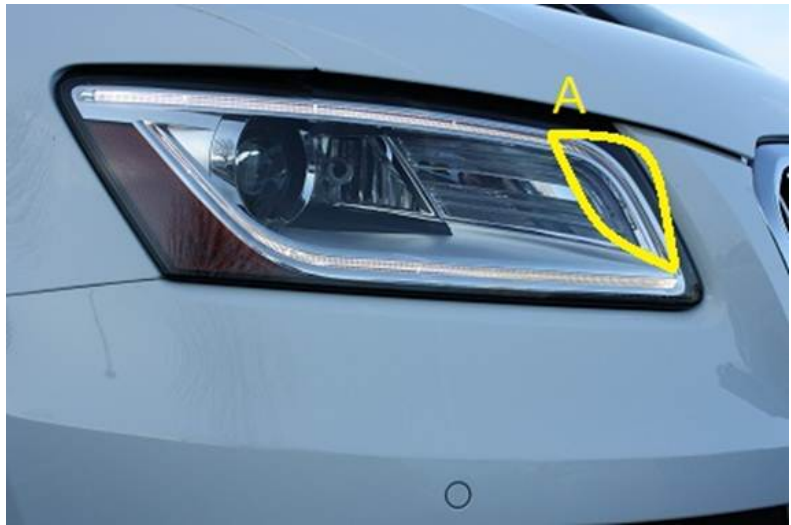
- A defect may be perceived for corner viewing angle (Figure 5).

**Figure 5.** Upper light pipe perceived defect (A).

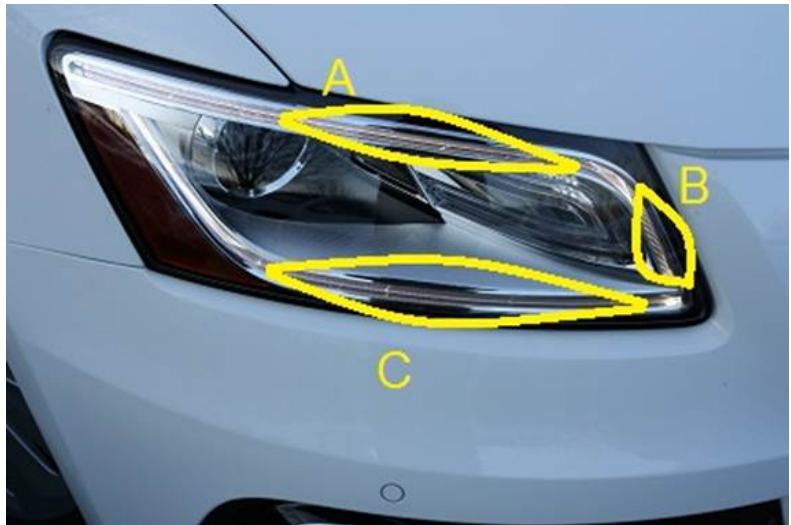
- A defect may be perceived for acute corner viewing angle (Figure 6).

**Figure 6.** Upper light pipe perceived defect (A, B). Lower light pipe perceived defect (C).

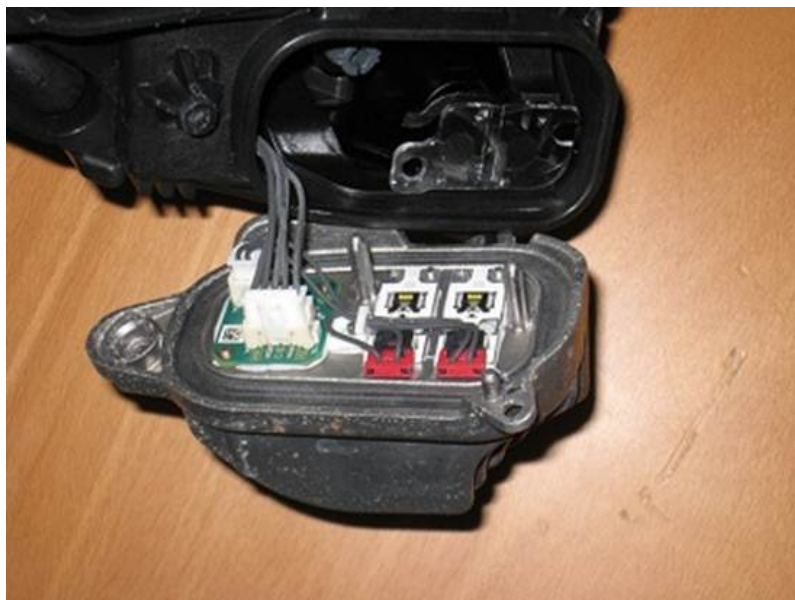
Be extra careful with red surface mount connectors. In general, a repair kit is not available for any internal headlight connectors.

Figure 7: Dual surface mount LED unit exposed.

1. With ignition off, remove DRL control module and check red connector at module. Secure it, if loose. If necessary, remove red connector and reinstall to be sure connector is engaged properly. The wiring harness guide of the red terminal housing may impede connector engagement.
2. Turn ignition on to see if DRL is now operating to specifications. If it is not, proceed to step 3.
3. Remove headlight(s) according to the instructions in ElsaWeb. See *Repair Manual >> Electrical System >> Electrical Equipment >> 94 Exterior Lights, Switches >> Removal and Installation*.
4. With ignition off, remove LED DRL unit with heat sink from headlight housing (Figure 7).
5. With ignition off, inspect and secure all electrical connectors, if loose. Remove and secure the white connectors, even if they do not appear to be loose.
