Technical Service Bulletin

48 Electric steering column adjustment is inoperative

48 14 59 2017266/7 June 2, 2014. Supersedes Technical Service Bulletin Group 48 number 13-51 dated August 30, 2013 for reasons listed below.

Model(s)	Year	VIN Range	Vehicle-Specific Equipment
A6	2005 - 2011	All	Not Applicable
A8	2003 - 2010	All	Not Applicable
Q7	2007 - 2013	All	Not Applicable
Q7	2014	000001 - 002000	Not Applicable

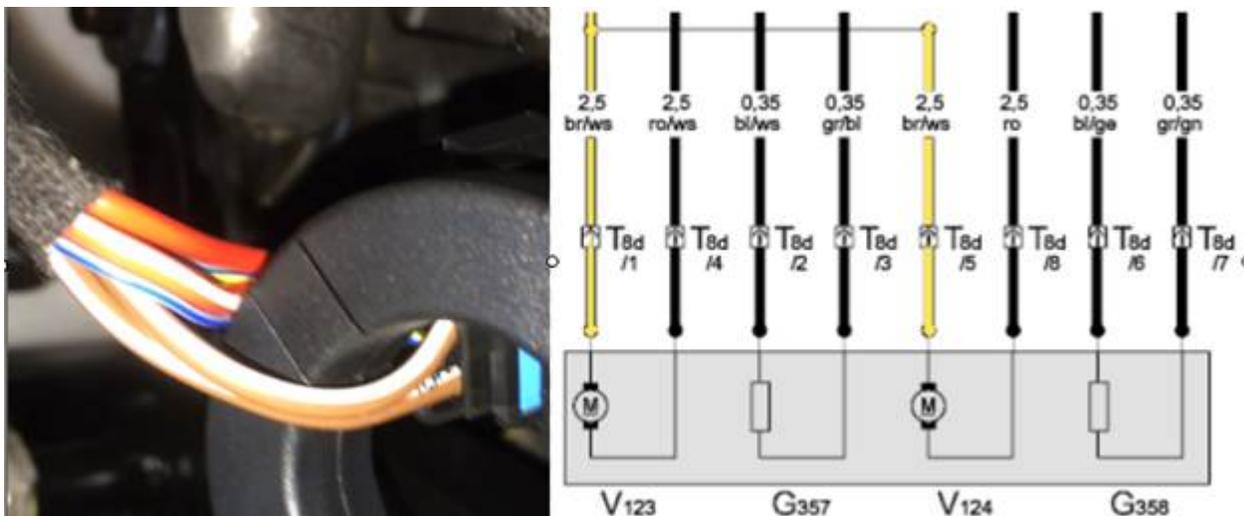
Figure 1. Current clamp installed (left), pins 1 and 5 (right).

1. Remove the steering column trim to gain access to the 8-pin (black) connector located under the dash.
2. Identify wires on T8d/1 and T8d/5. Install the current pick-up clamp around these wires (Figure 1).

3. Perform basic settings of the steering column in the J519 control module. Record the peak current values during the length and height adjustment.

- The expected current draw in correct steering columns is about 1A for axial adjustments and about 2.8A - 3.4A for vertical adjustment (lower current draw typically found during testing, 2.0A-2.5A). Current draws above these values are an indication of binding or a tight steering column.
4. Loosen the steering column from the cross carrier, then tighten the column according to ELSA instructions (Figure 2). This should relieve any tension between the steering column and cross carrier, if any existed.

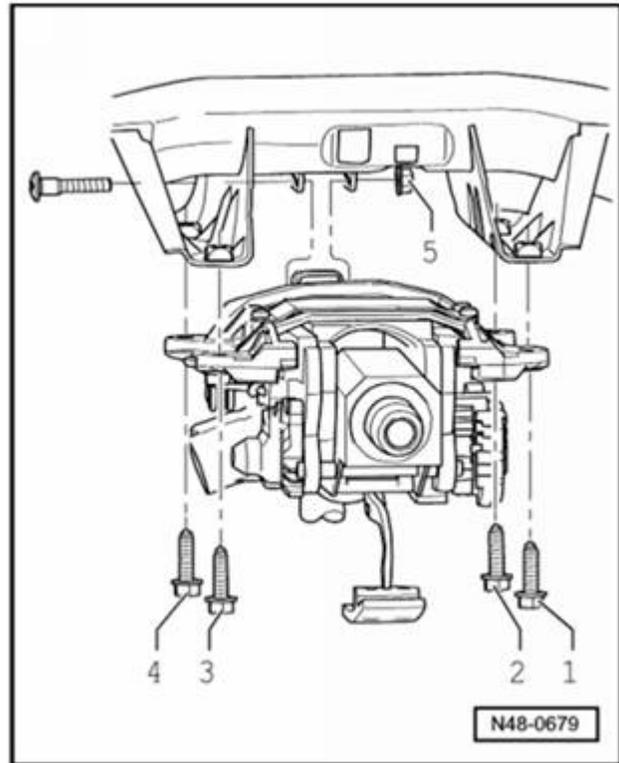
Figure 2. Tightening sequence (see ELSA for correct torque specifications)

5. Operate the steering column up and down and note the peak current draw:
- If the current draw is lower and within the specifications after the mounting bolts have been loosened and retightened, the steering column had tension. If the current draw stays low after the reinstallation, the tension is only caused by the installation. An adjustment of the steering column is not necessary.
 - If the current draw rises to its original level after the reinstallation, the tension is caused by unfavorable tolerances of the components. The steering column must be adjusted as described in the instructions that follow.

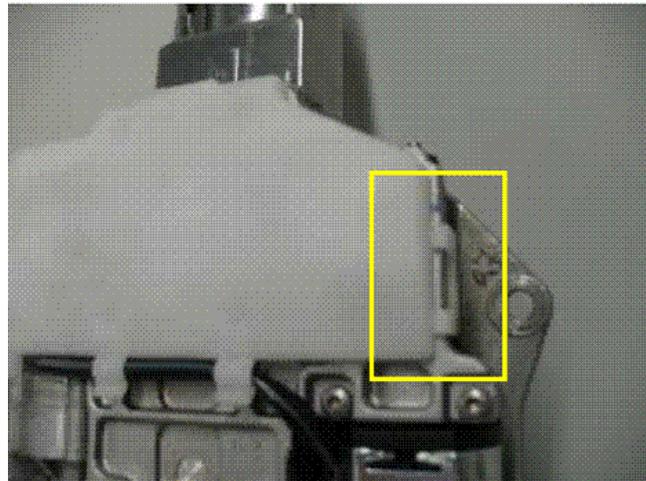
Figure 3. Side clips.

1. Loosen the belt cover of the steering column:
 - If necessary, remove the footwell and steering column covers.
 - Next, move the height adjustment of the steering column to a central position.
 - Then, carefully loosen the side clips without damaging the clasps (Figure 3).

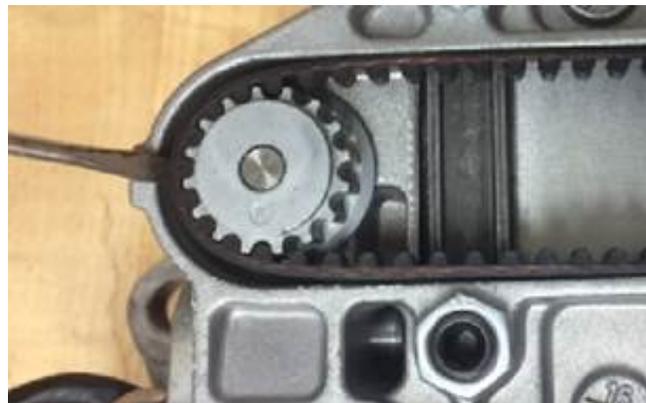
Figure 4. Remove the gear belt with a fine screwdriver.

2. Carefully remove the gear belt from one gear wheel, using a fine screwdriver (Figure 4). Leave the gear belt removed from one wheel for step 3.

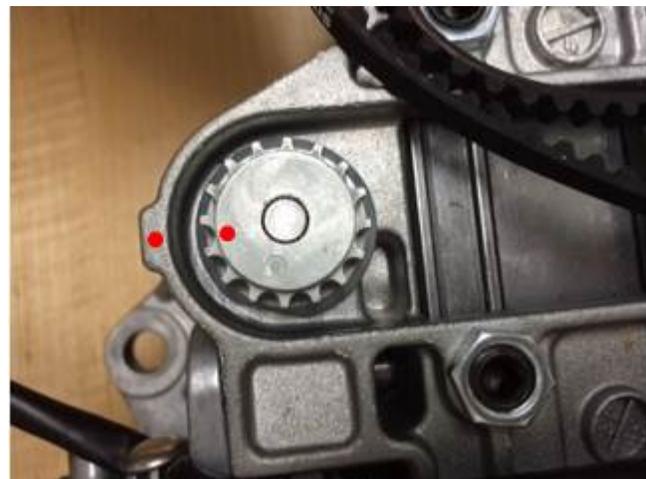
Figure 5. Marking original gear location.

3. Reduce the tension in the steering column:
 - Mark the gear's original location on the gear, on the housing, and on the belt (Figure 5).

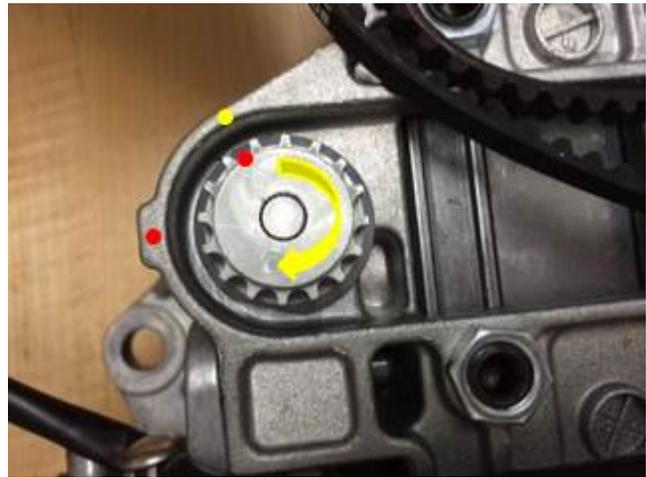
Figure 6. Marking the location with the greatest resistance in the clockwise direction.

- Turn the gear clockwise and mark the location with the greatest resistance (Figure 6).

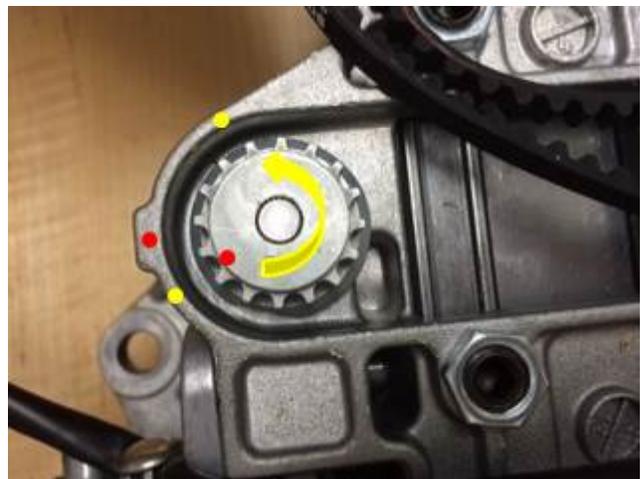
Figure 7. Marking the location with the greatest resistance in the counter-clockwise direction.

- Turn the gear counter-clockwise and mark the location with the greatest resistance (Figure 7).

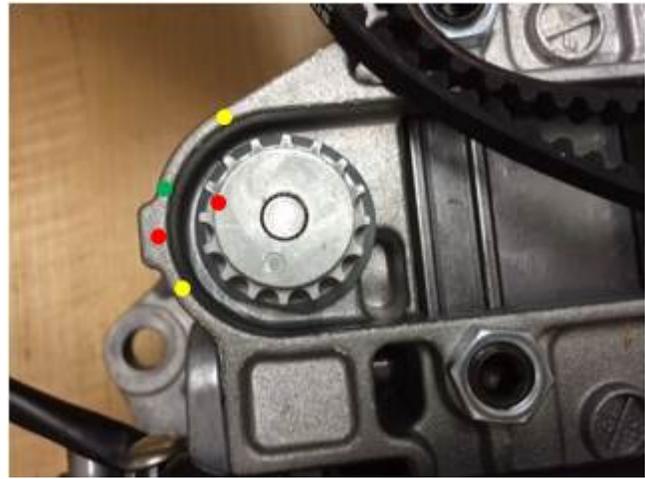
Figure 8. *Placing a green dot in between the two yellow dots and turning the gear (red dot) to match the green dot on the housing.*

- Place the original marking of the gear in the center of the two greatest resistance markings (Figure 8).

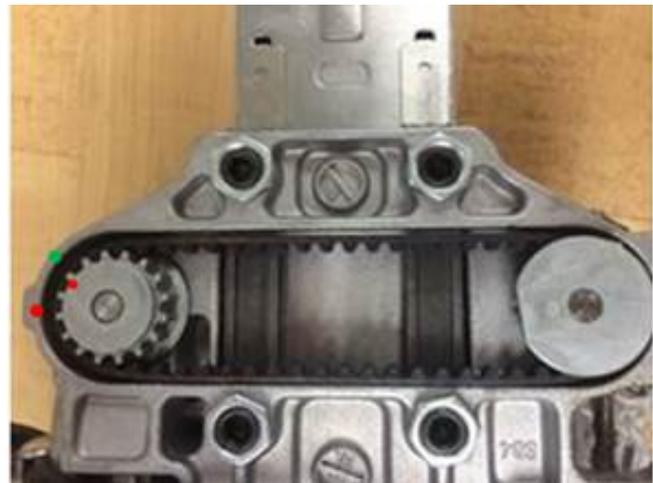
Figure 9. *Installation of gear belt.*

4. Place the gear belt, by hand, on the gear wheel (Figure 9).

The gear may have to move slightly to engage the belt during installation but other than that, the gear and green dot should line up (+/- ½ tooth). This will ensure that the gear is now centered between the two greatest resistance points.

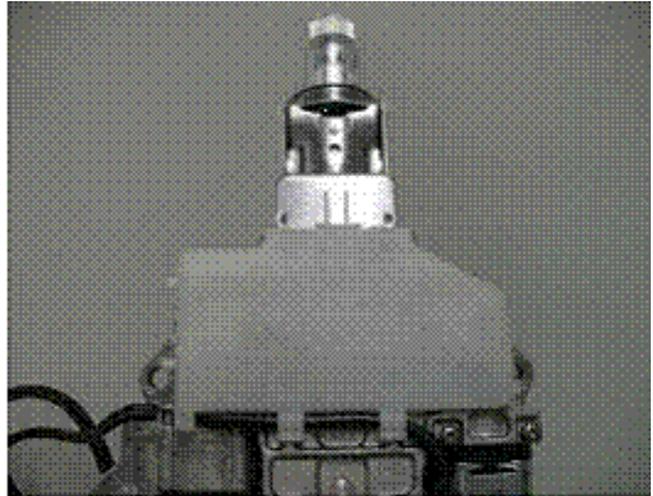
Figure 10. The cover, installed on the housing.

5. Carefully reinstall the cover on the housing (Figure 10).
