51 Full body cover removal - A3

51 14 08 2037319/1 May 23, 2014.

Model(s)	Year	VIN Range	Vehicle-Specific Equipment
A3	2015	000001 - 020115	Not Applicable

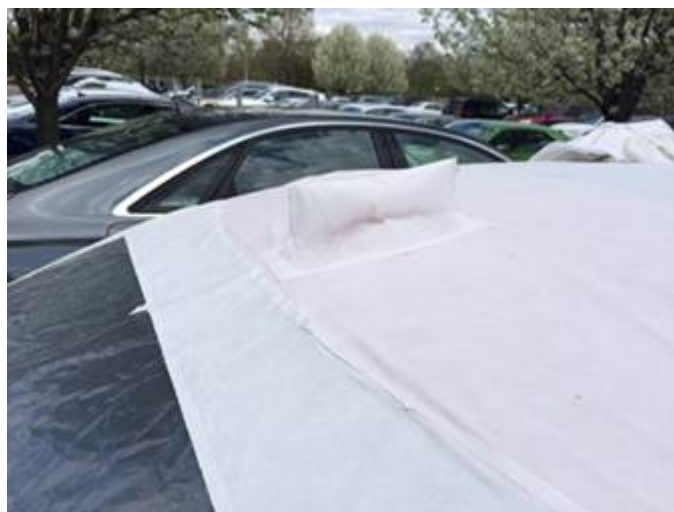
Under certain circumstances during full body cover removal (Figure 1), it is possible that the GPS antenna is subjected to electrostatic discharge (ESD) as the cover cloth is moved across it. This can cause failure of the GPS antenna.

Figure 1. Full body cover on the new 2015 Audi A3.

Before removing the full body cover using the guidelines in TSB 2009967, ***wet the entire full body cover thoroughly with water.*** Doing so will divert potential discharges away from electrical components during full body cover removal. This, combined with the removal process in TSB 2009967, will eliminate the likelihood of inadvertent ESD induction.
