Technical Service Bulletin

72 Seat bottom makes noise; seems to have play when vehicle is cornering

72 14 14 2037166/1 May 6, 2014.

Model(s)	Year	VIN Range	Vehicle-Specific Equipment
Q5	2013	078010 - 999999	Not Applicable
Q5	2014	000001 - 049004	Not Applicable

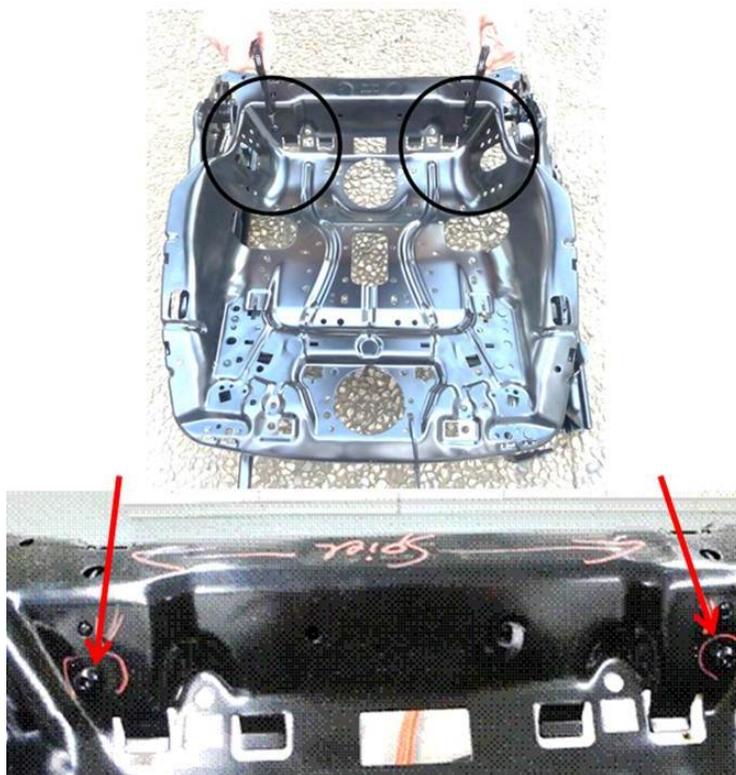
The front lower seat frame has play or makes noise when the vehicle is cornering.

The bolts on the seat pan that connect to the frame (Figure 1) were not properly torqued by the supplier, and they can become loose.

Figure 1. Bolts on seat pan (circled in black in top image and at red arrows in bottom image).

1. Remove the complete seat, seat cover, and seat foam according to the instructions in the Elsa Repair Manual.
2. Tighten the two support bracket bolts for the transverse pipe with 5 +/- 1 Nm.
3. Reinstall seat. Apply proper torque when bolting the seat frame to the floor.
