Technical Service Bulletin

94 Headlight cracked / water ingress into headlight lens

94 14 42 2034735/2 May 29, 2014. Supersedes Technical Service Bulletin Group 94 number 13-25 dated July 24, 2013 for reasons listed below.

Model(s)	Year	VIN Range	Vehicle-Specific Equipment
A6	2012-2013	All	Xenon or LED Headlights
A6	2014	000001-041047	Xenon or LED Headlights

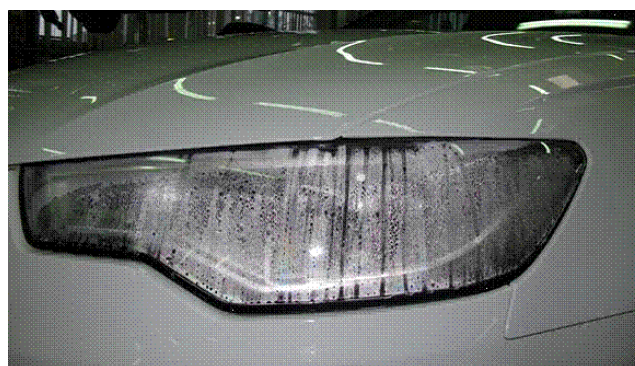
- Heavy condensation is present in the headlight (Figure 1).

Figure 1. Headlight with heavy condensation

The moisture is an optical condition that does not affect the function or performance of the headlights, and it will not lead to corrosion or damage of the internal headlight parts.

Replace the affected headlight with the updated part number found in the ETKA parts catalog.

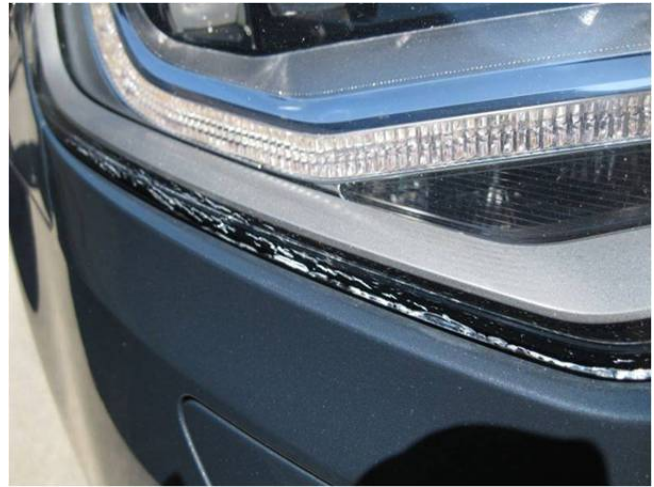
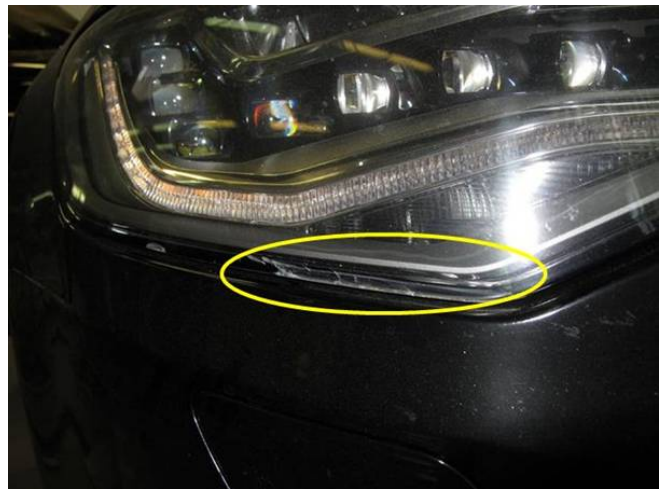
- Lower headlight lens cracking (Figure 2 and Figure 3).

Figure 2. Lower headlight lens cracking.

Figure 3. Lower headlight lens cracking.

The production process causes stress on the headlights from the bumper, as well as torsional force from installation.

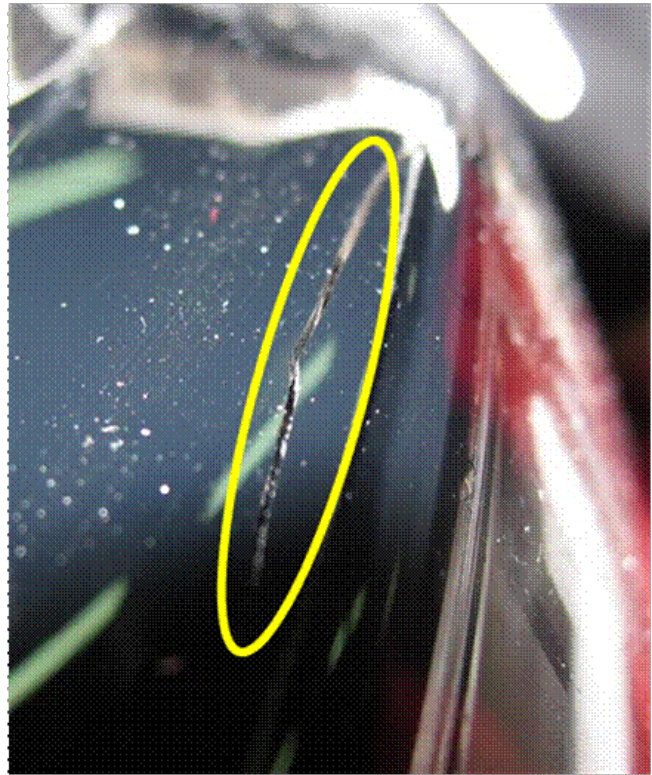
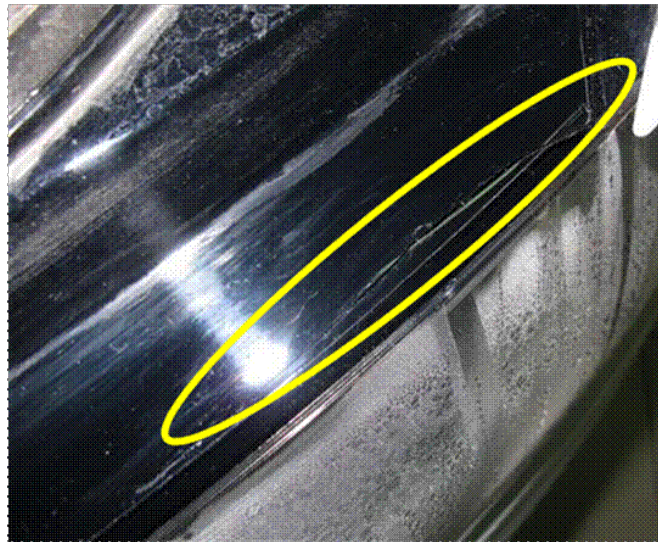
- Upper headlight housing cracking (at transition from lens to black surround) (Figure 4 and Figure 5).

Figure 4. Upper headlight housing cracking.

Figure 5. Upper headlight housing cracking.
