Technical Service Bulletin

68 Noises from center console

68 14 14 2034517/2 July 17, 2014. Supersedes Technical Service Bulletin Group 68 number 13-10 dated July 16, 2013 for reasons listed below.

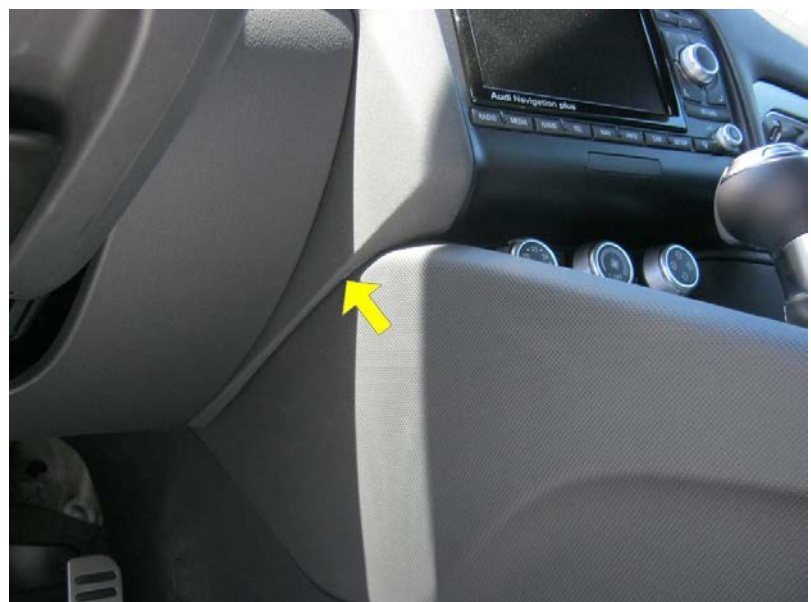
While driving the vehicle, the customer hears various noises coming from the center console area.

The noises are caused by too tight of a tolerance between the lower and upper portion of the center console (Figure 1).

Figure 1. No clearance between the upper and lower sections of the center console.

Adjust the console sections by following the instructions below. The objective is to eliminate the noise from this area by achieving a 1mm – 2mm clearance between the upper and lower sections of the center console:

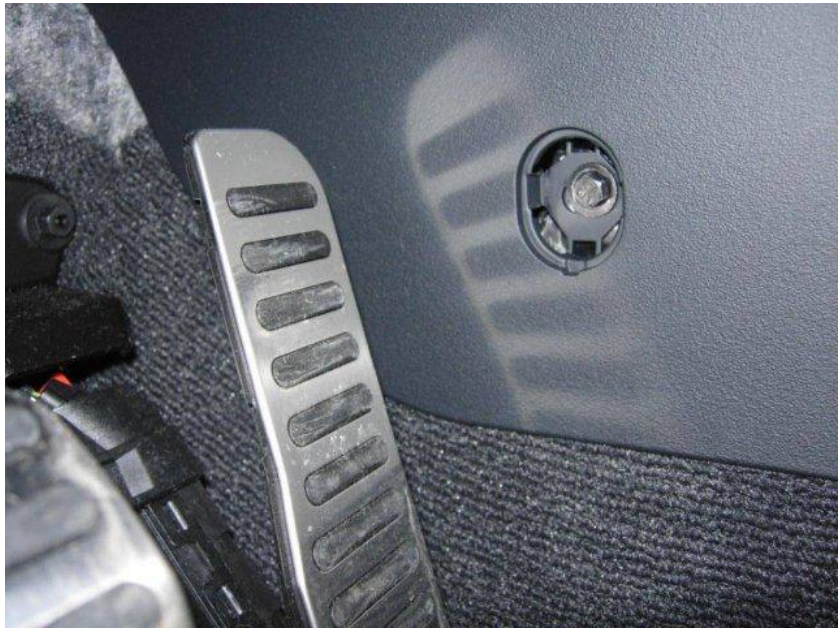
Figure 2. Mounting bolts for the console side trim.

1. Remove the covers that conceal the mounting bolts for the lower trim, then loosen the bolts for the center console side trim (Figure 2).

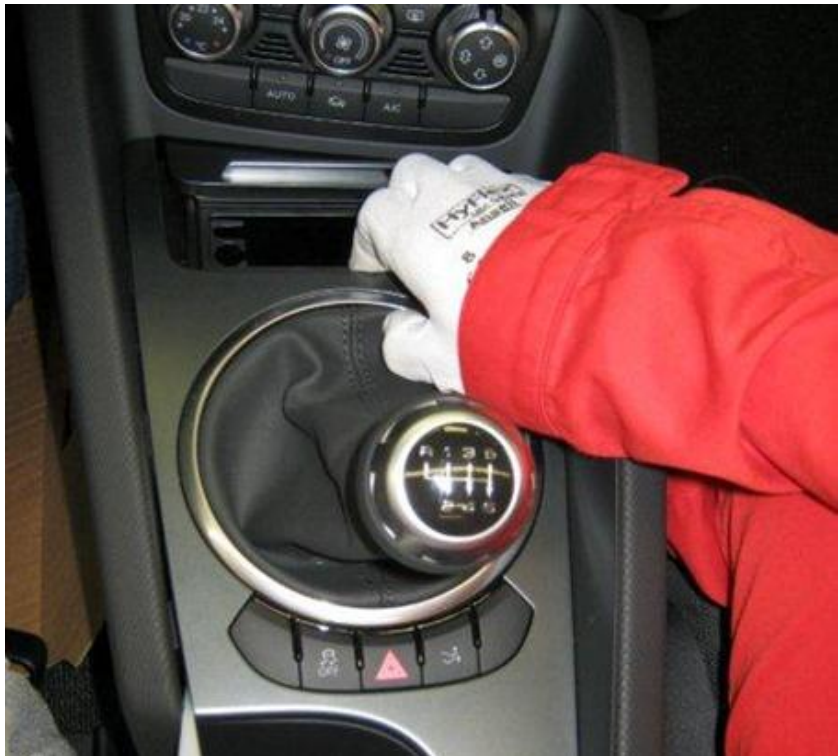
Figure 3. Removing the center console trim.

2. Remove the center console trim (Figure 3). There are seven clip points.

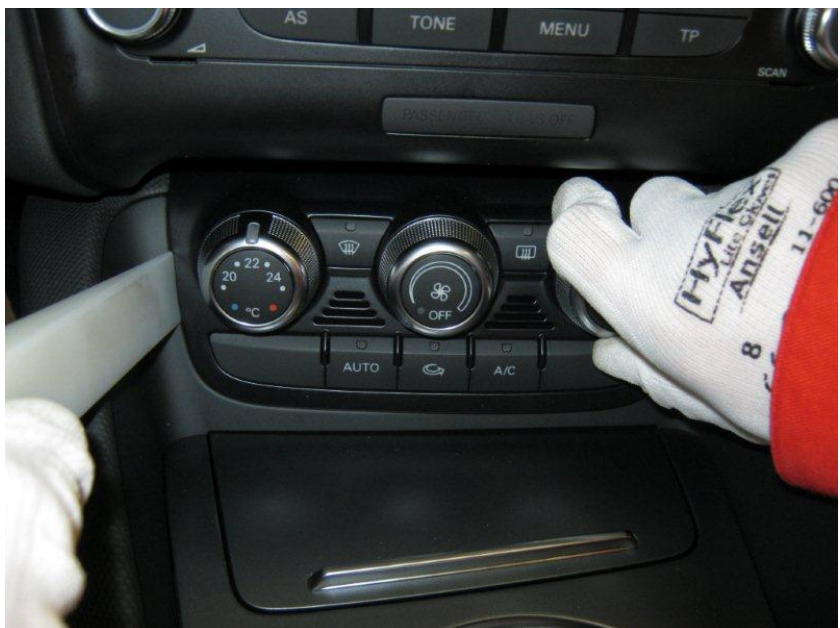
Figure 4. Removing the Climatronic control module.

3. Remove the Climatronic control module (Figure 4).

During removal of the control module, the rubber buffers can fall out. Ensure that these buffers are restored to their original positions when reinstalling the module.

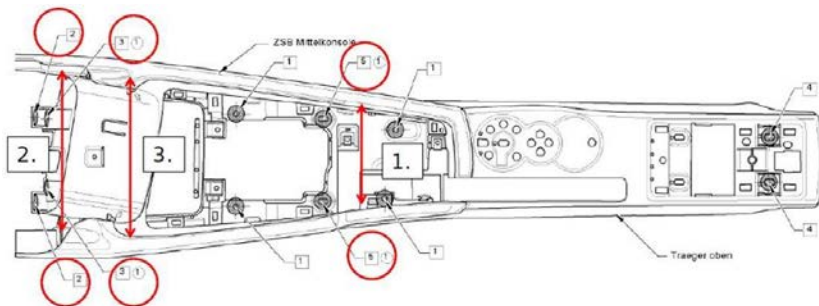
Figure 5. Front center console.

4. Remove the front center console (Figure 5).

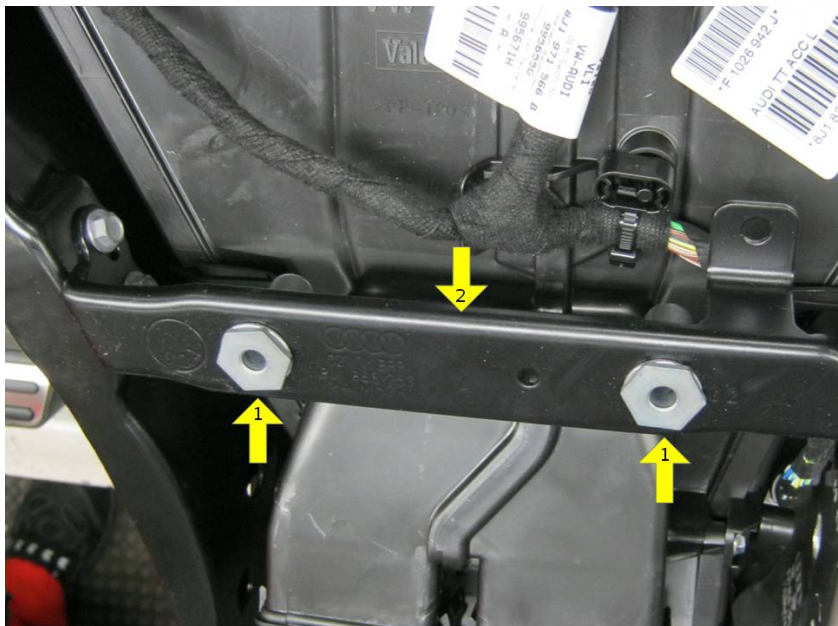
Figure 6. Center console mount with adjusting elements.

5. Move both adjusting elements into their basic position (Figure 6, arrow 1). Do not tighten. Loosen all 4 of the bolts for the mounting bracket (Figure 6, arrow 2). Push downward on the bracket to its lowest possible adjustment and retighten all 4 mounting bracket bolts.

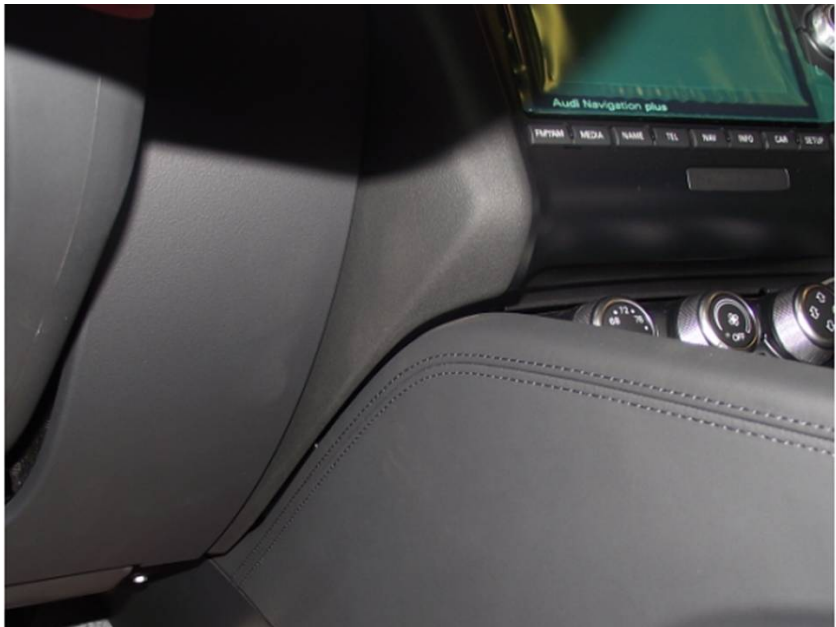
Figure 7. Gap achieved between the upper and lower sections of the center console after adjustment.

6. Reinstall the front center console. There should now be a gap of 1mm – 2mm between the upper and lower sections (Figure 7).

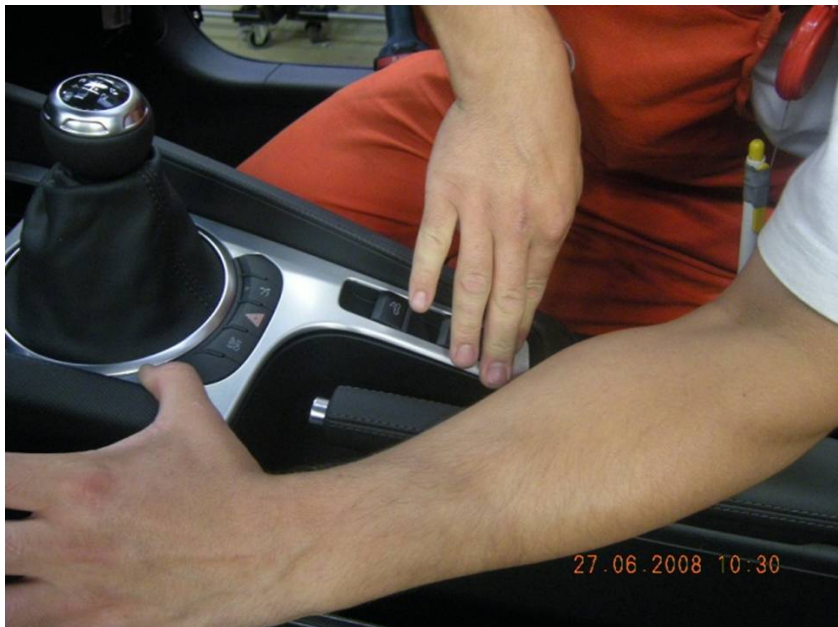
Figure 8. Installation of the center console trim.

7. When reinstalling the center console trim, begin at the rear. Pull the left edge of the console away from the trim slightly when pressing into place (Figure 8).

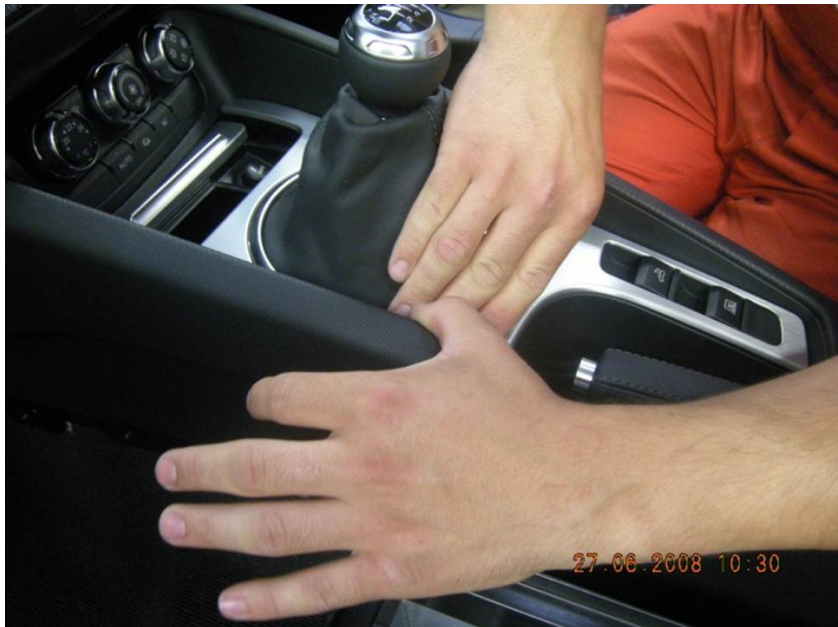
Figure 9. Pressing in the left center portion of the console trim.

8. Working forward to the center of the console trim, again pull the left edge of the console away from the trim slightly when pressing into place (Figure 9).

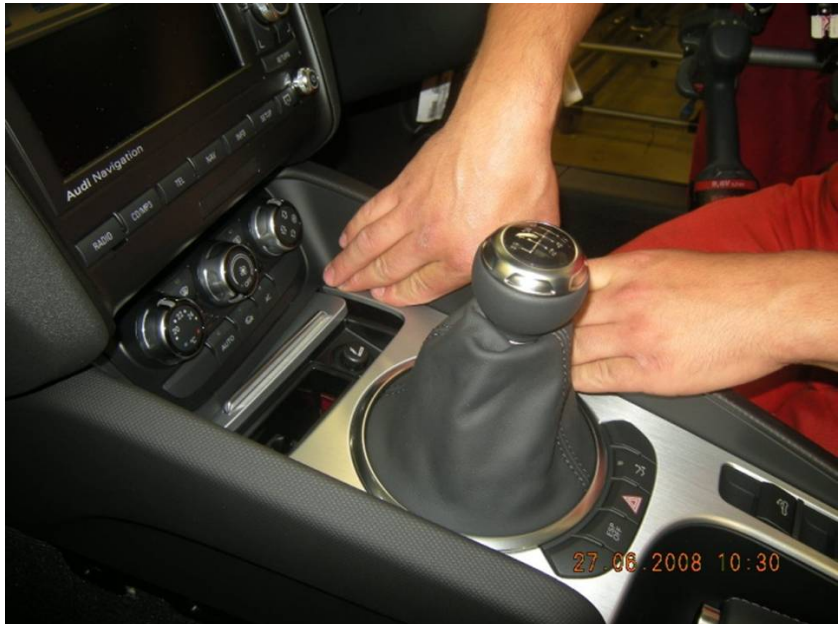
Figure 10. Pressing the right side of the console trim into place.

9. Pull the right edge of the console away from the right side of the trim when pressing the right side into place (Figure 10).
