Technical Service Bulletin

91 How to update MMI MIB navigation map - potential customer concerns

91 14 54 2037809/1 July 30, 2014.

Model(s)	Year	VIN Range	Vehicle-Specific Equipment
A3	2015 - 2016	All	Navigation

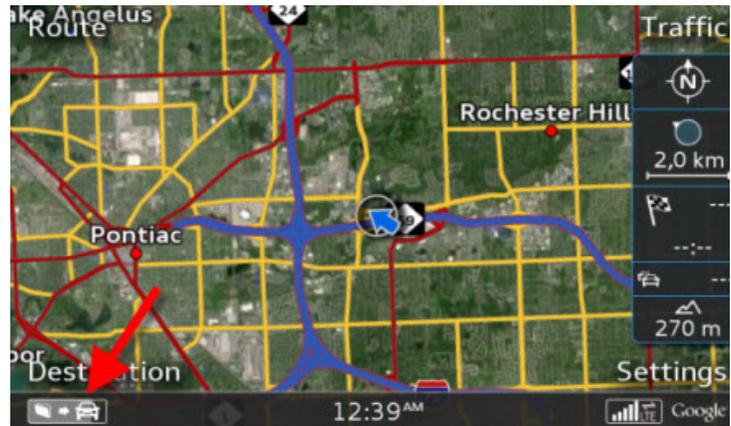
- During the map update process, the performance of the MMI system may be slow, with lagging or freezing during screen transitions or after a selection is made. These performance limitations should only occur during the map update, and no repairs should be made to correct them. A file transfer icon appears when the map update is running the background (Figure 2).

Figure 2. The background map update is indicated by the file transfer icon.

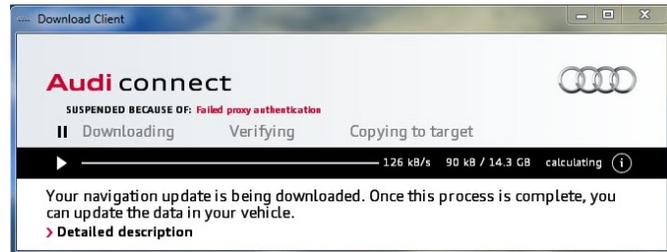
1. The map download is performed with a Java-based download manager (Figure 3). Ask the customer if the latest version of Java is installed on his or her computer. If the latest version of Java is not installed, it is possible that the map update cannot be performed.

Figure 3. Download manager

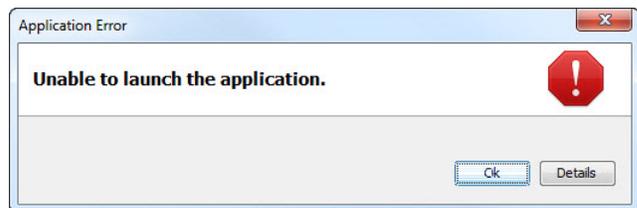
2. If the error message pictured at right (Figure 4) appears, it is because the Java download client cannot initiate a connection to the download site, which is indicative of a local issue with the customer's PC or ISP.

Figure 4. Error message

If this error message appears, ask the customer to do the following:

- Turn off all anti-virus software, which could be blocking the java application. Or, add the program to the exception list for the anti-virus software.
- Turn off any firewalls in the PC or in the router hardware.
- Try connecting the PC directly to the cable or DSL modem with the Ethernet cable, to bypass the router.
- Have the customer contact his or her ISP or local IT support.

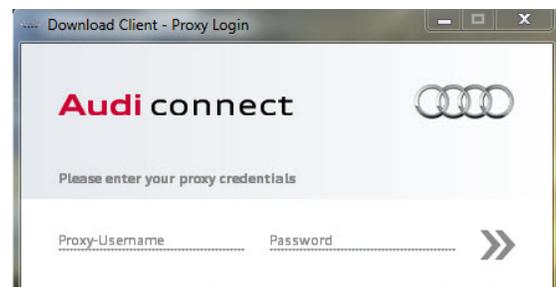
If the computer loses its internet connection, the customer will be required to reenter his or her myAudi password to restart the download (Figure 5). The map download client automatically saves all progress if the computer loses its internet connection.

Figure 5. Login prompt for my.audiusa.com

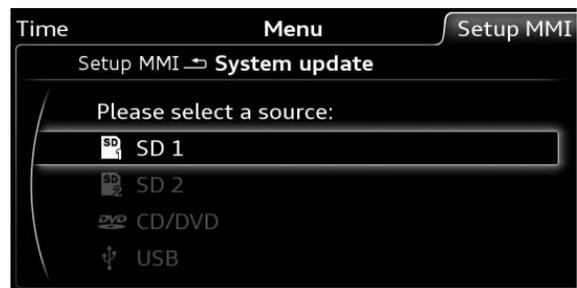
5. If the data was downloaded to the SD card correctly, the SD card will be highlighted in white (Figure 7). If no SD card is highlighted, ask the customer to troubleshoot the issue (Check formatting and verify that all the data is in the root directory of the media).

Figure 7. SD card that contains the map update data

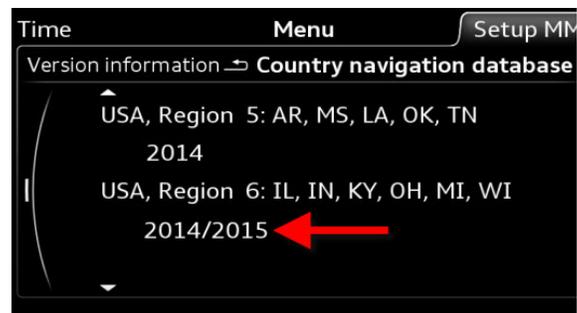
The MMI system will allow the same map data to be overwritten at any time, which means that if the customer puts the same SD card with the same map data into the main unit after a successfully-completed map update, the MMI will still indicate that a map update is available. This does not directly indicate the map update was incomplete; the customer must review the “Version Information” data and verify that the latest calendar year listing is shown under each region (Figure 11).

Figure 11. The updated map regions will be indicated by the calendar year listing under the region. In this figure, only “USA, Region 6” was updated.
