Technical Bulletin

Model(s)	Year	Eng. Code	Trans. Code	VIN Range From	VIN Range To
Jetta	2005 – 2010	All	All	All	All
Sportwagen	2008 – 2009	All	All	All	All
Golf	2006 – 2014	All	All	All	All

51 14 02 November 25, 2014 2038990

Rocker Panel - Front Fender – Corrosion

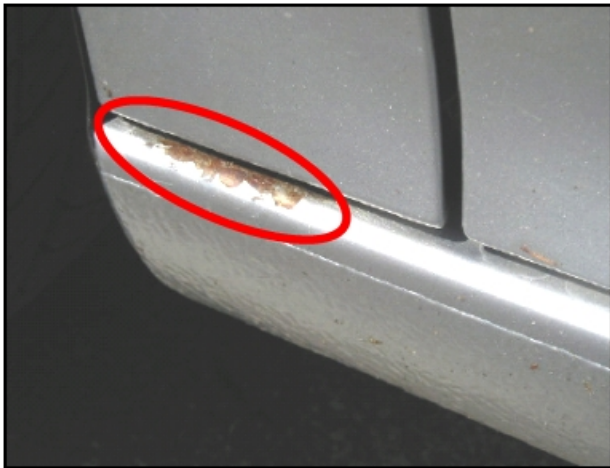
- Corrosion between the rocker panel (side member) and the fender (Figure 1, red outline).

Figure 1 - corrosion in the area of the rocker panel/front fender

Corrosion on contact surfaces of the front fender to rocker panel (side member).

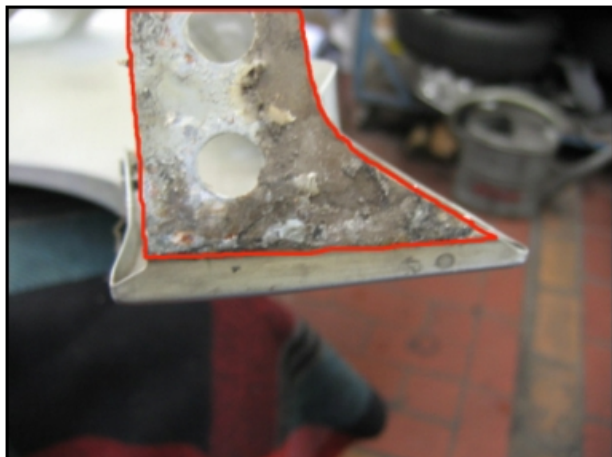
- Corrosion on the contact surface of the fender (Figure 2, in red outline).

Figure 2 - fender removed (corrosion on the contact surface of the fender)

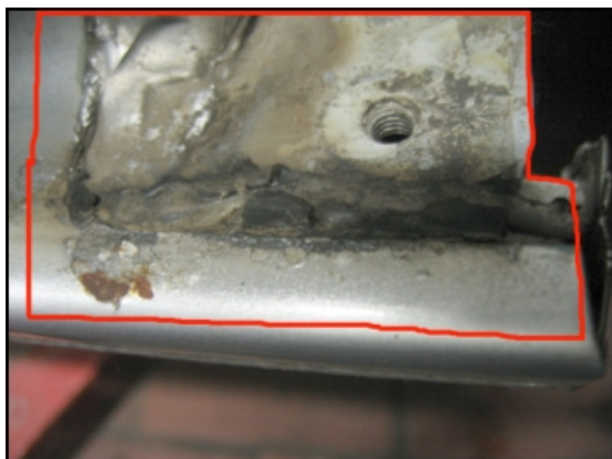
- Corrosion on the contact surface of the rocker panel (side member - Figure 3, in red outline).

Figure 3 - fender removed (corrosion on the contact surface of the rocker panel [side member])

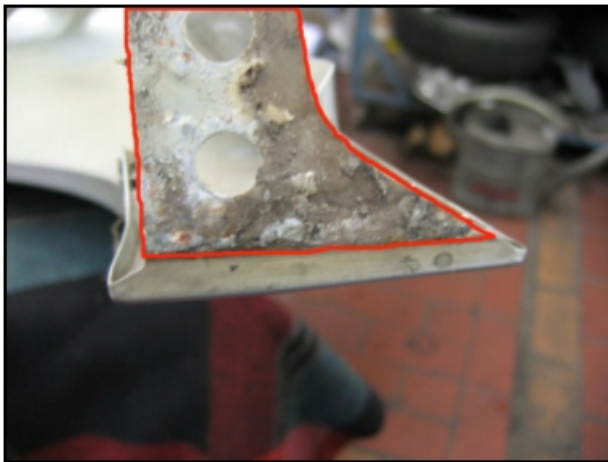
- Remove the front door according to the repair manual. See Repair Group 57 in Elsa.
- Remove the front fender according to the repair manual. See Repair Group 50 in Elsa.
- Check the contact surface of the fender for corrosion (Figure 4, in red outline).

Figure 4 (corroded contact surface of fender)

- Remove the corrosion in the contact area of the fender with the pneumatic brush grinder.
- Apply a VOC compliant epoxy primer as an anti-corrosion treatment and primer (locally sourced).
- Restore the paint structure according to the paint repair manual.

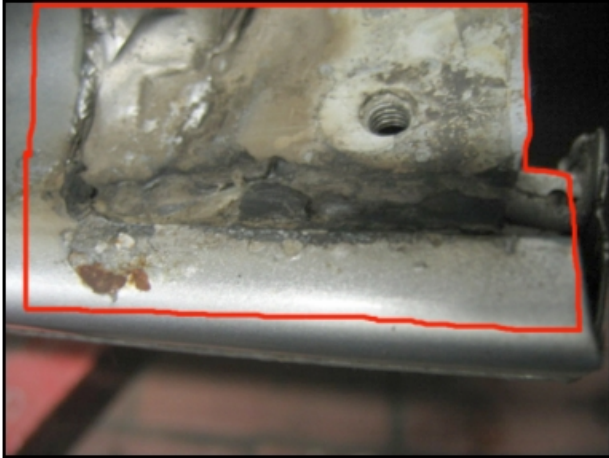
- Check the rocker panel (side member) in contact surface of the fender for corrosion (Figure 5, in red outline).

Figure 5 (corroded contact outer rocker panel [side member])

- Remove the corrosion on the rocker panel (side member) with the pneumatic brush grinder.
- Apply a VOC compliant epoxy primer as an anti-corrosion treatment and primer (locally sourced).
- Seal and smooth the rocker (side member) in the area of the metal edge (Figure 6, in red) with polyurethane sealer (part number: AKD 476 KD5 05).

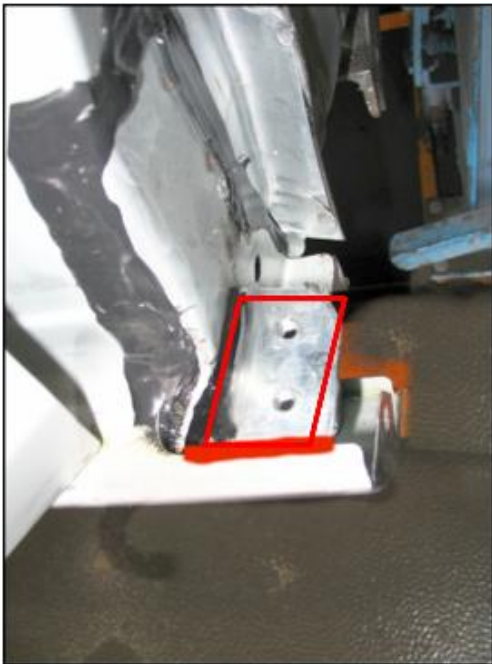
Figure 6 – rocker (side member) during repair

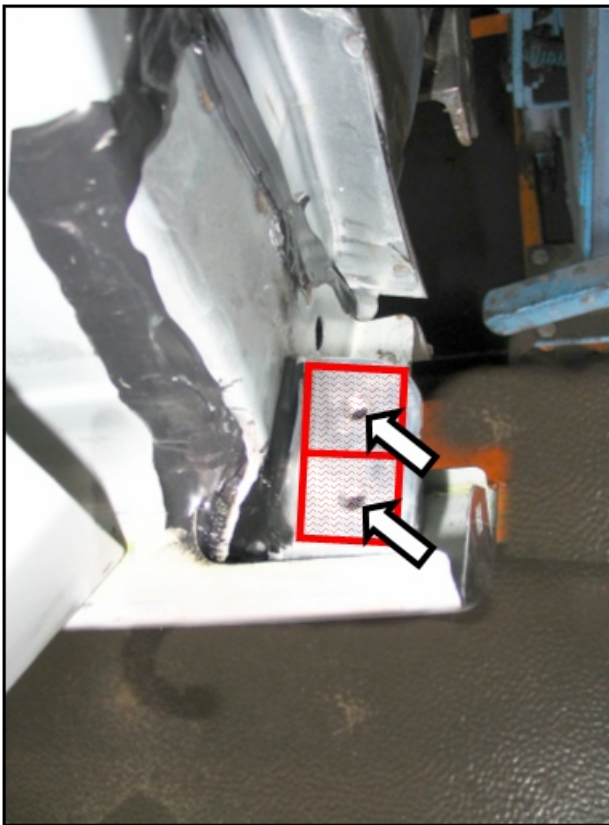
Figure 7 - during repair

Before installing the fender, attach two zinc layers (part number AKL 381 035 50) in the contact area between fender and rocker panel (side member - illustration 7, arrows) and bond them on the rocker panel - see also Figure 8 (number 1).

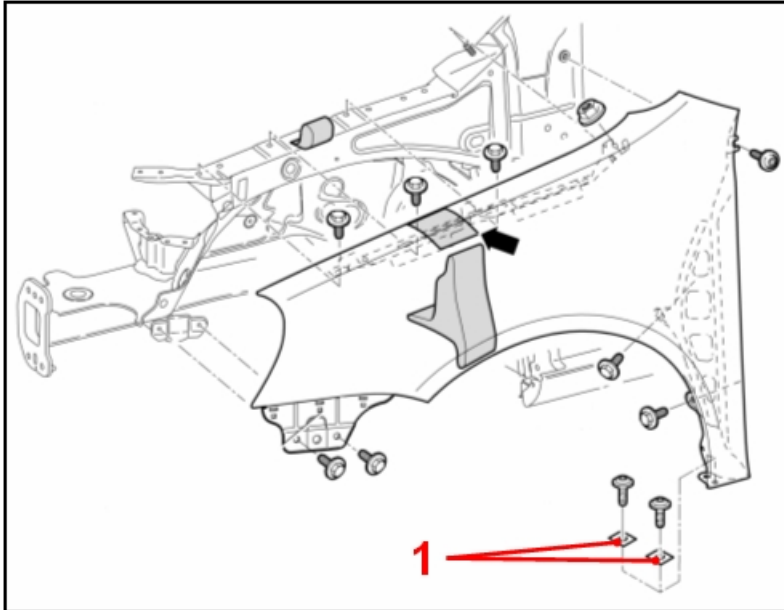
Figure 8 - zinc layers (No. 1)
