**Freightliner  
Service Bulletin**

# 32-50

## Incorrect ECAS Ride Height Sensor and Linkage Installation

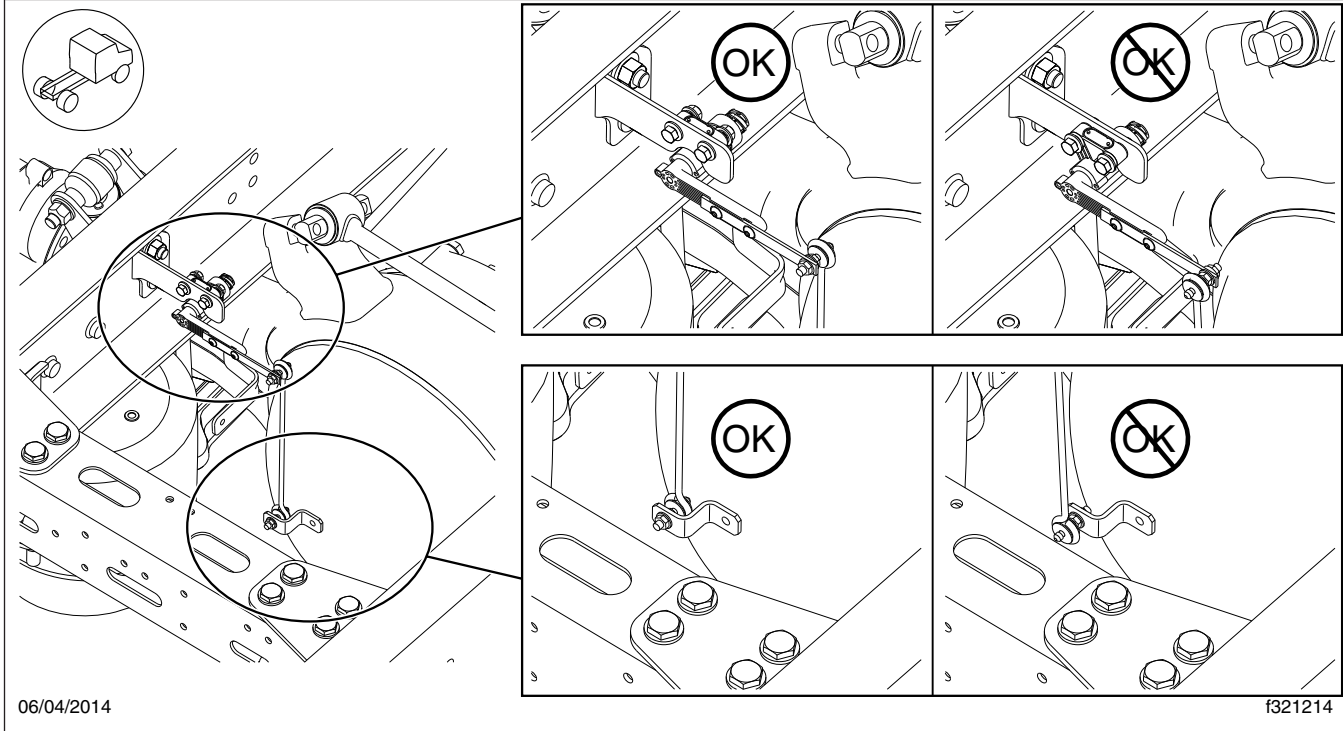
**Fig. 1, Inspection of the Ride Height Sensor Installation**

6. Compare the ride height sensor position of the vehicle to **Fig. 1**. The sensor should be installed on the forward side of the sensor bracket, and the linkage rod should be on the forward side of the Z-bracket on the axle. The linkage rod should be upright, with no fore-aft tilt, as shown in **Fig. 2**.

If the sensor or linkage rod are out of position, reposition them to match **Fig. 1**. While the sensor is off the vehicle, inspect it for damage. If any cracking is found on the arm or body, replace the sensor.

10. Reconnect the linkage, making sure it matches the installation in **Fig. 1**. Turn the key on and use the ECAS remote control to lift the suspension enough to remove the height blocks.

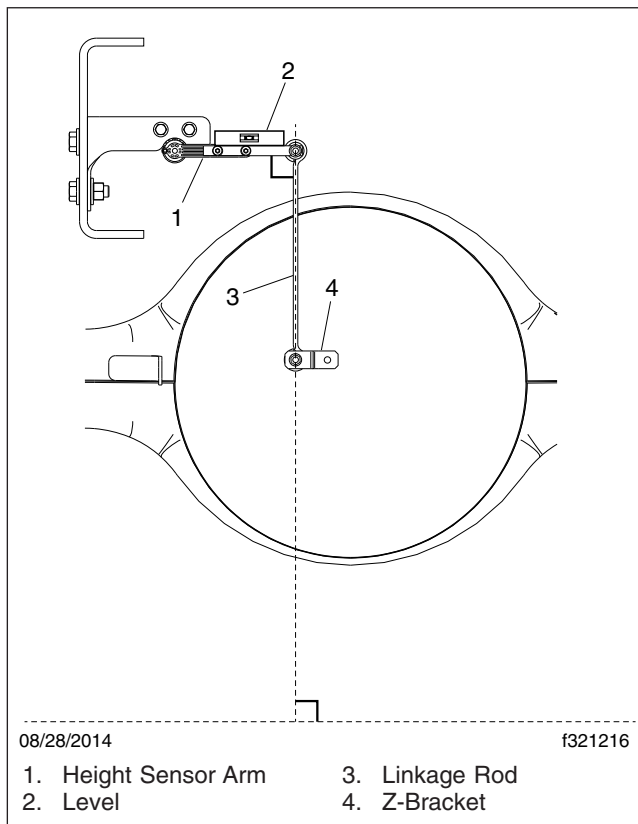
**Fig. 3, Correct Position of the Arm, Linkage, and Z-Bracket**

7. Check the position of the height sensor arm and linkage rod. See **Fig. 3**. Check that the arm is level using a level, then use a plumb bob or carpenter's square to check that the linkage rod is at a 90° (right) angle to the level sensor arm.

If the arm is level, and the linkage rod is 90° to the arm and perpendicular to the ground, no further work is necessary.

If the arm is not level, and/or the linkage rod is not 90° to the arm, check the position of the Z-bracket as follows.

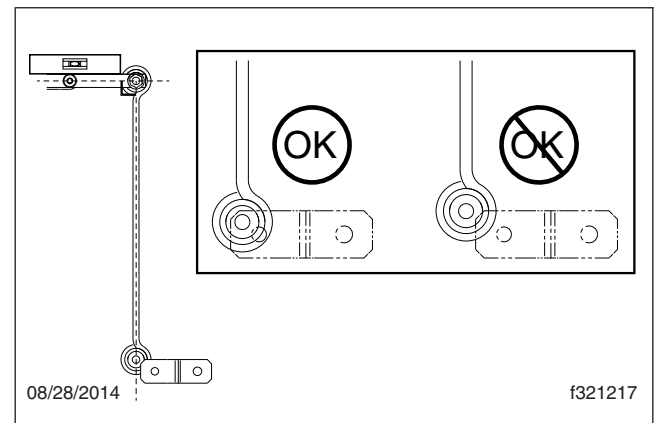
**Fig. 4, Permissible Variation in Z-Bracket Position**

- 7.2 Pin the arm to the sensor body using a 5/32-inch drill bit. If the arm isn't level when pinned, loosen the mounting fasteners and adjust the position of the sensor body on the frame bracket until the arm is level.
- 7.3 With the height sensor arm level and the linkage rod at 90°, check if the linkage end hole is within the perimeter of the Z-bracket mounting face. See **Fig. 4**.

If the end hole is within the perimeter of the Z-bracket mounting face, as shown in **Fig. 4**, the component positions are sufficient. No further work is necessary.

If the end hole is not within the perimeter of the Z-bracket mounting face, as shown in **Fig. 4**, install a new Z-bracket in the correct position. See **Positioning the Z-Bracket**.

1. Cut off and discard the existing Z-bracket.
2. Grind off the welds, leaving the differential housing smooth.
3. With the height sensor arm pinned and level, and the linkage at 90° to the arm and perpendicular to the ground, hold the new Z-bracket up to the linkage rod end and axle housing and mark the new position on the housing.

4. Remove the paint where the new Z-bracket will be located.
5. With the height sensor arm pinned and level, and the linkage at 90° to the arm and perpendicular to the ground, hold the new Z-bracket up to the linkage rod end and axle housing and mark the new position on the housing.

6. Find a good spot for the welder ground clamp on the housing near the work area. Remove paint as needed for good contact.
7. Weld the new Z-bracket in place. Weld the center hole first, then the top and side edge.

8. Check the position of the height sensor arm, linkage, and Z-bracket to make sure the angles are correct with the new Z-bracket position.
9. Once the Z-bracket and housing are cool, prime and paint the new Z-bracket and anywhere paint was removed. See **Group 98** of the *Cascadia Workshop Manual*.
