SUBJECT: Aftertreatment Harness Diagnostics

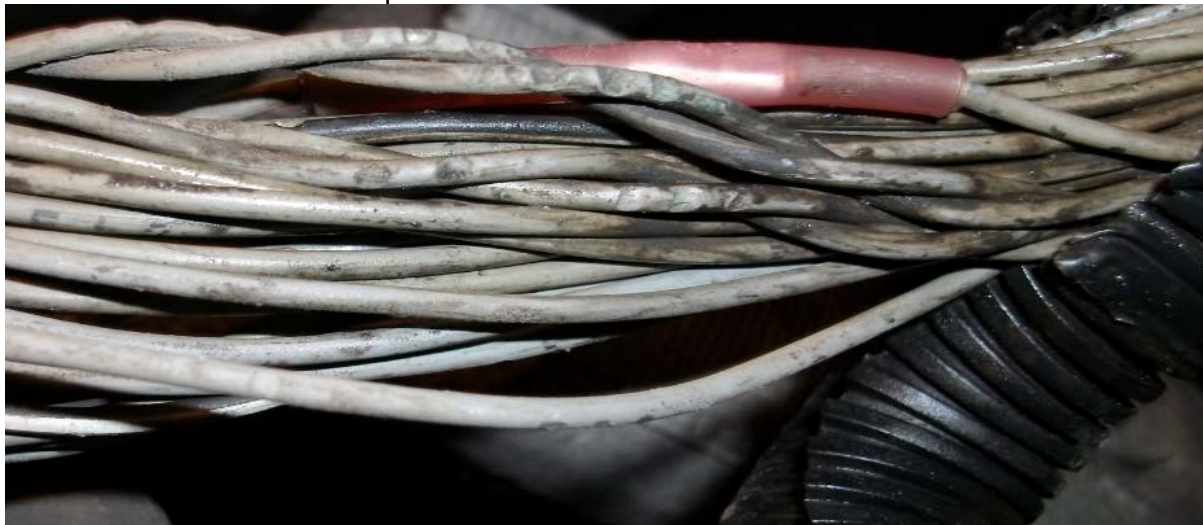
If after completing all troubleshooting in Power Service Literature and no issue was found, technicians should inspect the chassis side ATD harness. The chassis side harness links the aftertreatment harness to the ACM, DEF pump, DEF tank and heated DEF lines and is susceptible to wire chaffing and corroding within the wire loom. Technicians should inspect the areas listed below. The attached picture shows an example of wires chaffing within the harness, and a splice connection where a repair was made.

- Model year 2010 trucks have a higher tendency to rub on the two brackets above the transmission at the weather pack.
- Model year 2011 thru 2013 trucks have a tendency to rub on the bracket above the transmission where zip tied.
