122SD and Coronado
Business Class M2
Cascadia
> 108SD/114SD

Freightliner
Service Bulletin

General Information

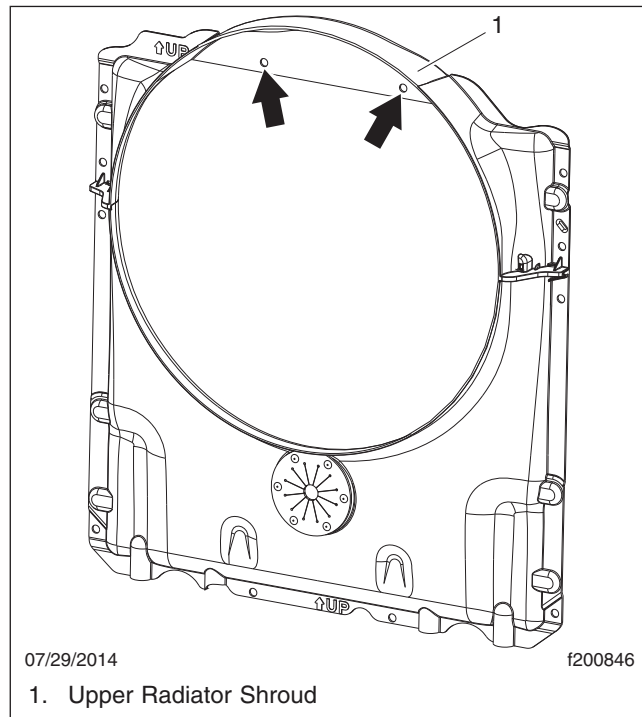
Fig. 1, Fastening Points

If the upper radiator shroud on a Freightliner 114SD equipped with a DD13 engine comes loose, it may be due to loose plastic push rivets (23-12274-003) that attach the shroud to the upper radiator tank. See [Fig. 1](#) for the push rivet location. If needed, replace the push rivets with metal J-nuts, fender washers, and 1/4–20 x 0.5 bolts.

When installing the shroud, use the 1/4–20 x 0.5 bolts listed in [Table 1](#). Using longer bolts will damage the radiator, which may lead to engine damage.

1. Park the vehicle on a level surface, shut down the engine, and set the parking brake. Chock the tires.
2. Remove the upper fan shroud. Discard the plastic push rivets.
3. Install J-nuts on the radiator at the two fastening points. See [Fig. 1](#). For the correct part numbers, see [Table 1](#).
4. Using fender washers and 1/4–20 x 0.5 bolts, attach the upper fan shroud to the radiator. For the correct part numbers, see [Table 1](#).
