Technical Bulletin

Model(s)	Year(s)	Eng. Code(s)	Trans. Code(s)	VIN Range From	VIN Range To
Eos	2006 - 2007	2.0L (BPY)	All	All	All
GTI	2006 - 2007	2.0L (BPY)	All	All	All
Jetta (A5)	2005 - 2007	2.0L (BPY)	All	All	All
Passat, Passat Wagon	2006 - 2007	2.0L (BPY)	All	All	All

15 14 01 March 11, 2014 2015153 Supersedes T. B. V151202 dated August 20, 2012 to update technical diagnosis labor operation in warranty table and update the Intake camshaft suffix number.

MIL ON, DTC P0087, P1093 or P2293 Stored in ECM Fault Memory

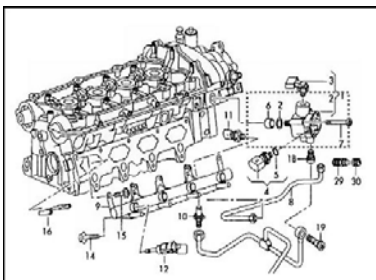
Figure 1

Remove the high pressure fuel pump and visually inspect:

1. Base surface of the cam follower -6- in contact with the camshaft lobe.
2. Tip of the high pressure fuel pump plunger.

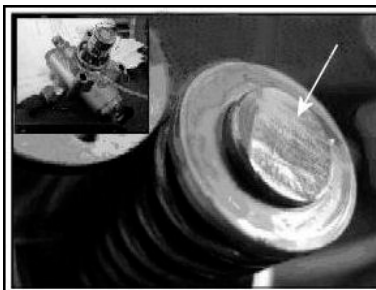
Figure 2

Inspect the tip of the high pressure fuel pump plunger (Figure 2) for excessive wear.

If plunger tip of fuel pump is **NOT WORN**, **DO NOT REPLACE** the fuel pump.

If excessive wear is found the high pressure pump must also be replaced, see Group 20 Fuel Supply in ElsaWeb.
