# Technical Bulletin

**01 14 07** March 18, 2014 **2014603** Supersedes Technical Bulletin V011005 dated April 1, 2010 to update SVM function information and to include *Response Codes* with explanation.

### Software Version Management

This Technical Bulletin details the general process for carrying out a Software Version Management (SVM) software update for any Technical Bulletin (TSB) / Required Vehicle Update (RVU).

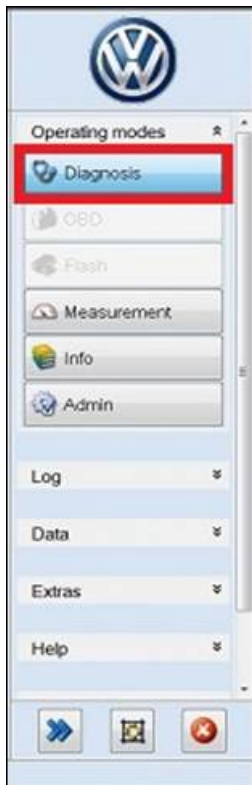
Figure 1

6. On ODIS start up, make sure to select “Diagnosis” under Operating modes and not “Flash” (Figure 1).

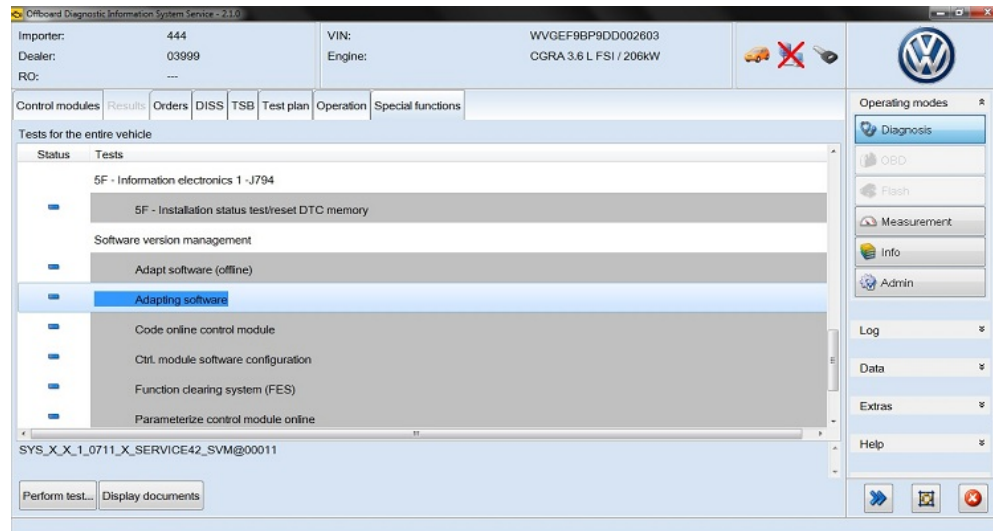
**Figure 2**

7. Enter the SVM test plan by selecting the following inside GFF: Special Functions >> Software Version Management >> Adapting Software (Figure 2).

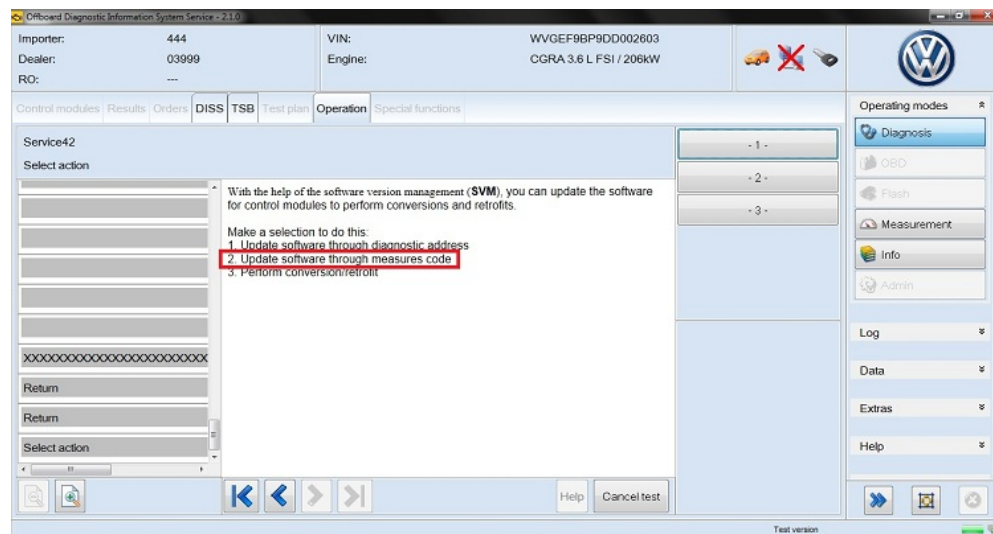
**Figure 3**

8. Select update software through measures code (Figure 3).

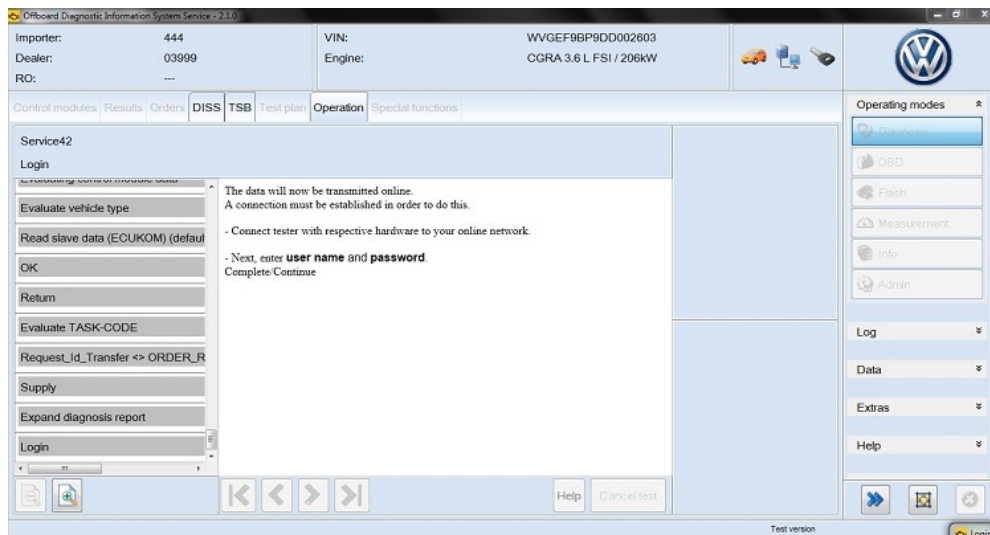
Figure 4

10. Enter your GeKo ID when requested. This will allow data to be transmitted to the SVM server and will provide instructions on how to continue the procedure (Figure 4).

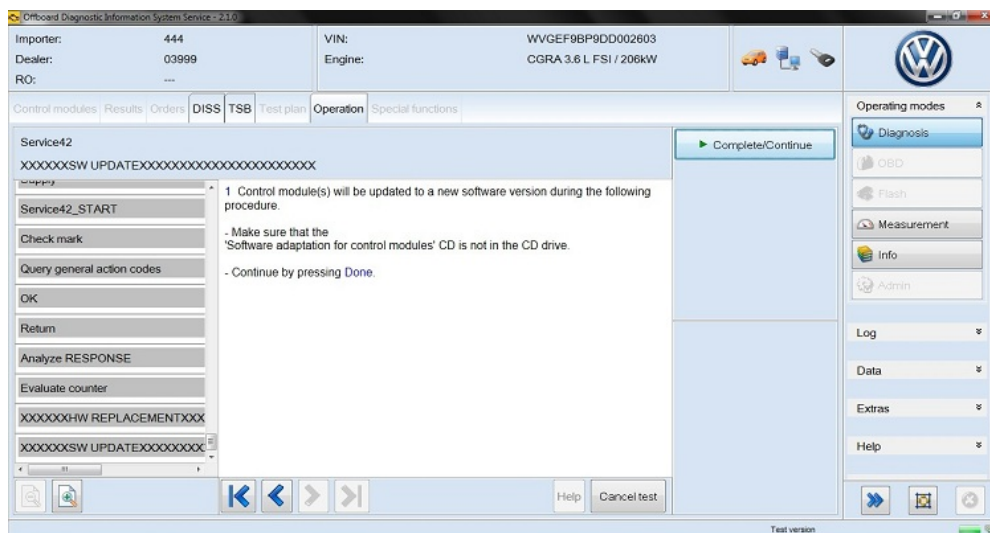
Figure 5

11. The procedure may include one, or any combination of the following comments for one or more control modules as specified in the Technical Bulletin/RVU (Figure 5):

- Update a Control Module (flash)
- Code or Adapt a Control Module

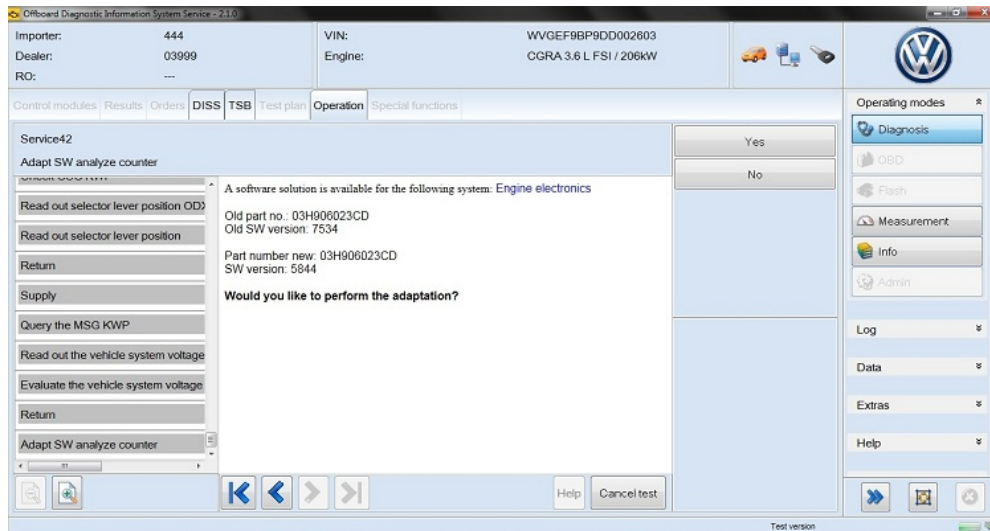
Figure 6

12. Select "Yes" to perform adaptation (Figure 6).

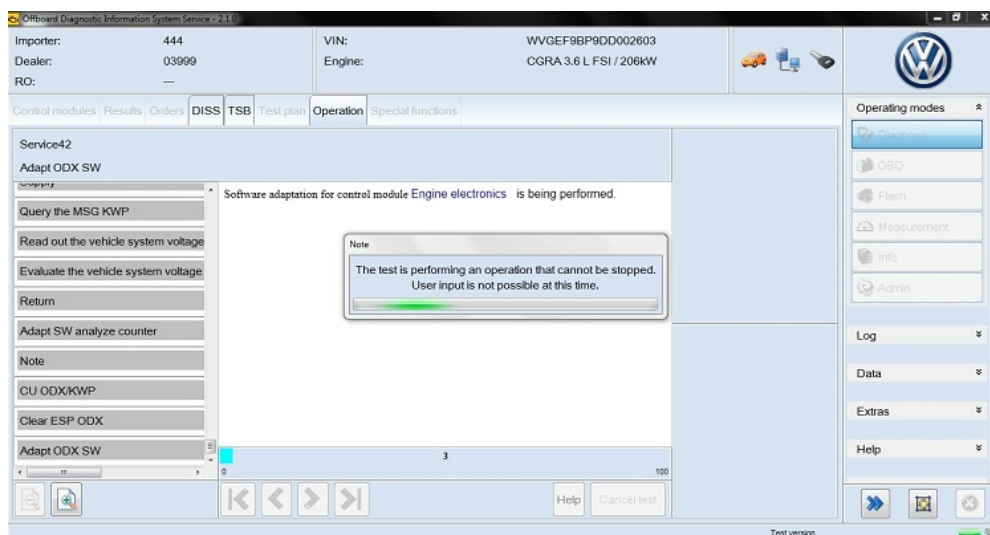
Figure 7

13. Software adaptation is being performed (Figure 7).

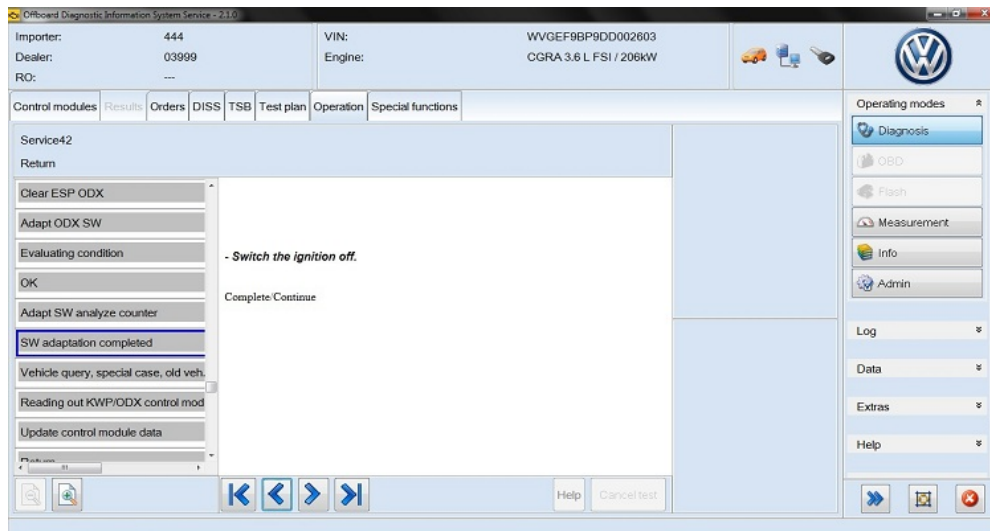
Figure 8

14. When the adaptation completes, switch the ignition OFF (Figure 8).

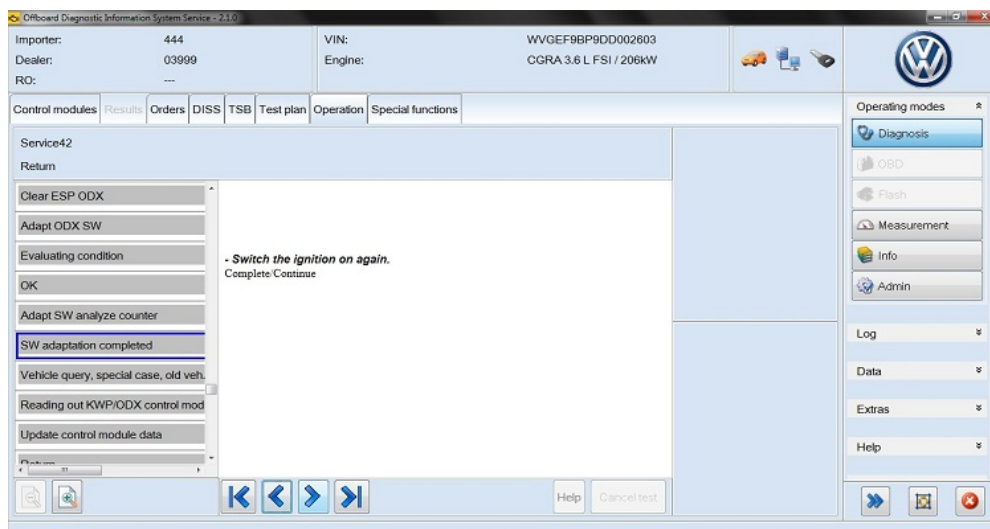
Figure 9

15. When prompted, switch the ignition ON (Figure 9).

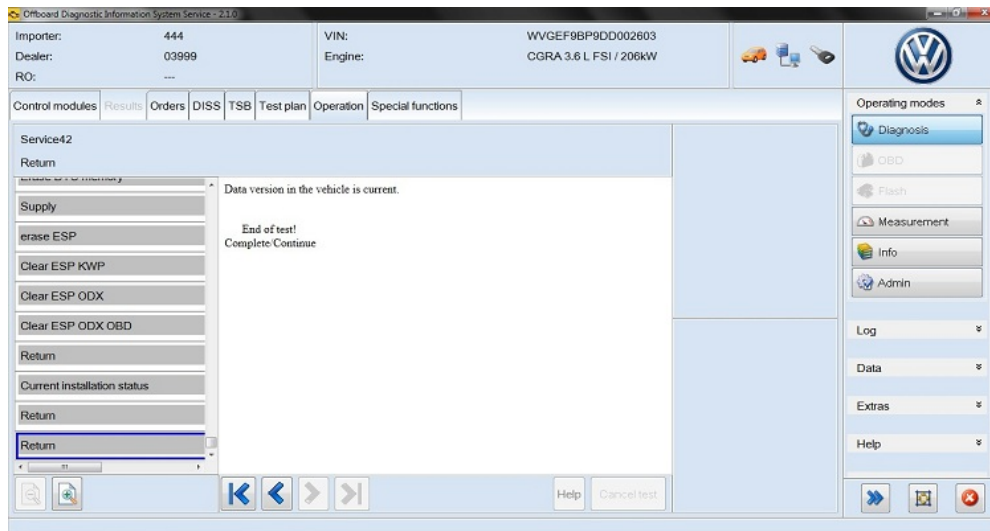
Figure 10

16. This completes the software adaptation “flash” (Figure 10).
