Technical Bulletin

21 14 03 April 24, 2014 **2026771** Supersedes T. B. V211108 dated November 16, 2011 to include additional model year applicability.

Engine Lacks Performance, Engine Warning Light ON, DTCs P2563, P2564, P0299 or P20D8 Stored in ECM Fault Memory

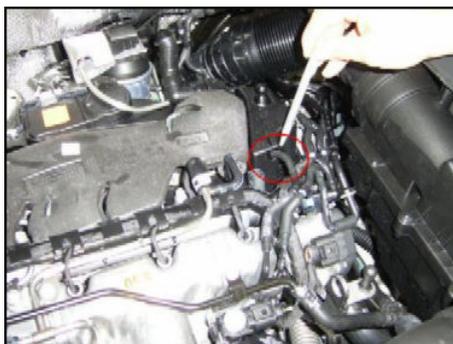
Figure 1

Hose not inserted into the vacuum container.

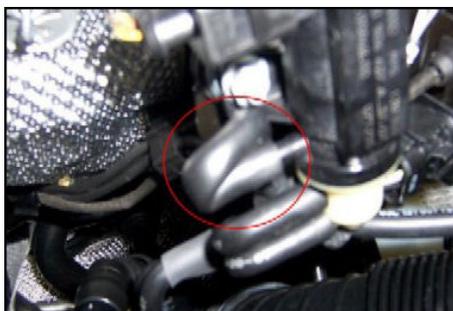
Figure 2

Vacuum hose at the solenoid valve, or in the pipe system, is kinked.

- Re-position hoses to avoid pinching. It is not necessary to replace the hoses.

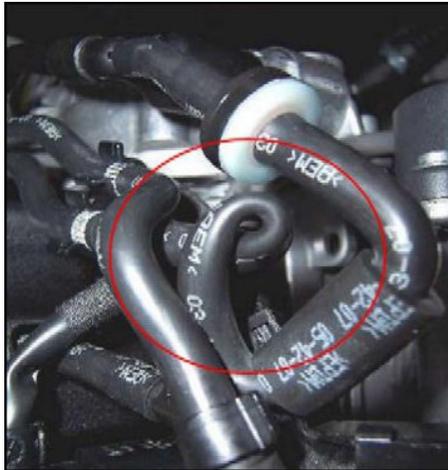
Figure 3

Vacuum hose at the solenoid valve, or in the pipe system, is twisted.

- Re-position hoses to avoid pinching. It is not necessary to replace the hoses.

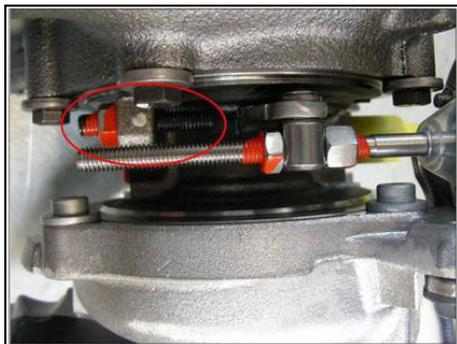
Figure 4

- Inspect the turbocharger stud with clamp nut (min. flow adjustment screw) (Figure 4).

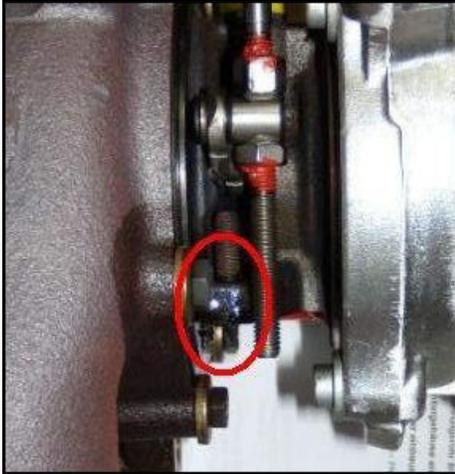
Figure 5

- Inspect the turbo charger to see whether the stud with clamp nut is broken (Figure 5).

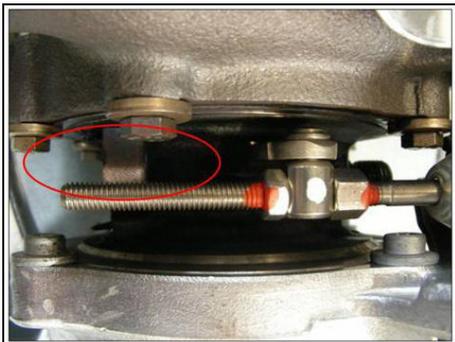
Figure 6

- Inspect the turbo charger to see whether the stud with clamp nut is missing (Figure 6).
- If the stud or clamp nut are missing, replace turbocharger.

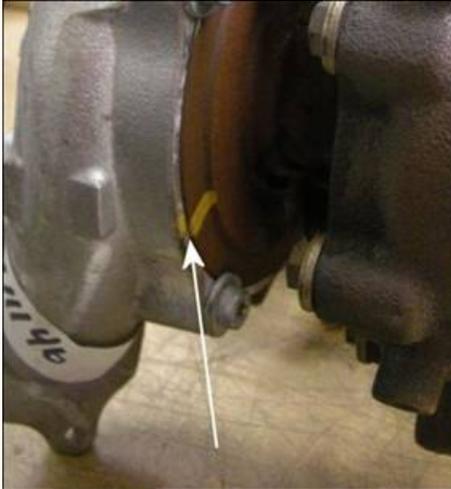
Figure 7

- Carefully inspect the turbocharger housing around the entire housing assembly for an alignment mark (Figure 7). If the alignment mark is misaligned, this indicates that the housing has rotated.
- If misaligned, replace turbocharger.

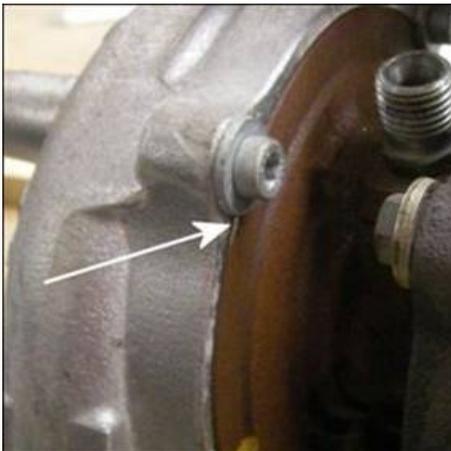
Figure 8

- Carefully inspect the turbocharger housing around the retaining bolts for witness marks (Figure 8), indicating that the housing has rotated.
- If witness marks are present from washers, replace turbocharger.

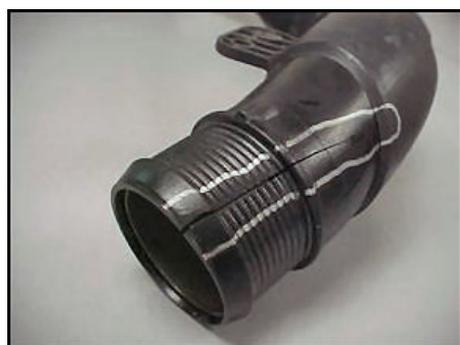
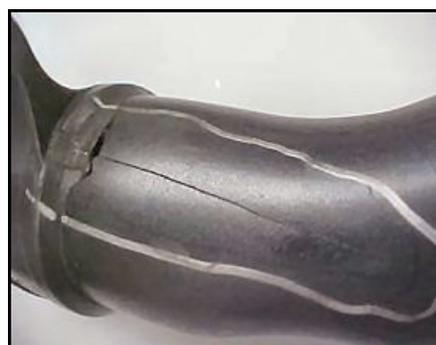
- Inspect the plastic boost pipe that runs from the intake side of the turbocharger to the intercooler for cracks or leaks (Figures 9 and 10).

These cracks can be difficult to see. It may be necessary to pressure test the charge air system according to the repair manual under Engine > Engine Mechanical, Fuel Injection and Glow Plug > 21 turbo charger, G charger =>Diagnosis and Testing => Charge Air System, Checking for Leaks.

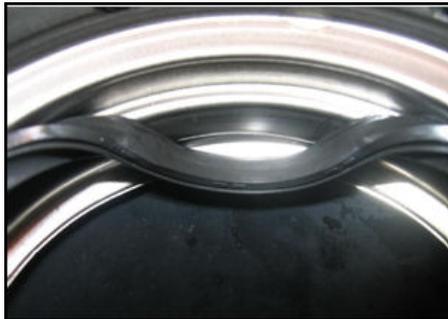
Figure 11

- Inspect the boost pressure hose connections to the intercooler for leaks.
- Ensure that the seals are in the proper position and not damaged (Figure 11). Damaged or missing seals should be replaced. The seals are available separately, it is not necessary to replace the entire hose.
