Technical Bulletin

96 14 01 May 2, 2014 2028844 Supersedes Technical Bulletin V961204 dated May 4, 2012 to add cargo light and trim panel inspection/replacement procedure and revise warranty statement.

Rear Cargo Lamp Loose or Falls Out when Closing Rear Lift Gate

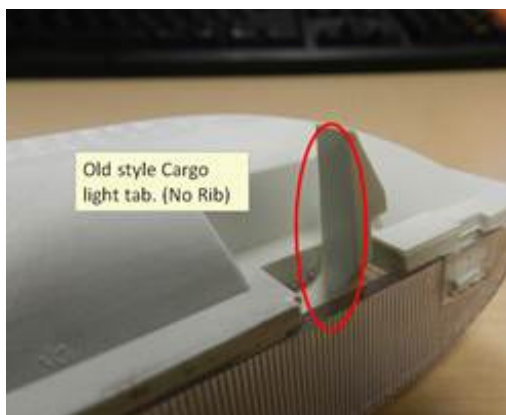
Figure 1

Original cargo light through MY 2012 will have no reinforced rib. (Figure 1)

- Inspect the rear cargo light.
- Using a trim removal wedge remove the rear cargo light and inspect for reinforced rib on fastener tabs.
- If the rib is missing on the reinforcement replace the rear cargo light with new part number in figure 2.

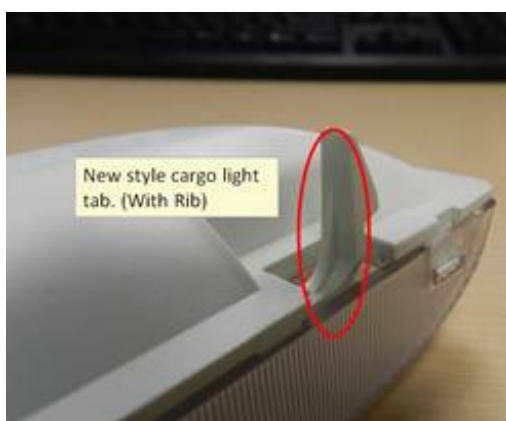
Figure 2

MY2013 introduced rib reinforcement with part number 7B0947105C. (Figure 2)

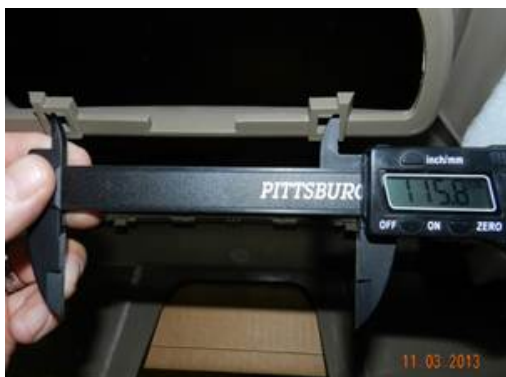
Figure 3

- Remove the lower lift gate trim panel.
- Measure the trim panel lower fastener holes distance between the outside edges as shown in Figure 3.

Is the distance greater than 115.7mm (+/- 1.5mm).

Yes: Replace the trim panel with part number 7B0867605D. (Always check ETKA for the latest part number and color code.)

No: Reinstall the trim panel.
