Tech Tips

TT 97-14-01

2011-2014 All models (Except Routan)– Washer Level Sensor

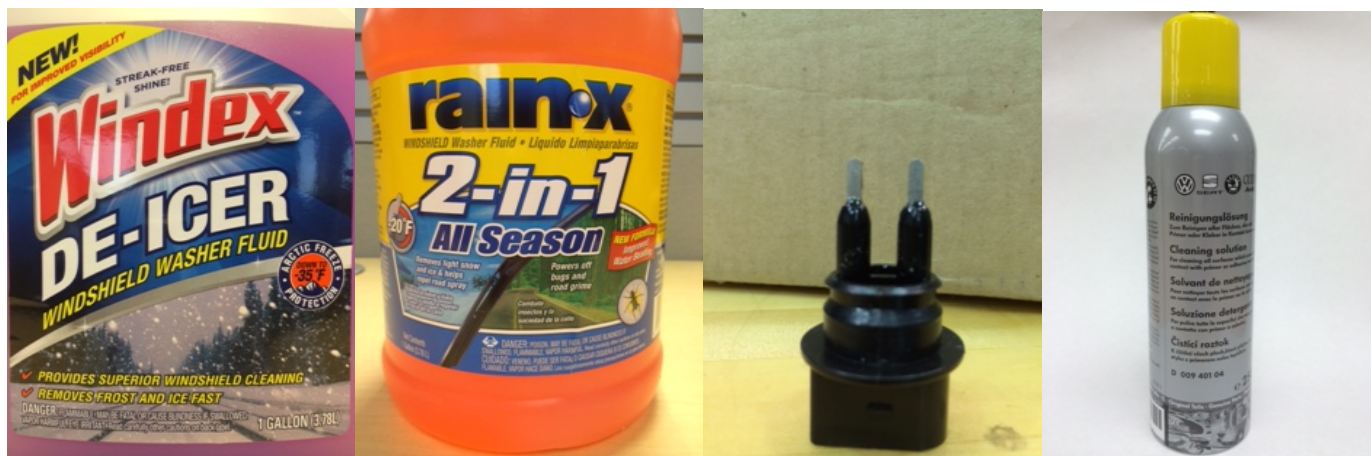
Non-approved fluids can cause residues to form on the sensor which causes the washer fluid lamp to remain on when reservoir is full. Below are examples of non-approved fluids, a picture of the sensor in question (G33) and a picture of the approved cleaner (D-009-401-04).

The indicator lamp in the I.P. for washer fluid remains illuminated and the washer reservoir is full. Validate the washer reservoir is full with the proper washer solvent (G-052-164). Refer to Elsa for proper fluid type and fluid quantities under repair manual, maintenance, fluid capacity table. If the fluid is not blue in color, drain the fluid, remove the sensor and clean with cleaner (D-009-401-04) or equivalent. Reinstall the sensor, top off washer reservoir with proper fluid and validate that the indicator lamp in the I.P. is no longer illuminated.
