VW Elsa Newsletter

Edition 97: August 4, 2014

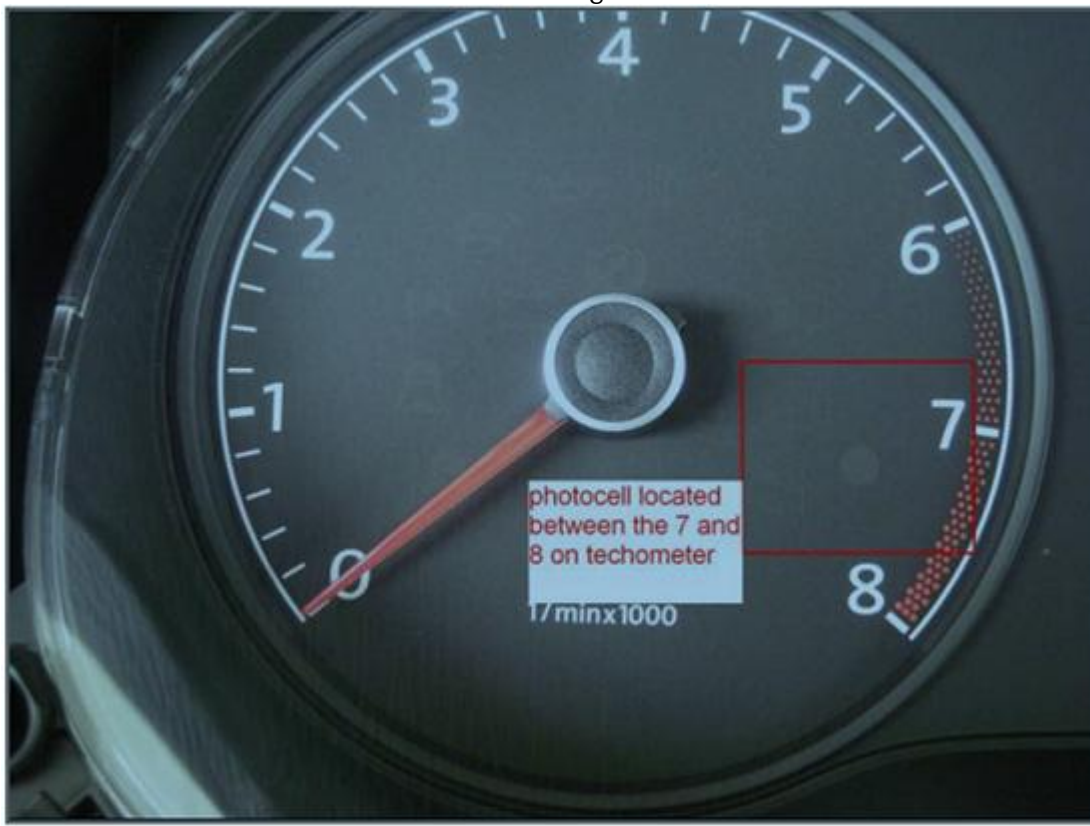
90-11-07 Instrument Cluster Illumination

The instrument cluster illumination is controlled by a photocell inside the cluster. If an illumination concern is suspected, darken the area over the photocell, or use a flashlight to simulate natural light changes, to see how the illumination is affected. See figure 1 below for example of the photocell location based on a 2011 Jetta sedan. Location can change based on model.

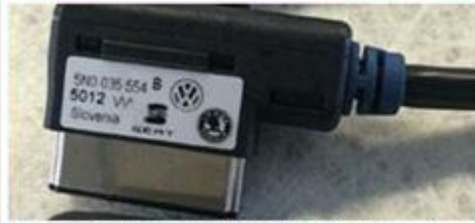
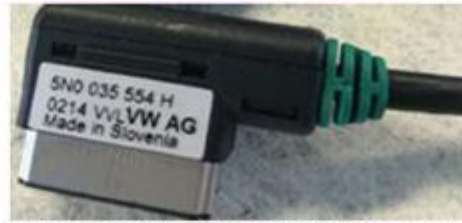
91-14-04 Entertainment Center MDI Cables – 2015 (A7) Golf/GTI			
Model(s)	Year	Eng.Code	Trans.Code
(A7) Golf/GTI	2015	All	All

For the A7 Golf/GTI the MDI cables are not the same as the ones used in the A6 Platform. Below you can see it is easy to tell the difference. When performing a PDI, check to make sure the correct cables are included in the by-pack. If a missing or incorrect cable is found please open a VTA during the launch period.

These 2 cables are the correct cables. Look for the green and blue collars around the cable.

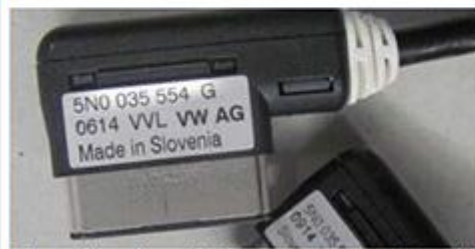
The cable above is the incorrect cable. This can be identified by the white collar around the cable.
