Technical Bulletin

87 14 07 August 6, 2014 **2037280**

Water /Snow in Blower Housing

Blower Motor Noisy, Water/ Snow Ingress in the Blower Housing

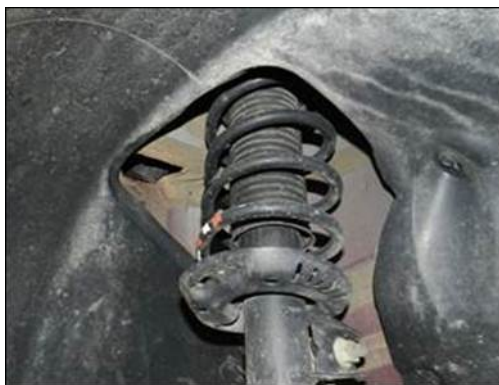
Excess water/snow enters the water box through the drain port located in the wheel housing. Revised parts.

Original wheel liner 561.805.912C.

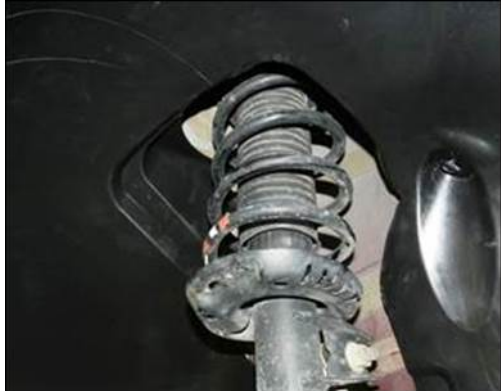
New wheel liner 561.805.912D_9B9 with added material.

- Remove and replace the passenger wheel liner with 561.805.912D.

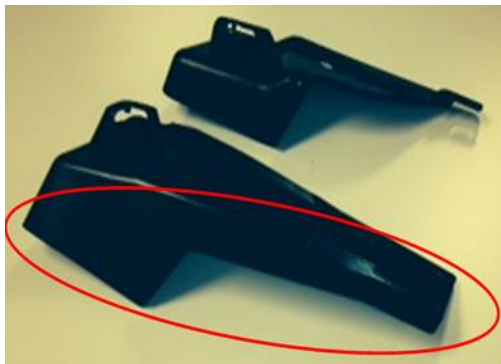
New HVAC air inlet cover 561.815.159C with added material.

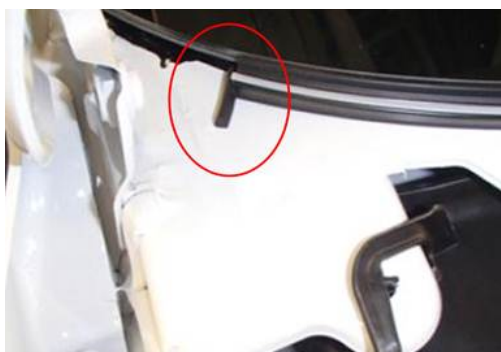
Addition of water deflector 3C0.845.237.

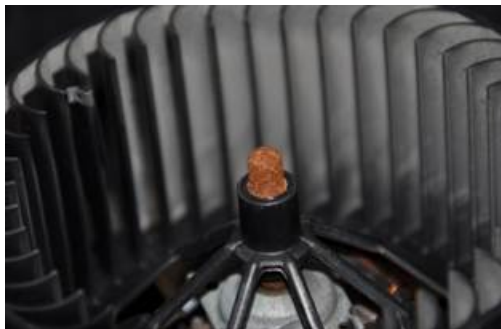
- Remove and inspect the blower motor, Check for water ingress in the blower housing

- Signs of water contamination, corrosion or rust
- Noise from blower bearings
- Blower is hard to turn or binding

Replace the blower if the following conditions are found.

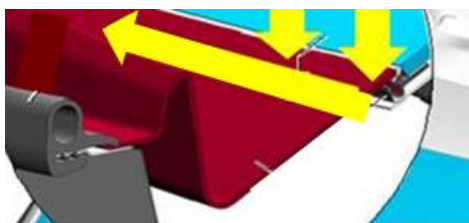
Be sure to press firmly down to snap the cover completely into the retainer. If the cover is not snapped in excess water will run under the cover.

- Reinstalling Plenum, Chamber Cover
